Inspect Minnesota & Midwest Soil Testing

SUBSURFACE SEWAGE TREATMENT SYSTEM COMPLIANCE REPORT

Date: February 23, 2016 **Time:** 12:45 PM **Owner:** Roger & Kim Zimmerman **Inspection Address:** 9861 51st St N, Lake Elmo, MN **Site Conditions:** 4" Snow 4" Frost

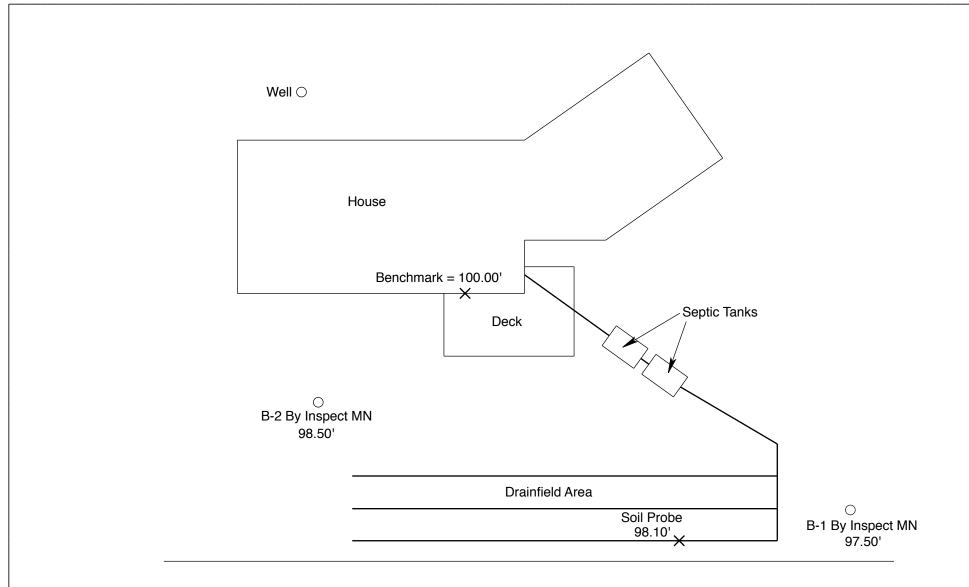
Log Of Soil Borings

My inspection indicates that this system is presently "non-compliant" in accordance with MPCA rules 7080.1500 Subp.4(B)(D) because of the lack of the required three foot separation between the bottom of the drainfield and seasonally saturated soils. This system <u>is not</u> an imminent threat to public health or safety per MPCA rule 7080.1500 Subp. 4(A).

Locat	Location of Project: 9861 51st St N, Lake Elmo, MN 55042					
	ings Made By:	Inspect Minnesota	Date: 2/23/16		2/23/16	
	Auger Used:	Hand/Bucket	Class	sification System:	USDA	
Во	oring Number:	1		Boring Number:	2	
Surface		97.50'	Surface	2		
Elevation of		: 100.00' patio door	Elevation of		98.50'	
Boring	l th	reshold	Boring			
Depth In	Soils Er	ncountered	Depth In	Soils Encountered		
Inches 0-8	10VP 2/2	Sandy Loam	Inches 0-10	10VP 4/2 Loam	(Fill/Disturbed) With	
8-35		Loamy Sand	0-10		Redox	
35-41	10YR 3/4	Sandy Loam	10-24	10YR 3/4	4 Sandy Loam	
41-47		andy Loam With	24-35		andy Loam With	
47-55		7.5YR 5/8 Redox 3 Loam With	35-42		5/8 Redox andy Loam With	
	10YR 6/1 &	7.5YR 5/8 Redox	55 ,2	10YR 5/3 L	oam Layers And	
55-67		andy Loam With		7.5YR 5/8 &	10YR 6/2 Redox	
	10YR 6/2 &	7.5YR 5/8 Redox

95.52' Elevation To Bottom Of Distribution Media		95.52'	Elevation To Bottom	Of Distribution Media		
-94.08' Depth To Redox Or End Of Boring		-96.50'	Depth To Redox			
=1.44'/17" Of Separation		=0'/0"	Of Separation			
End Of Boring At: 67"				End Of Paring At-	42"	
				End Of Boring At: Redox Present At:	24"/96.50'	
Redox Present At: 41"/94.08' Standing Water Present At: None			Standing Water Present At: None			
Standing water Present At: None			Standing	water Hesent At.	INUITE

Bottom Of Distribution Medium At: 31" Or Elevation 95.52' At Soil Probe
