Compliance Inspection Form
Existing Subsurface Sewage Treatment Systems (SSTS)

Property address: 932 NW 2nd St Forest Lake, MN 55025

Brief system description: 1500 gallon septic tank, 1000 gallon lift station, mound dispersal system

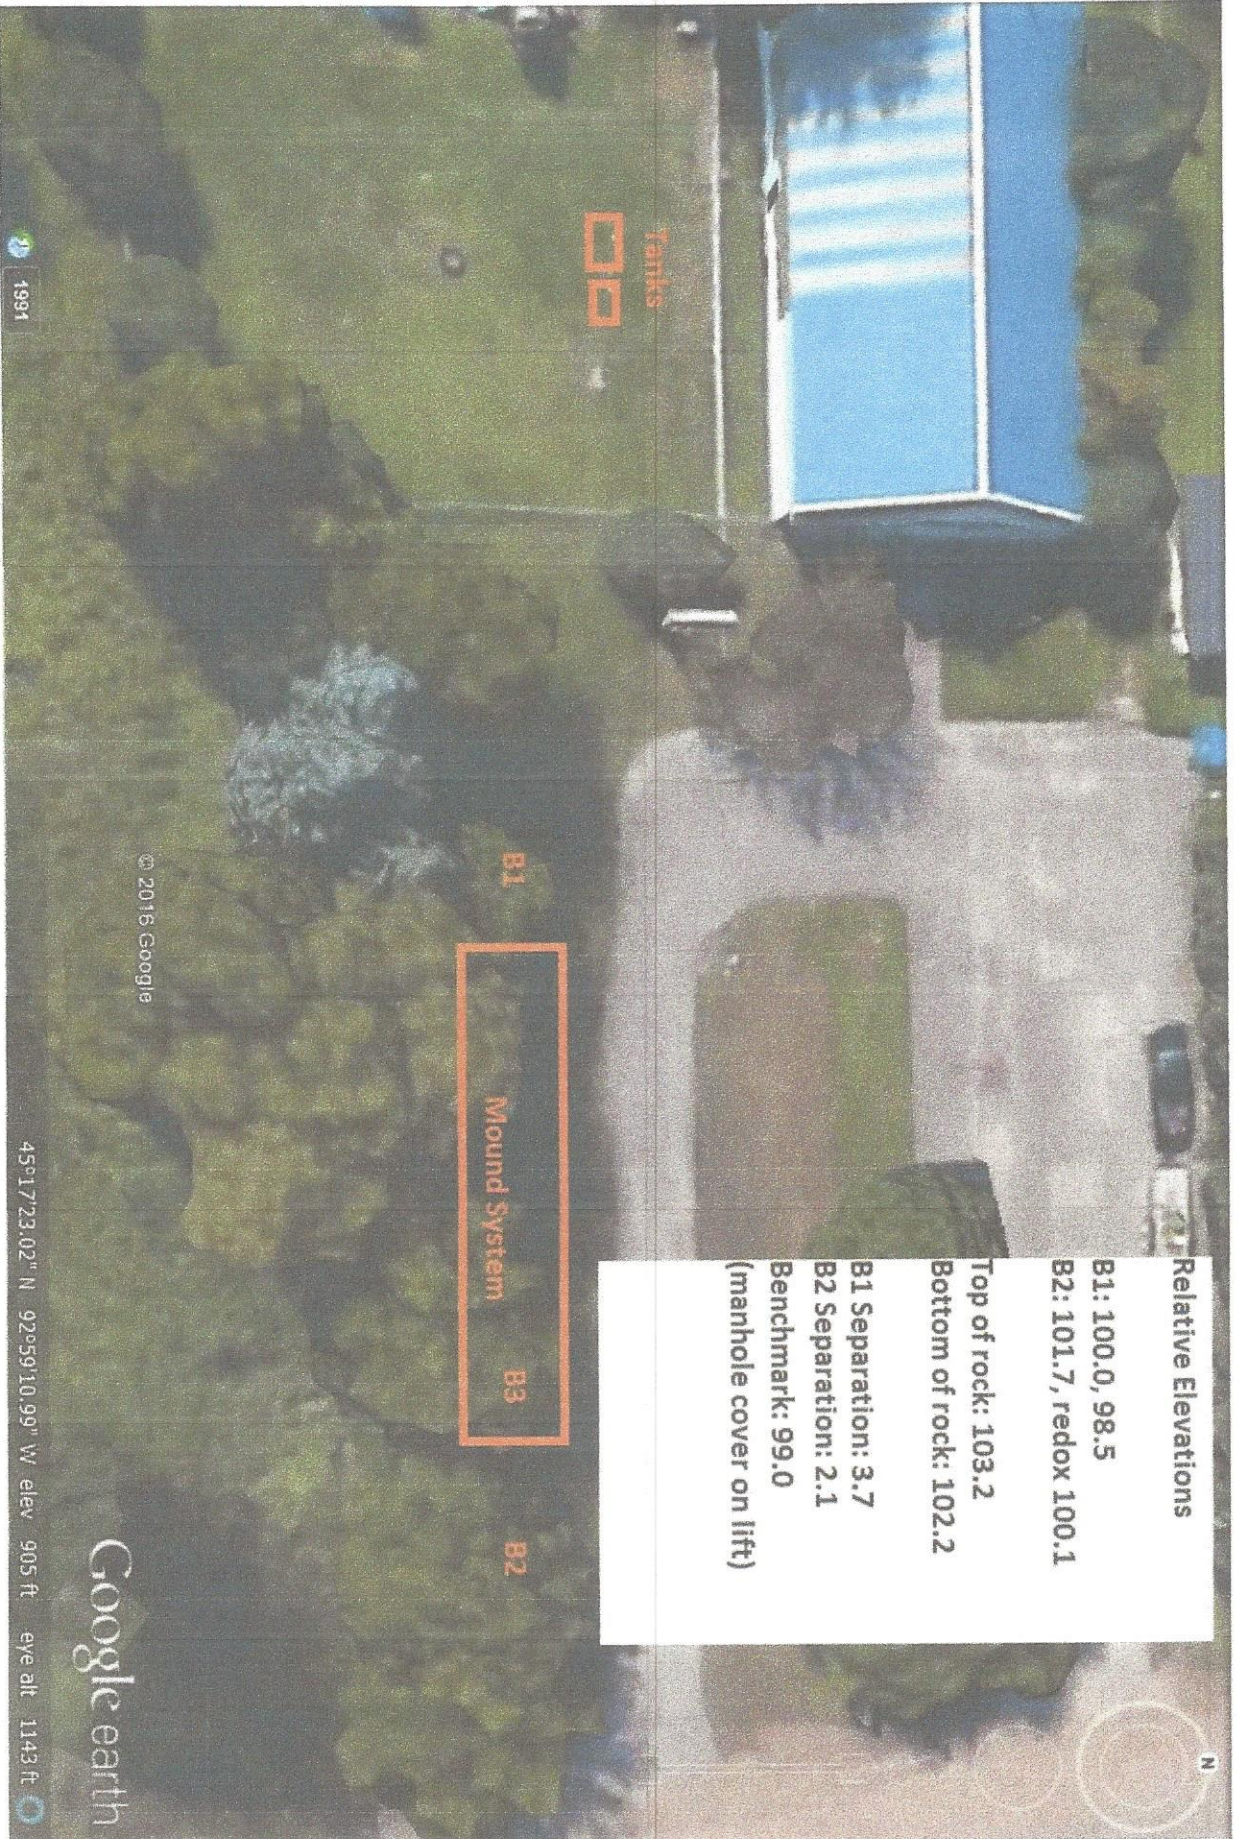
Mound is situated up/down a slope of about 2.5-3.0%. This skews elevations shot on site to the positive on the downslope and negative on the upslope. A boring performed on top of the mound showed 18 inches of sand under the rock, and both borings had redox between 18-20 inches. Despite slope alignment, system has required vertical separation.

Relative Elevations

B1: 100.0, 98.5

B2: 101.7, redox 100.1

Top of rock: 103.2

Bottom of rock: 102.2

B1 Separation: 3.7

B2 Separation: 2.1

Benchmark: 99.0

(manhole cover on lift)
