Inspect Minnesota & Midwest Soil Testing

SUBSURFACE SEWAGE TREATMENT SYSTEM COMPLIANCE REPORT

Date: May 2, 2018

Inspection Address: 9411 Newgate Ave N, Stillwater Twp, MN 55082

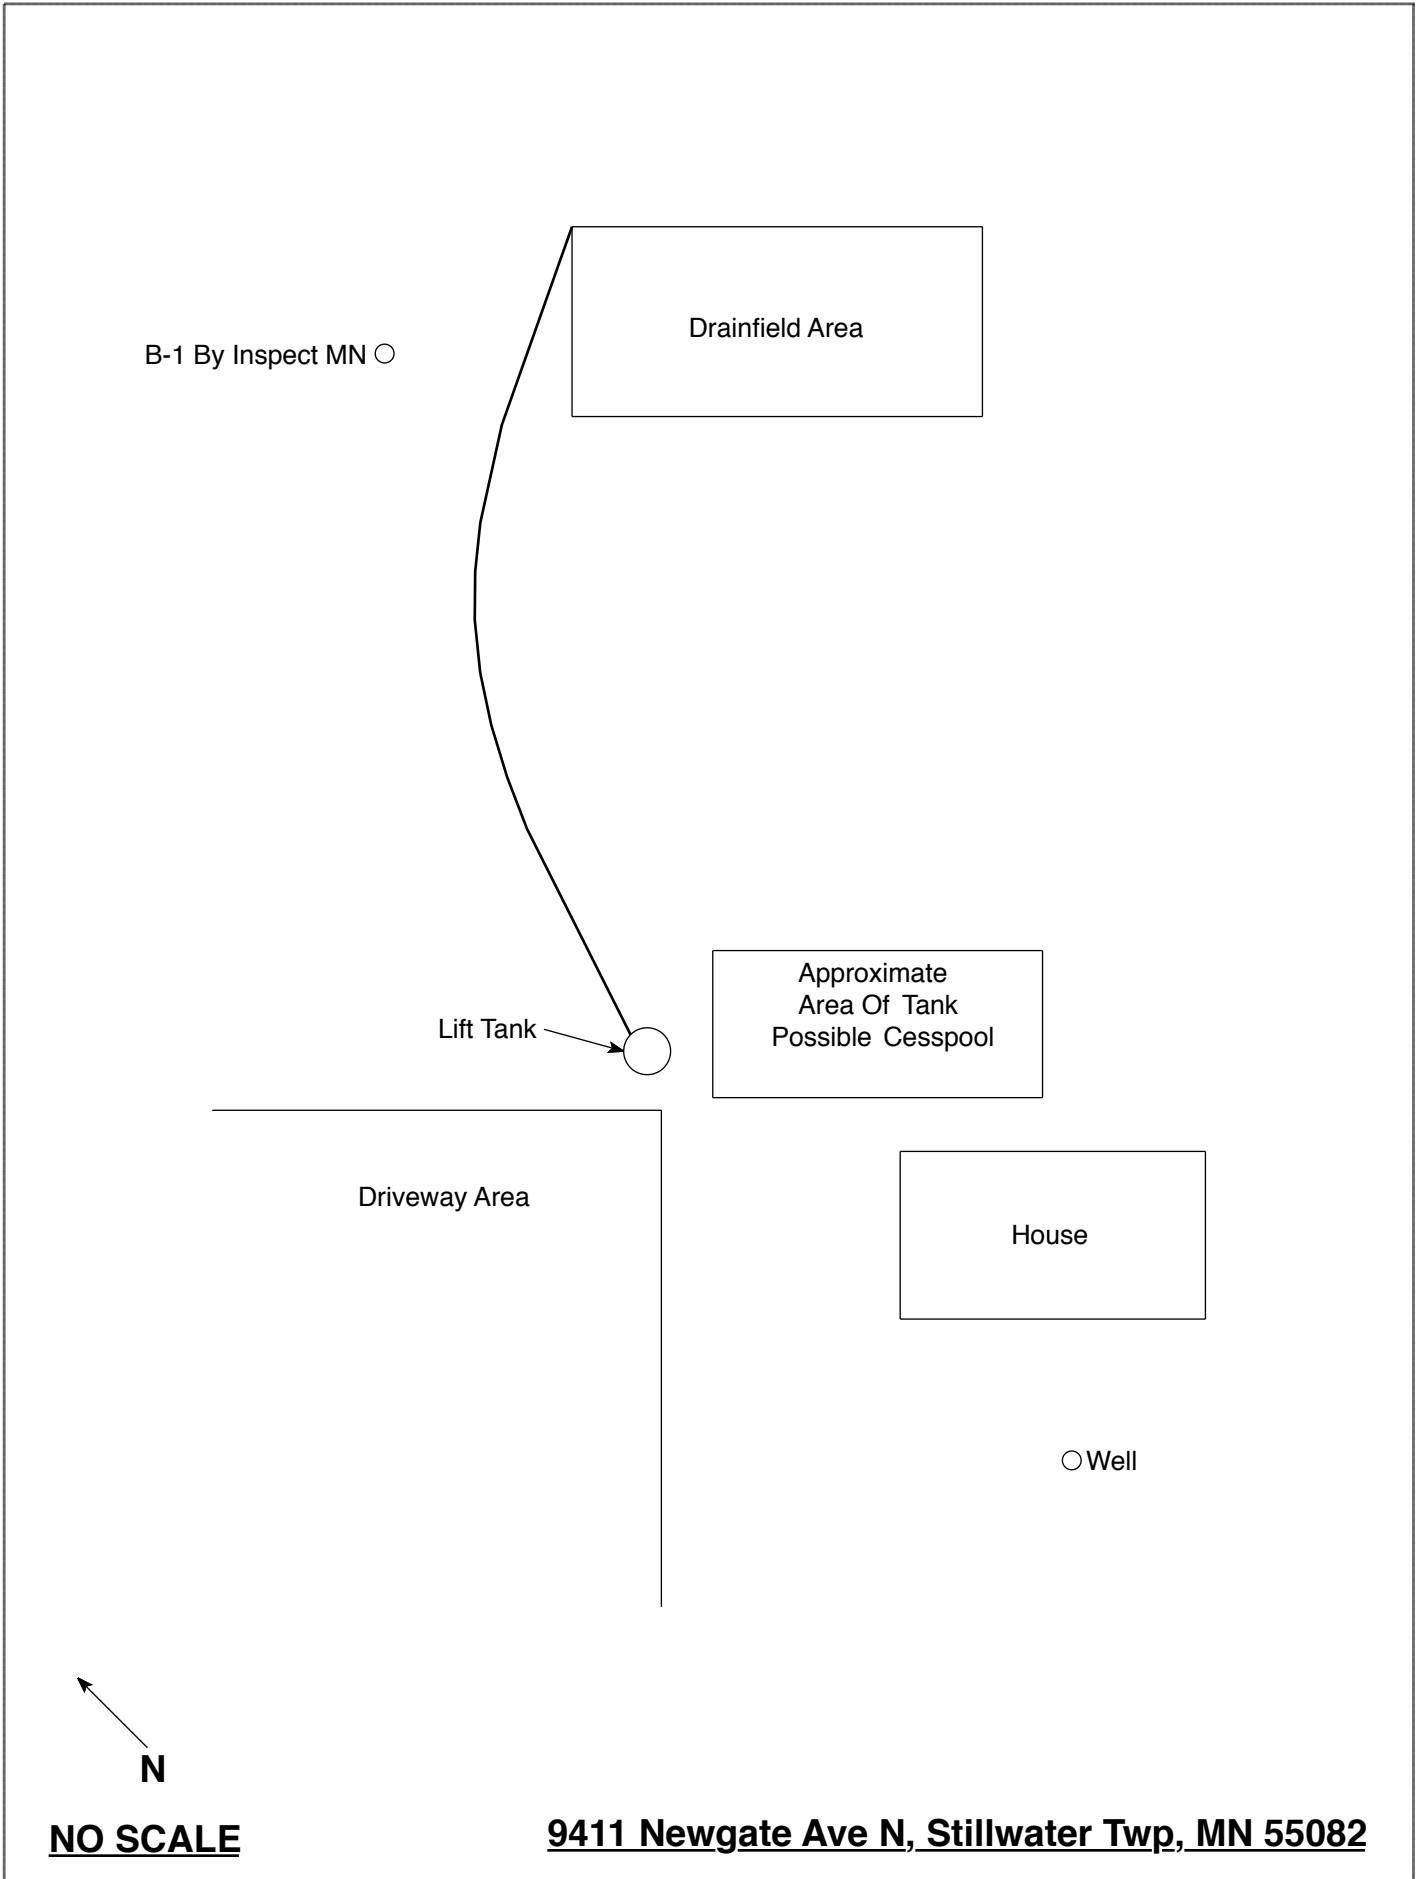
B-1 By Inspect MN ○

Drainfield Area

Lift Tank

Approximate
Area Of Tank
Possible Cesspool
