Minnesota Pollution Control Agency 520 Lafayette Road North St. Paul, MN 55155-4194	Control Agency 520 Lafayette Road North Existing Subsurface Sev	
Inspection results based on Minnesota Por requirements and attached forms – additional		For local tracking purposes:
Submit completed form to Local Unit of G within 15 days	overnment (LUG) and system owner	
System Status

Parcel ID# or Sec/Twp/Range: 1603220440003

Property address: 21207 NEW	VBERRY AVENUE N SCANDIA MN	Reason for inspection: SALE		
Property owner: CRAIG PETERSON		Owner's phone:		
or				
Owner's representative:		Representative phone:		
Local regulatory authority:	ASHINGTON COUNTY	Regulatory authority phone:		
Brief system description: 2) 1000-GALLON SEPTIC TANKS, 1000-GALLON LIFT TANK PRESSURIZED MOUND SYSTEM				
Comments or recommendations:

Compliance Inspection Attachment for Existing Individual Sewage Treatment Systems

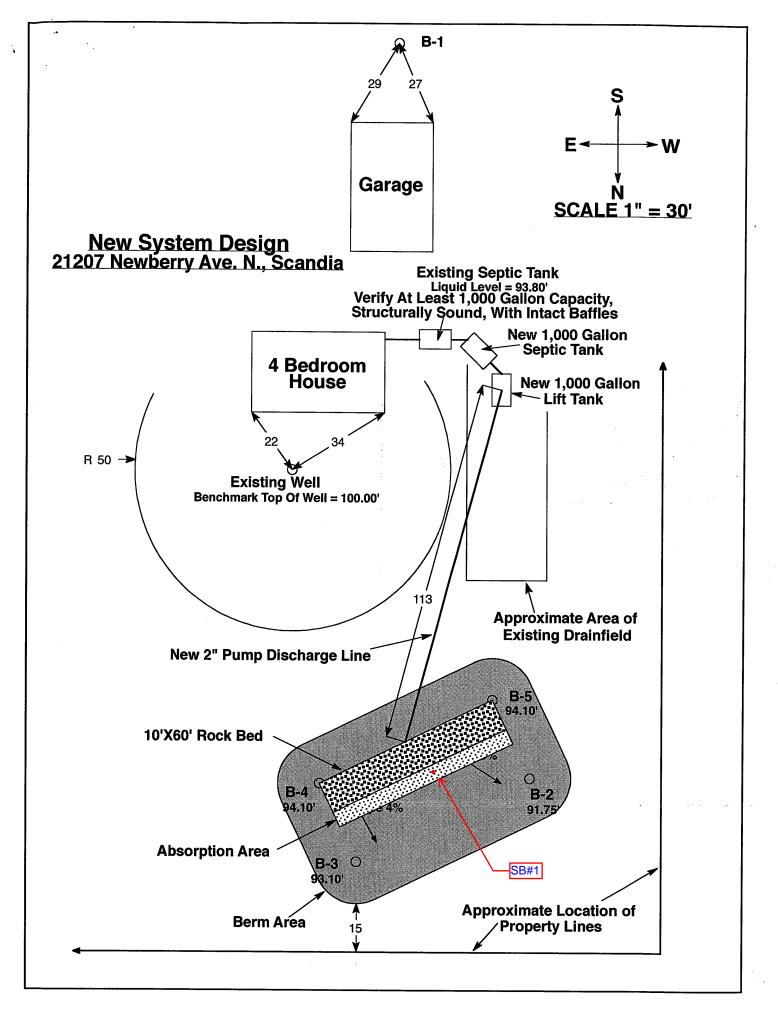
Sketch:

Comments: Benchmark = Top of manhole cover on lift tank. Assumed elevation = 100'0". Soil boring #1 indicated redoximorphic mottling at 60". The system does meet the required 36" (32" with the allowed 15% reduction) vertical separation from seasonally saturated soils. The system consists of two 1000-gallon septic tanks, a 1000-gallon lift tank and a 600 sq. ft. pressurized mound system. The tanks were not pumped for this inspection and due to be pumped in July 2019. The baffles were checked and are o.k. The lift pump was manually run and operable, the control floats and alarm are in working order. The mound was dosed with approximately 200 gallons of effluent with no signs of ponding observed in the sand or rock layers of the mound. There is a minimal amount of cover over the mound (4-6"), however enough for grass to grow and no erosion was observed. This inspection is not a warranty or guarantee, either written or implied, of future or long-term hydraulic functionality/performance, but rather a determination if the systems use is/may cause pollution and/or adverse harm to the environment, groundwater or public health and safety at the time of this inspection. No guarantee can be made on future hydraulic performance, or the performance of system components (pumps, controls, etc.). Changes in use can cause any system, failing or compliant, to become hydraulically overloaded and ultimately fail. Owner/buyer assumes full responsibility for the long-term performance of this system as well as any future upgrade, repairs or replacement costs. Liability is limited to the cost of this inspection.
