Compliance Inspection Form
Existing Subsurface Sewage Treatment Systems (SSTS)

System status on date (mm/dd/yyyy): 9/26/2018

Property address: 12640 Mayberry Trail N Scandia, MN 55073 Reason for inspection: Sale

Brief system description: 1500 gallon septic tank, 1000 gallon septic tank, 1000 gallon lift station, mound dispersal system

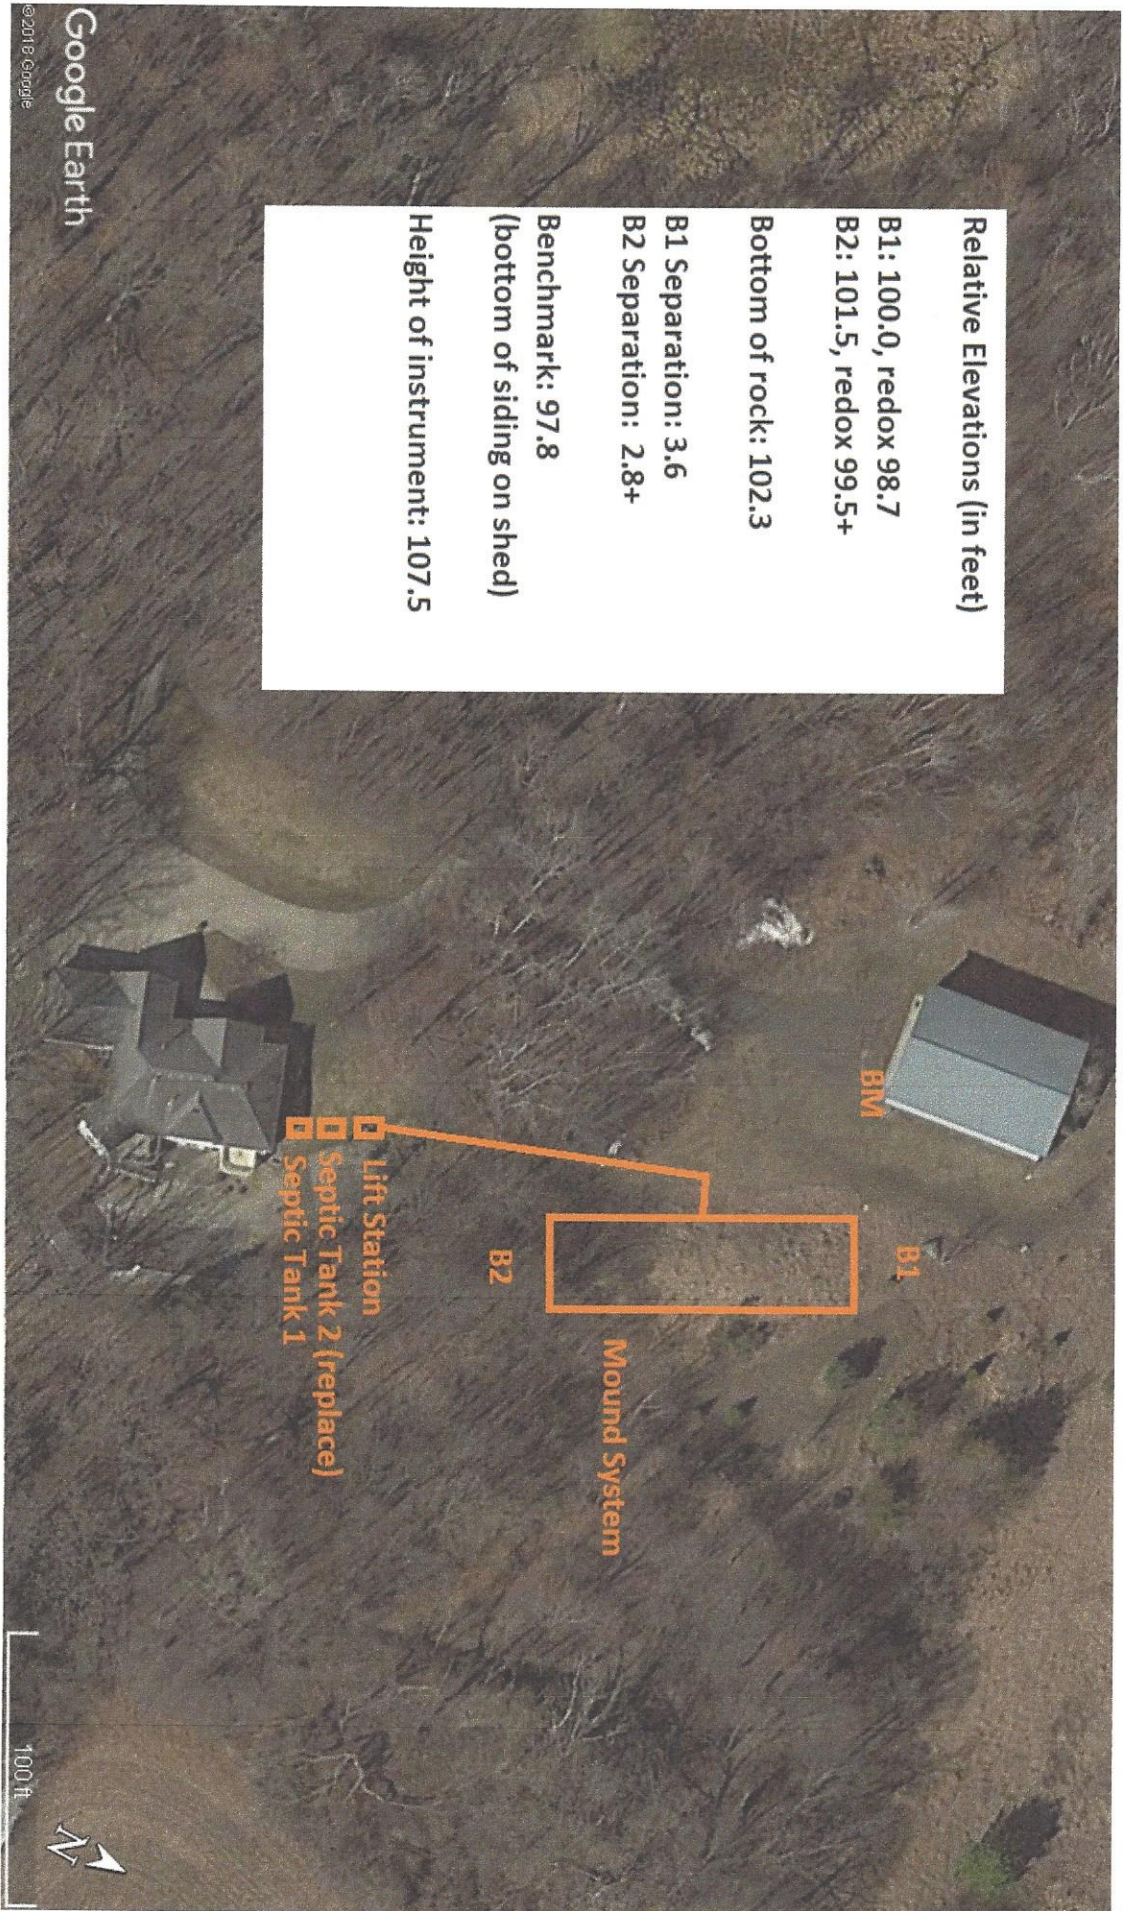
**Relative Elevations (in feet)**

B1: 100.0, redox 98.7

B2: 101.5, redox 99.5+

Bottom of rock: 102.3

B1 Separation: 3.6

B2 Separation: 2.8+

Benchmark: 97.8  
(bottom of siding on shed)

Height of instrument: 107.5
