Inspect Minnesota & Midwest Soil Testing

SUBSURFACE SEWAGE TREATMENT SYSTEM (SSTS) COMPLIANCE REPORT

Inspection Address: 4210 Penfield Ave S, Afton, MN 55001

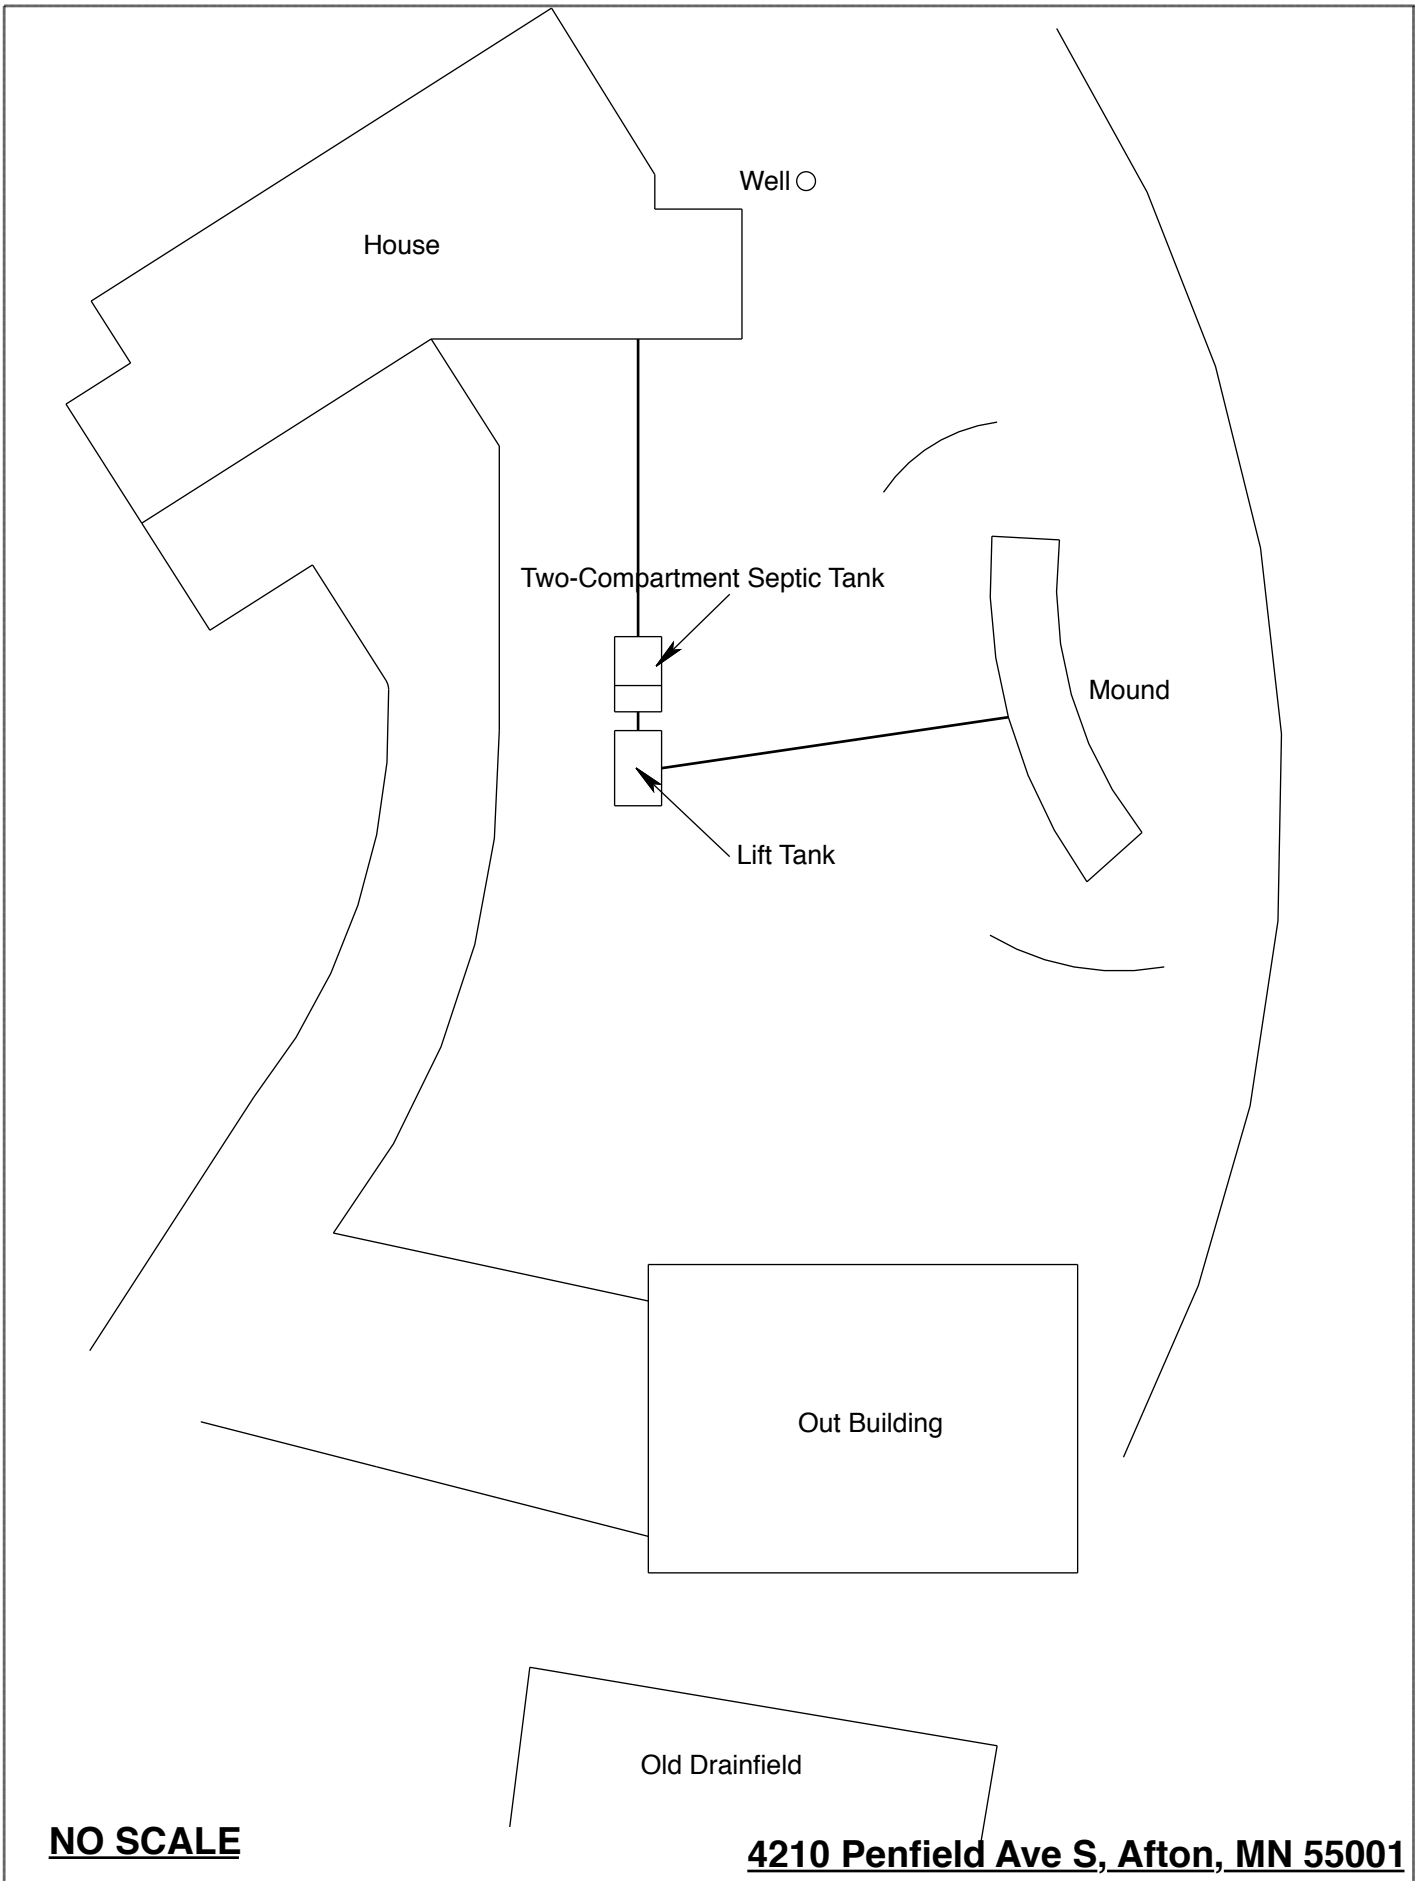
4210 Penfield Ave S, Afton, MN 55001

In addition, it should be noted that there was a valve located in the lift tank, which would allow effluent to be pumped into an old drainfield. This drainfield has been permanently disconnected from the main system.

Disconnected
