#### **Inspect Minnesota & Midwest Soil Testing**

#### SUBSURFACE SEWAGE TREATMENT SYSTEM (SSTS) COMPLIANCE REPORT

Inspection Address: 20941 Meadowbrook Ave N, Scandia, MN 55073

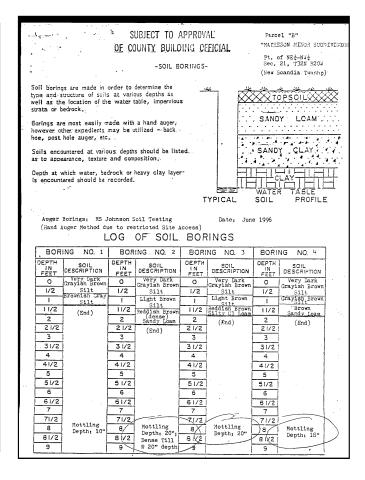
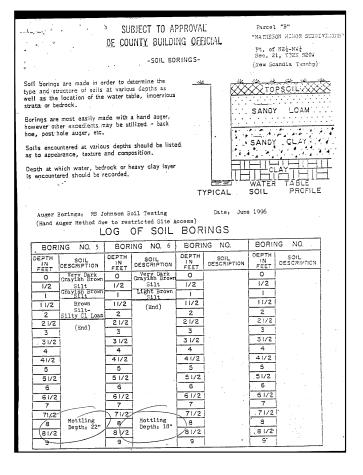
Location of Project: 20941 Meadowbrook Ave N, Scandia, MN 55073					
Borings Made By: Inspect Minnesota		Date:		5/13/19	
Auger Used: Hand/Bu		Hand/Bucket	Classification System:		USDA
Boring Number: 1		1		Boring Number:	
Surface Elevation of Boring  51" below top of mound on original contour		-	Surface Elevation ( Boring	of	
Depth In Inches	Soils E	ncountered	Depth In Inches	Soils En	countered
0-8 8-17 17-21	10YR 4/4 Fine 10YR 4/4 Fine Sa	/2 Silt Loam Sandy Loam (Moist) Indy Loam (Saturated) S & 10YR 6/2 Redox			
17"	Depth To End Of B	oring Or Redox		Depth To End Of Bo	oring Or Redox
+51"	Elevation Of Boring	g Below Top Of Mound	E	Elevation Of Boring	Relative To System
-22" Depth To Bottom Of Distribution Media				f Distribution Media	
=46" Of Separation			Of Separation		
	E J Of D - 1 At	24"		End Of Delta At 1	
End Of Boring At: 21"			End Of Boring At:		
Redox Present At: 17"		Redox Present At:			
Standing Water Present At: None		ivone	Standing	Water Present At:

Bottom Of Distribution Medium At: 22 Inches

#### Log Of Soil Borings Location of Project: 20941 Meadowbrook Ave N, Scandia, MN 5507 Borings Made By: Inspect Minnesota Date Auger Used: Hand/Bucket Classification System 5/9/16 Boring Number: Boring Number: Surface 54" below top of mound on original contour Elevation of Elevation of Boring Depth In Boring Depth In Soils Encountered Soils Encountered Inche 10YR 2/2 Loamy Sand 10YR 4/3 Sandy Loam 7.5YR 4/4 Sandy Clay Loam 7.5YR 4/4 Sandy Clay Loam With 7.5YR 5/8 Redox Depth To End Of Boring Or Redox Depth To End Of Boring Or Redox Elevation Of Boring Relative To System Elevation Of Boring Relative To Syste Depth To Bottom Of Distribution Media Of Separation Depth To Bottom Of Distribution Media Of Separation End Of Boring At: End Of Boring At: Redox Present At: Standing Water Present At: Redox Present At: Standing Water Present At: Bottom Of Distribution Medium At: 22 Inches
