SUBSURFACE SEWAGE TREATMENT SYSTEM (SSTS) COMPLIANCE REPORT

Date: August 28, 2019

Inspection Address: 4961 Northbrook Blvd N, Baytown, MN 55082

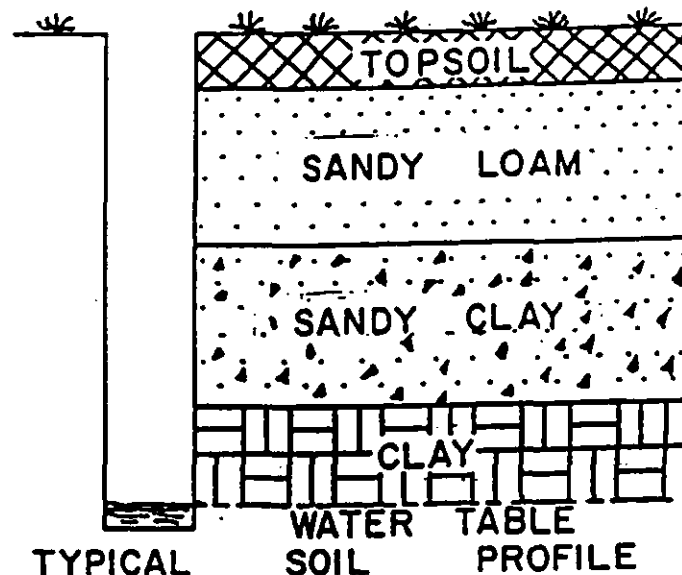
LOG OF SOIL BORINGS

BORING NO. 5		BORING NO. 6		BORING NO. 7		BORING NO. 8	
DEPTH IN FEET	SOIL DESCRIPTION	DEPTH IN FEET	SOIL DESCRIPTION	DEPTH IN FEET	SOIL DESCRIPTION	DEPTH IN FEET	SOIL DESCRIPTION
0	Dark Brown Silt	0	Dark Brown Silt	0	Dark Brown Silt	0	Very Dark Grayish Brown Fine Sandy Loam
1/2	Brown Silt	1/2	Yellowish Brown Silt	1/2	Yellowish Brown Silt	1/2	Yellowish Brown Silt
1	Dark Brown Silt	1	Pale Brown Silt	1	Brown Silt	1	Silt
1 1/2	Dark Brown Sandy Loam	1 1/2	Pale Brown Silty Clay Loam	1 1/2	Pale Brown Silt	1 1/2	Dark Brown Silt
2	(End)	2	Dark Brown Sandy Loam	2	Silt	2	Dark Brown (7.5YR 4/4) Sandy Loam
2 1/2		2 1/2	(End)	2 1/2	(End)	2 1/2	Dark Brown (7.5YR 4/4) Silt
3		3		3		3	
3 1/2		3 1/2		3 1/2		3 1/2	
4		4		4		4	
4 1/2		4 1/2		4 1/2		4 1/2	
5		5		5		5	
5 1/2		5 1/2		5 1/2		5 1/2	
6		6		6		6	
6 1/2		6 1/2		6 1/2		6 1/2	
7	Mottling Depth: 24"	7	Mottling Depth: 36"	7	Mottling Depth: 30"	7	Mottling Depth: 42"
7 1/2		7 1/2		7 1/2		7 1/2
