SUBSURFACE SEWAGE TREATMENT SYSTEM (SSTS) COMPLIANCE REPORT

Date: September 18, 2019

Inspection Address: 21820 Lofton Ave, Scandia, MN 55073

Brief system description: Two pre-cast septic tanks and a rock trench drainfield.

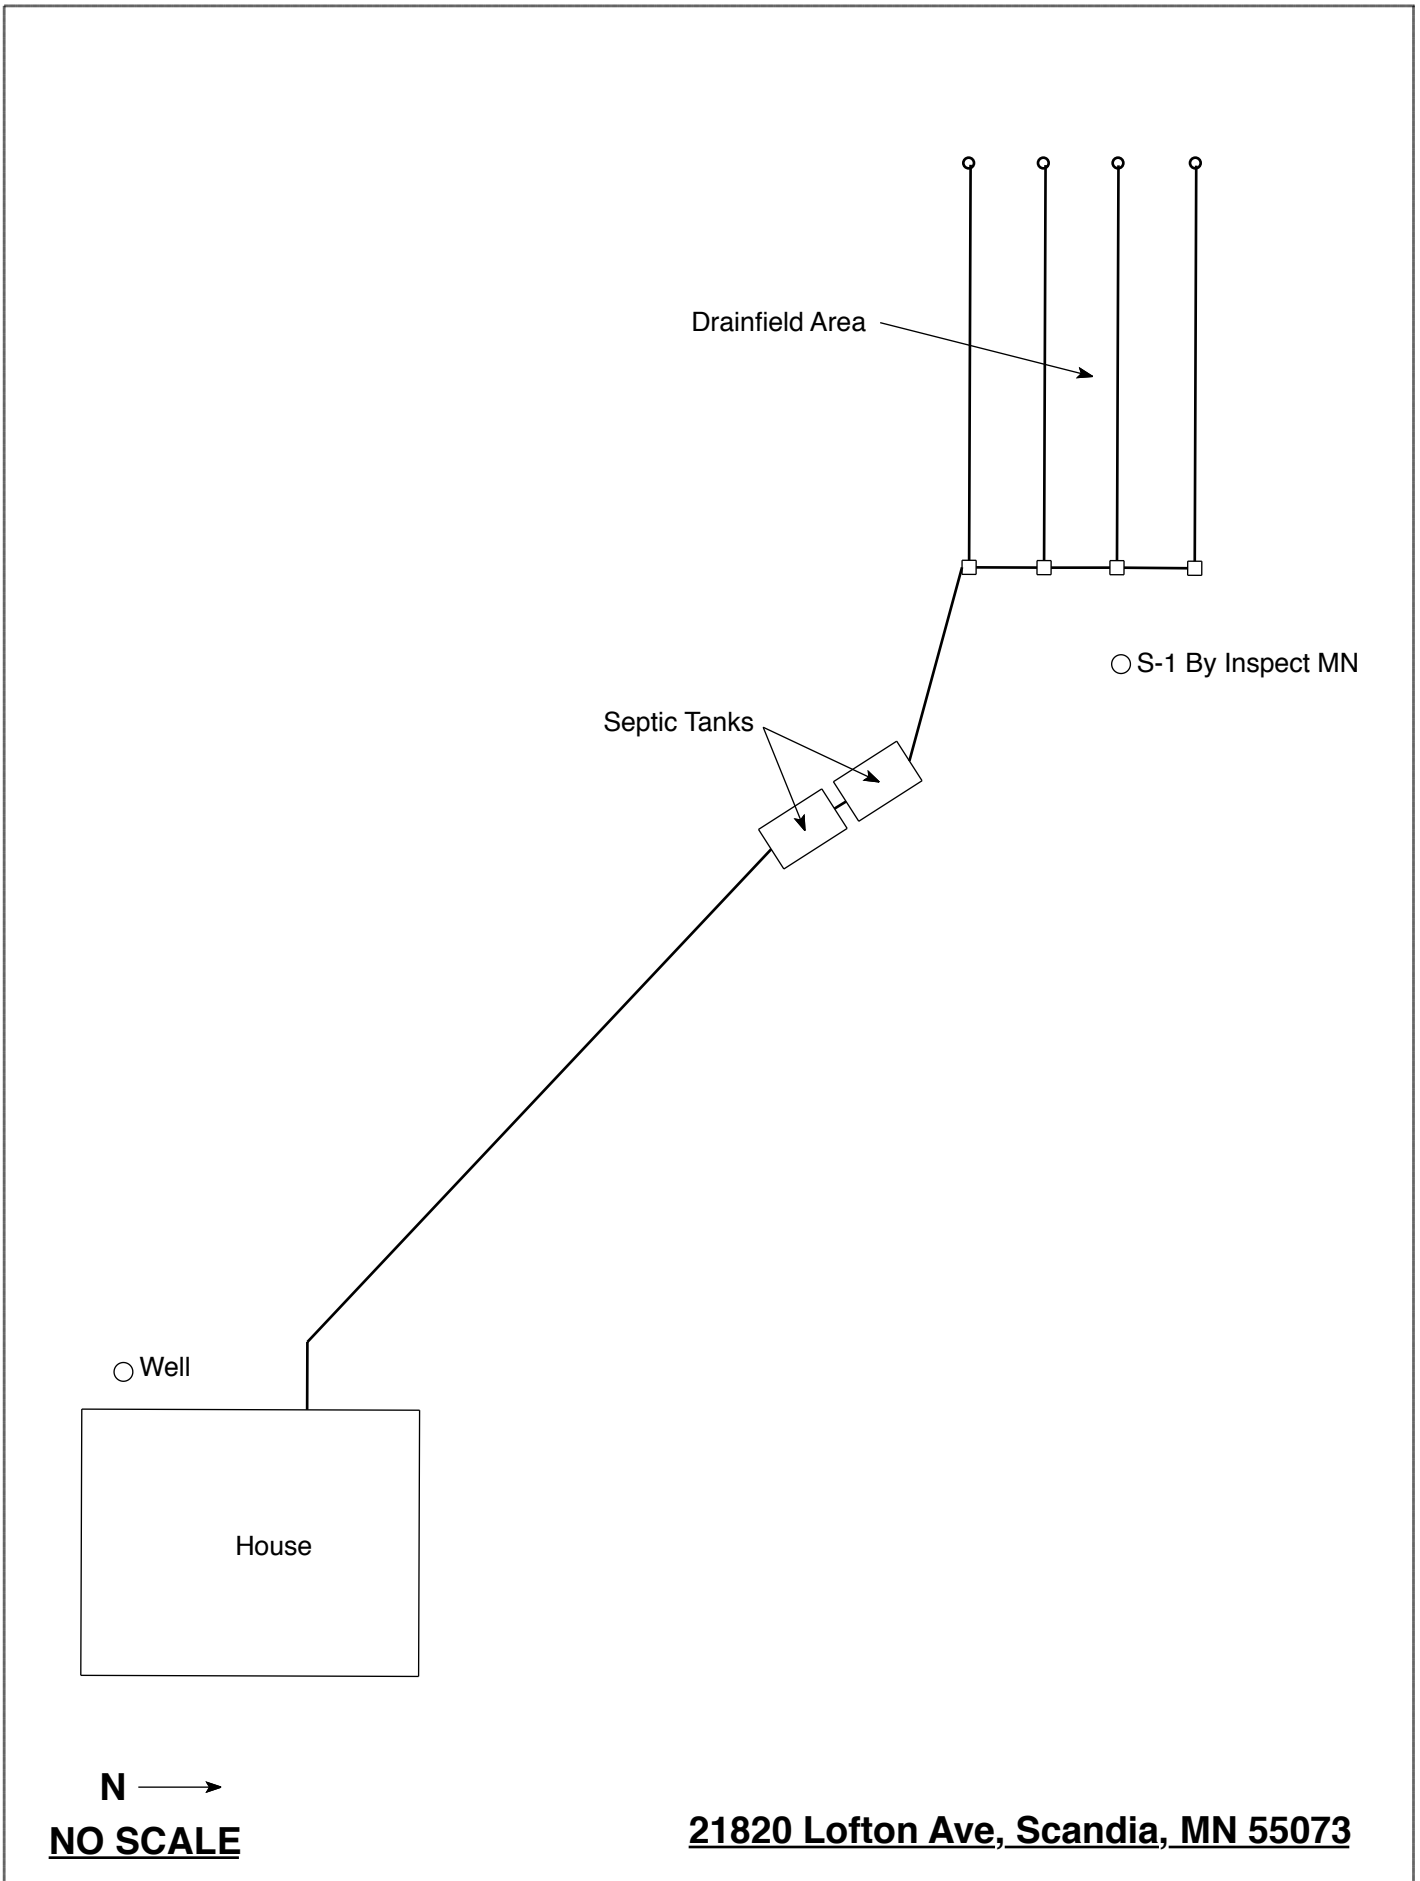
○ Well

House

Septic Tanks

Drainfield Area

○ S-1 By Inspect MN
