## **SUBSURFACE SEWAGE TREATMENT SYSTEM (SSTS) COMPLIANCE REPORT**

**Date:** March 4, 2020

**Inspection Address:** 12445 235<sup>th</sup> St N, Scandia, MN 55073

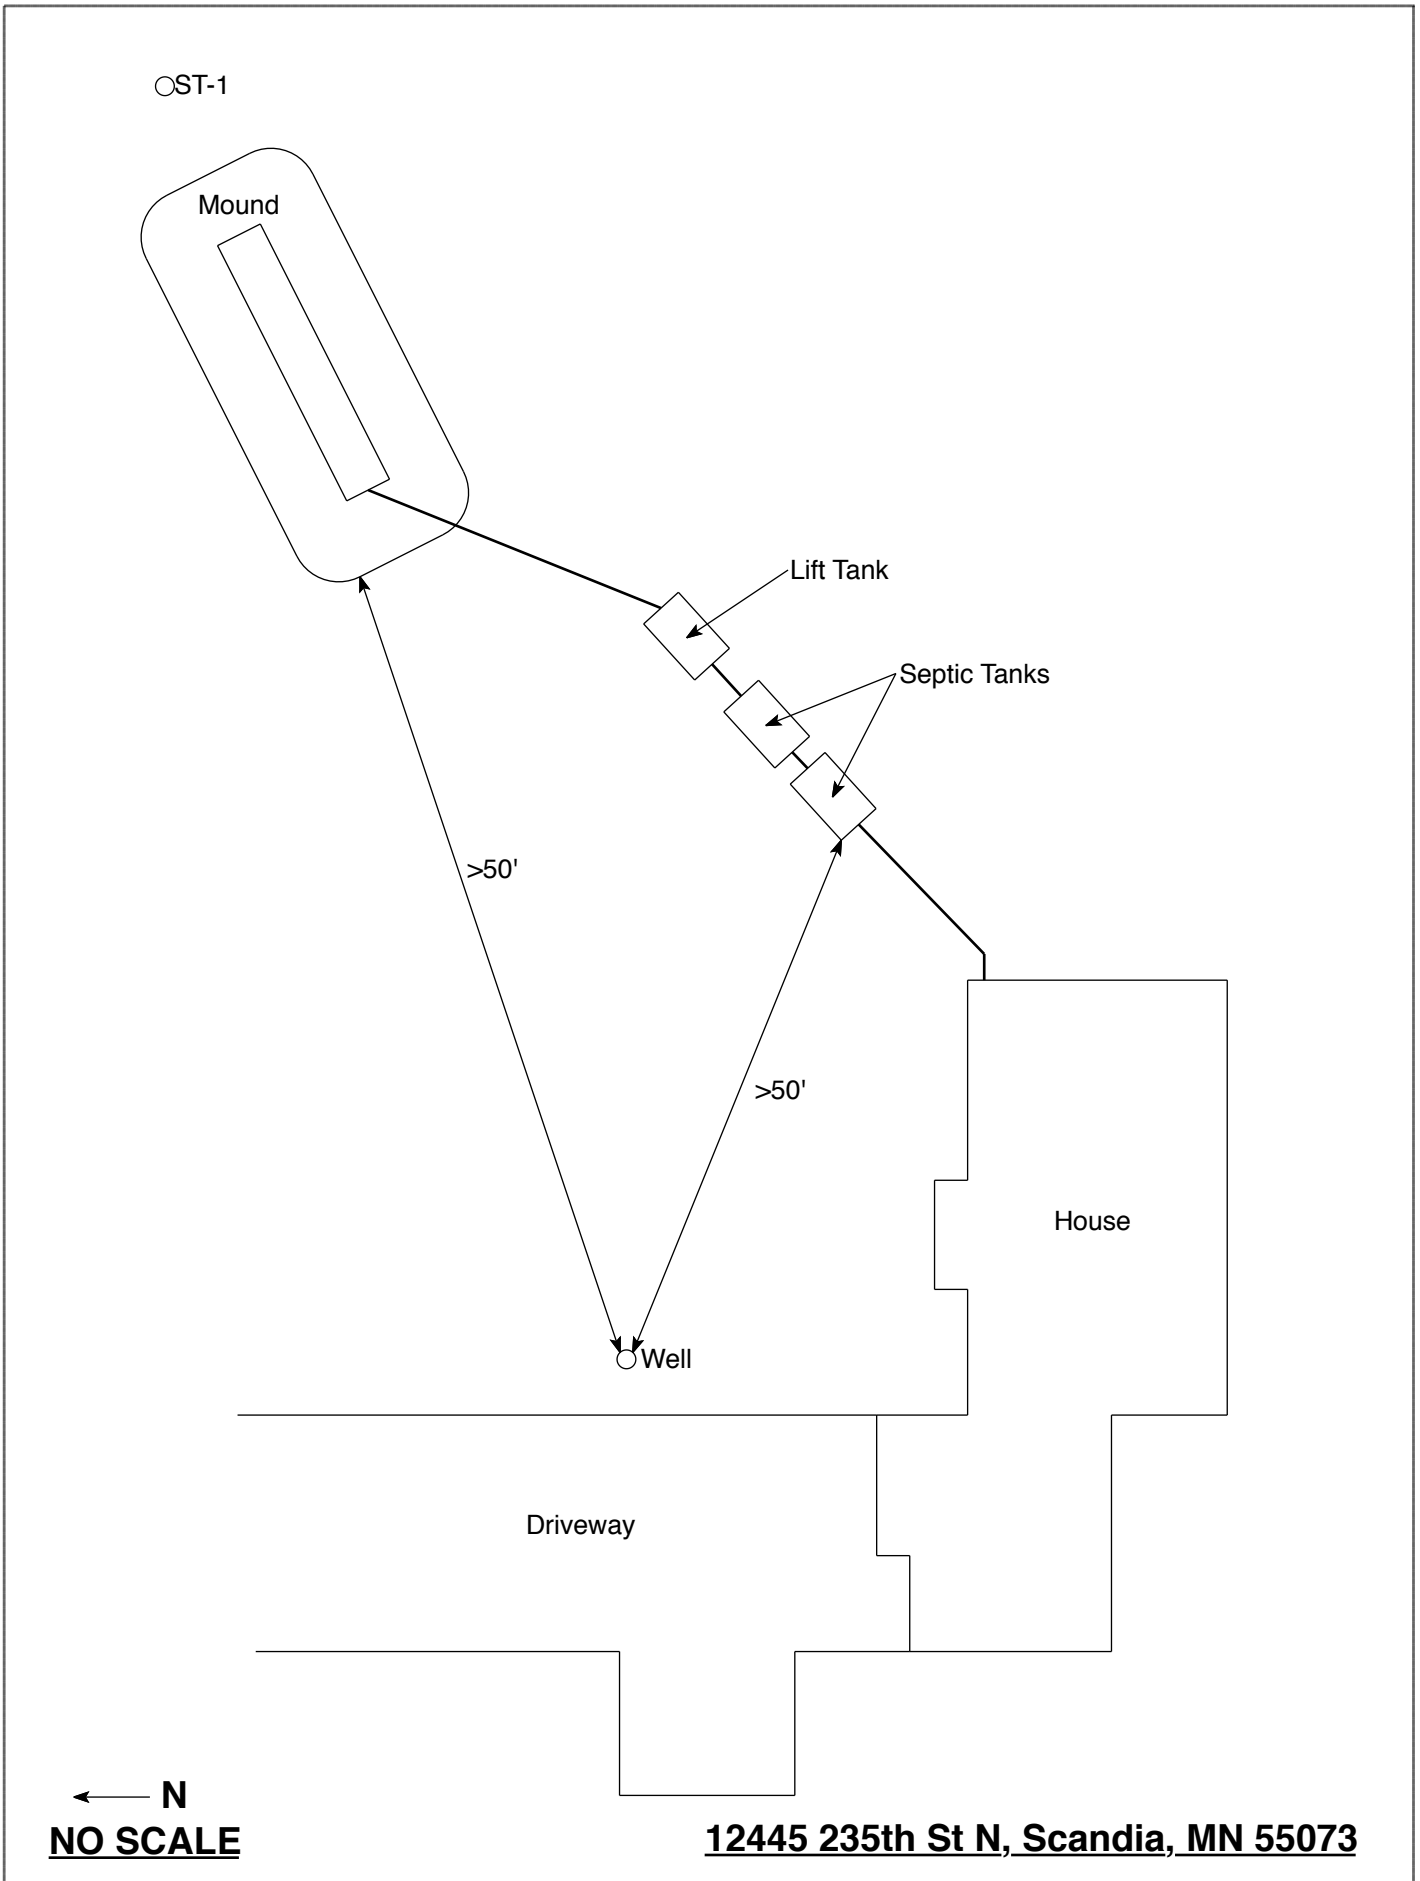
Are the tank maintenance covers accessible? <input checked="" type="checkbox"/> Yes <input type="checkbox"/> No *If no, proper maintenance must be performed through the maintenance holes. Maintenance hole covers should be made accessible to the ground surface to facilitate access and proper maintenance of the system.			
Year house built: 2004	Year septic installed: 2004	Tank size (gals.): 2-1000	
How long has seller owned the property?		Number of residents in home?	
Number of bedrooms? 3	Are all floors drained by gravity?		
Garbage disposal?	Whirlpool bath?		
More than one system (laundry, etc.)?			
Does this property have any footing drain tiles connected to the septic system?			
Are any buildings on this property such as garages or out-buildings connected to this system?			
Are there any additional systems on this property serving other buildings?			
Location of septic system on lot? Northeast Side

Location of water well on lot? North Side		Is the well a deep well? Y	
Have you ever experienced any problems with the system such as: tree roots, sewage back-ups, surfacing of sewage onto the ground, septic tank overflowing, etc.; or have any repairs been made to the system? If yes, explain:			
When was the system last pumped? 2020		Name of pumper:	
How often pumped in previous years?		Is system on a monitoring plan?	
Have you received notices from any government agency concerning this system?			
Is your property located in a shoreland management area? N			
Do you have any additional information that should be given to the new owner?
