Midwest Sewer Services

SUBSURFACE SEWAGE TREATMENT SYSTEM (SSTS) COMPLIANCE REPORT

Date: April 1, 2020

Inspection Address: 3363 Oasis Ave N, Baytown Twp, MN 55082

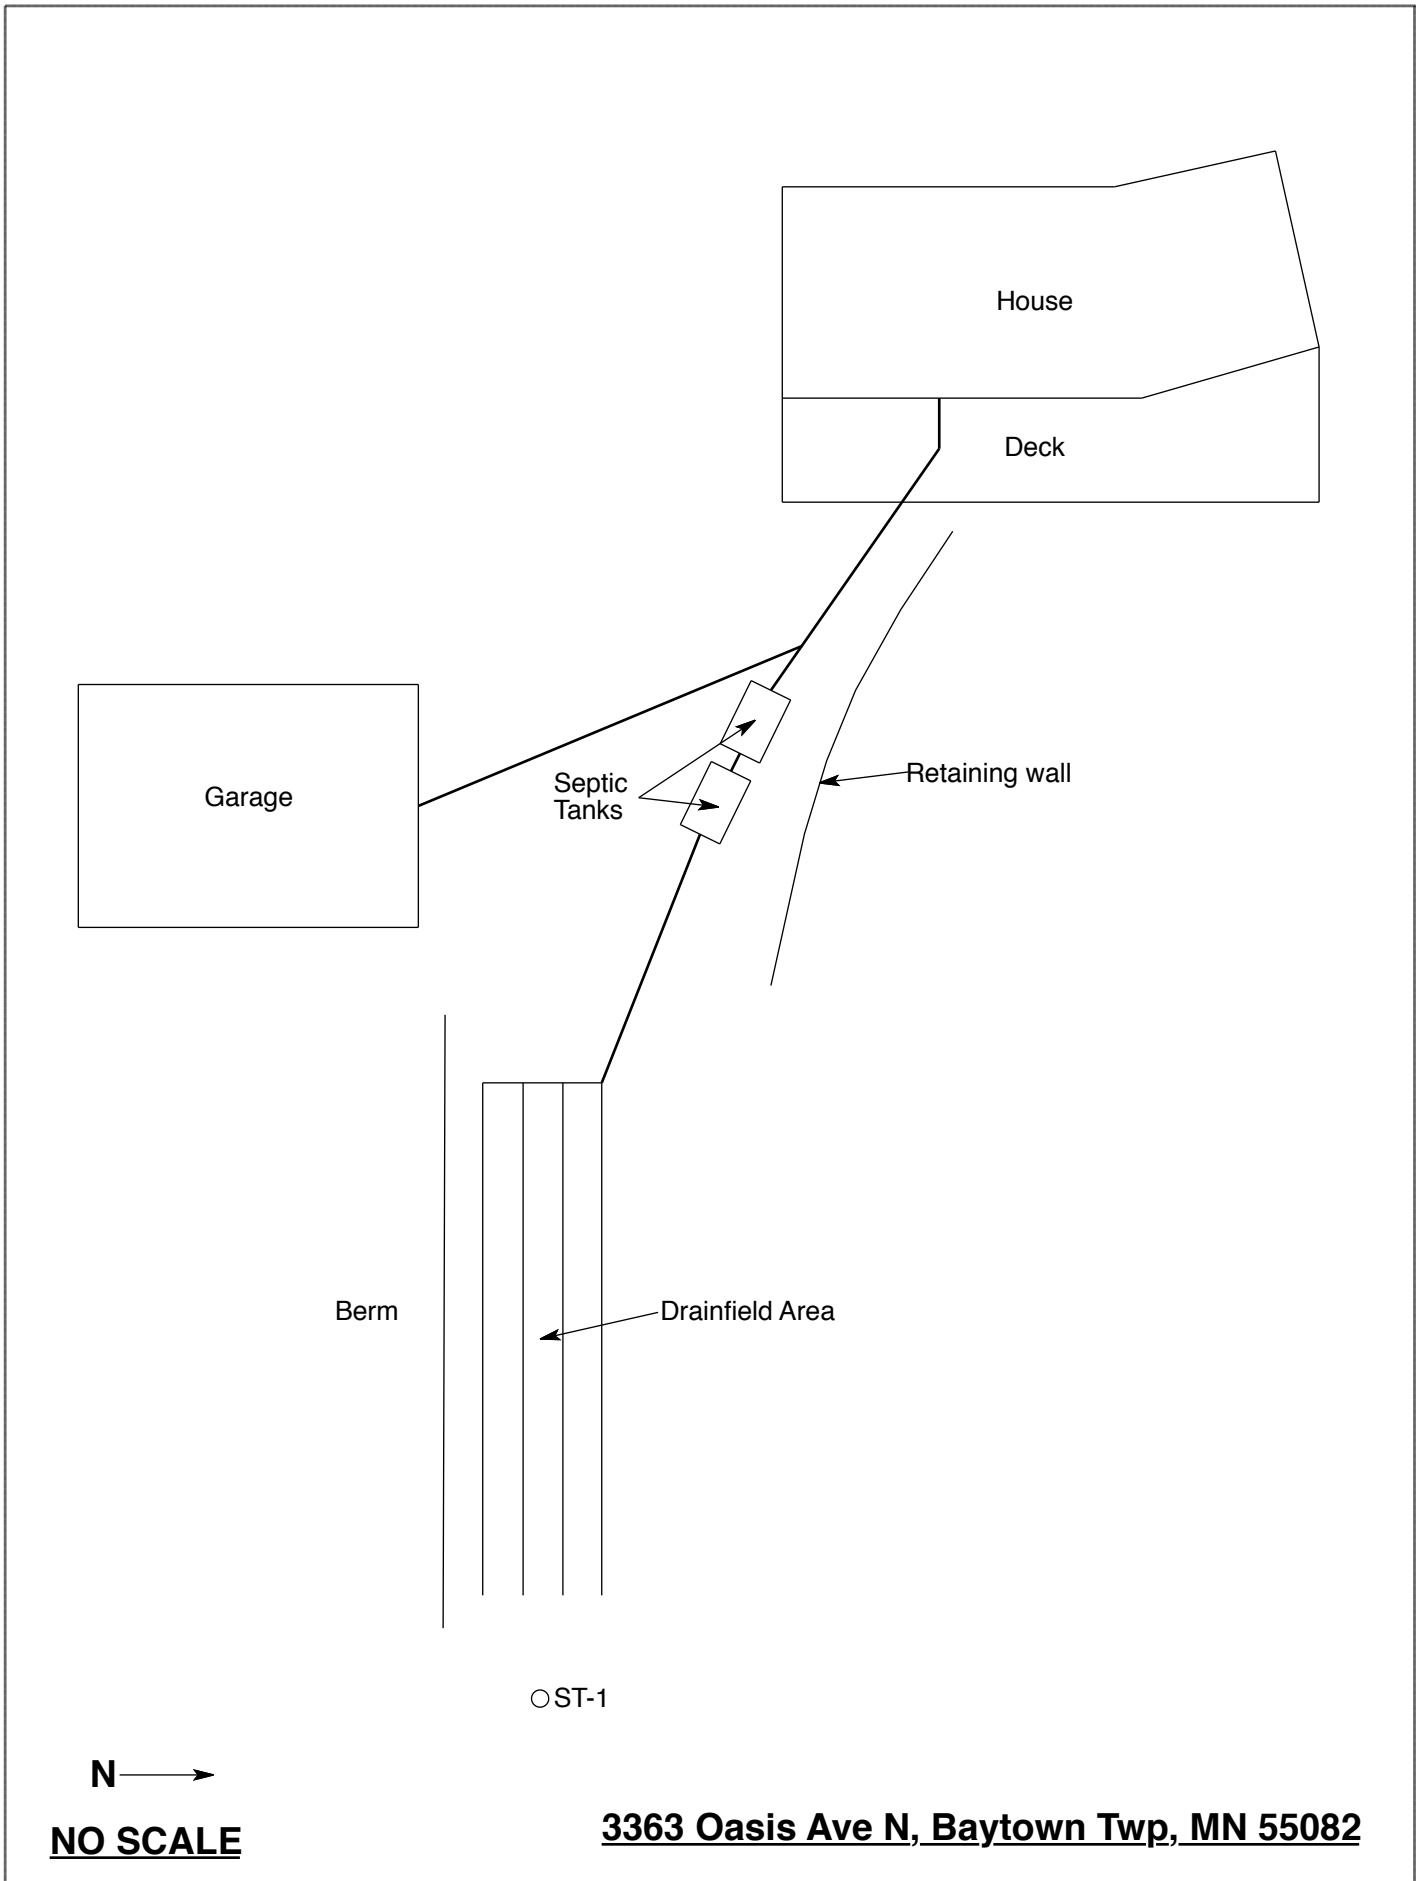
It should be noted that the drainfield is located in the powerline easement.

Septic Tanks

Drainfield Area

Although not a compliance criteria, it should be noted that the septic tank manhole covers are buried. I recommend extending these covers to the ground surface to facilitate easier access and proper maintenance. In addition, the septic tanks are currently due for maintenance pumping and should be pumped when possible.
