Midwest Sewer Services

SUBSURFACE SEWAGE TREATMENT SYSTEM (SSTS) COMPLIANCE REPORT

Date: August 13, 2020

Inspection Address: 7959 Quadrant Ave S, Denmark Twp, MN 55033

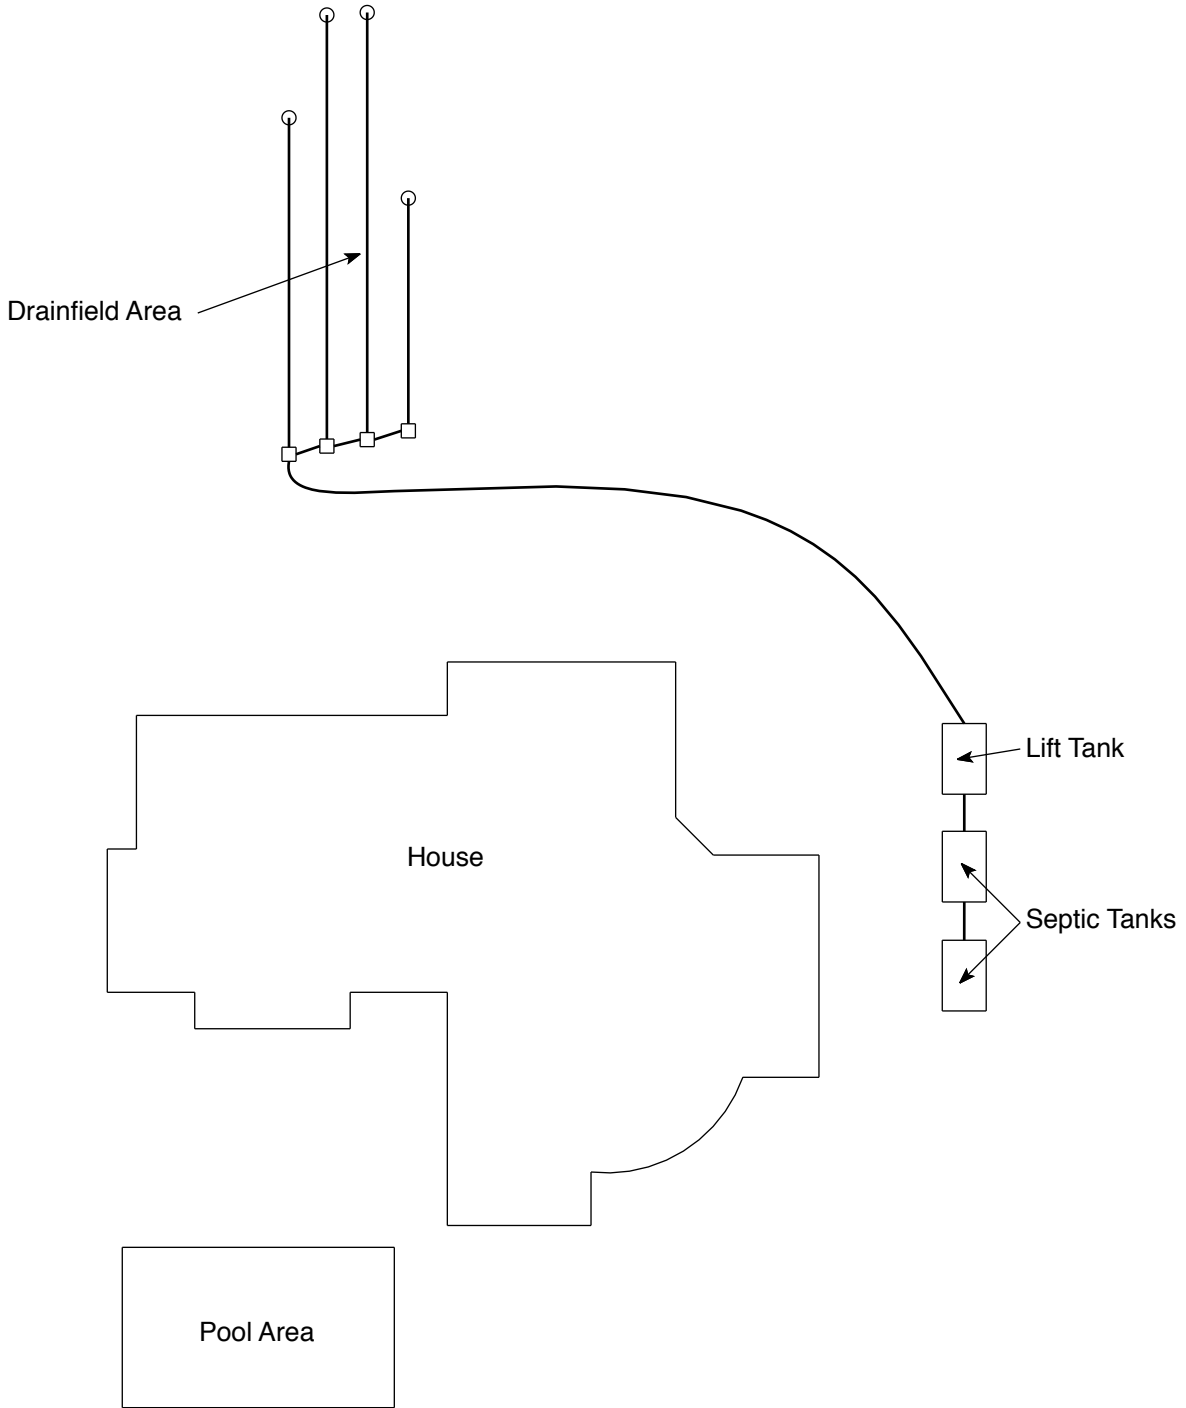
7959 Quadrant Ave S, Denmark Twp, MN 55033

Brief system description: Two pre-cast septic tanks, a pre-cast lift tank, and a chamber trench drainfield.
