# ZIERKE SOIL TESTING

# Compliance Inspection Form

## Existing Subsurface Sewage Treatment Systems (SSTS)

Property address: 6040 Inwood Court North Stillwater, MN 55082 Reason for inspection: Sale

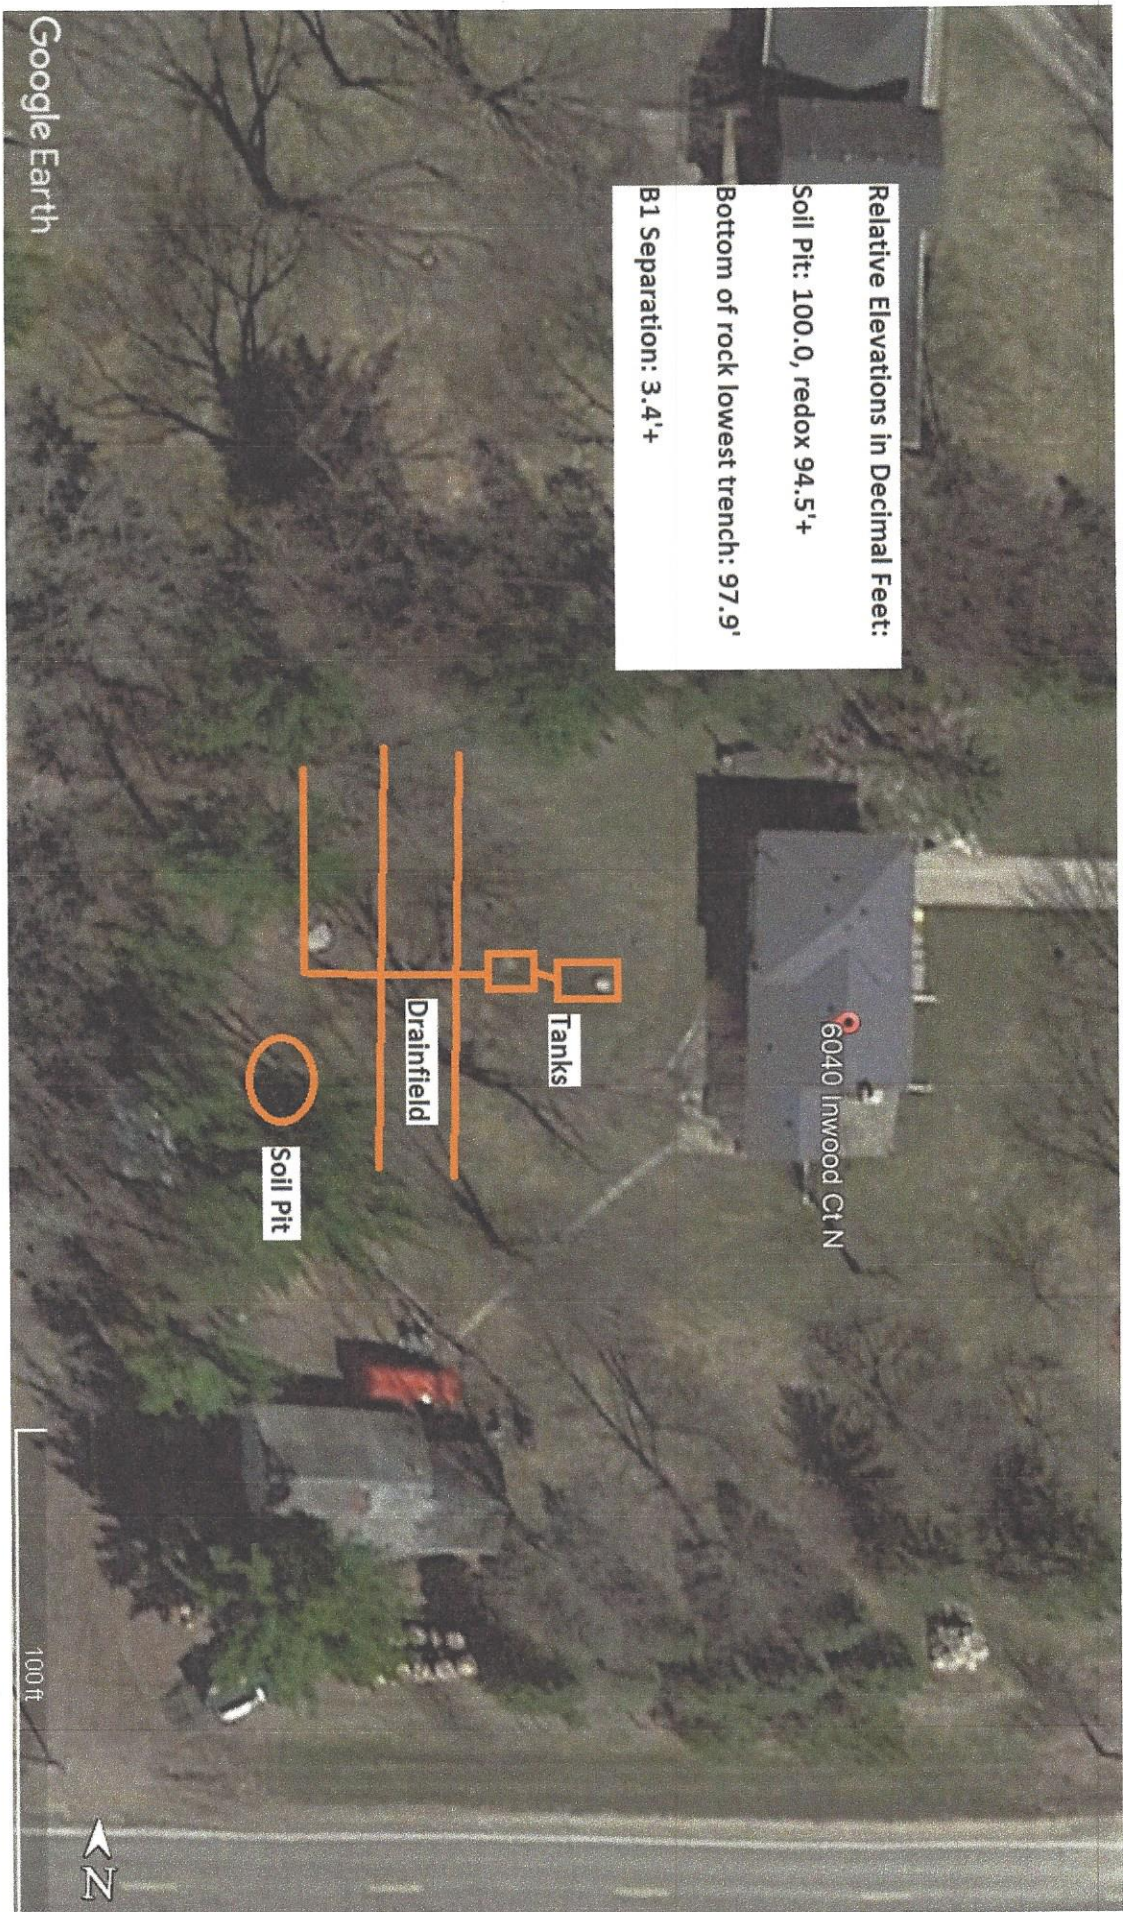
Relative Elevations in Decimal Feet:  
Soil Pit: 100.0, redox 94.5'+  
Bottom of rock lowest trench: 97.9'  
B1 Separation: 3.4'+
