P.O. Box 10853 White Bear Lak	Brian Humpal		
651-492-7550/Brian@Midwestso	MPCA Licensed Advanced Inspector		
SUBSURFACE SEWAGE TREATMENT SYSTEM (SSTS) COMPLIANCE REPORT			
Date: January 18, 2021	Time: 12:00 PM	Owner: Julie LaValle	
Inspection Address: 9810 Dale Rd	l, Woodbury, MN 551	29 Site Conditions: 7" Snow 5" Frost

REPORT SUMMARY

Compliance inspection report form

Existing Subsurface Sewage Treatment System (SSTS)

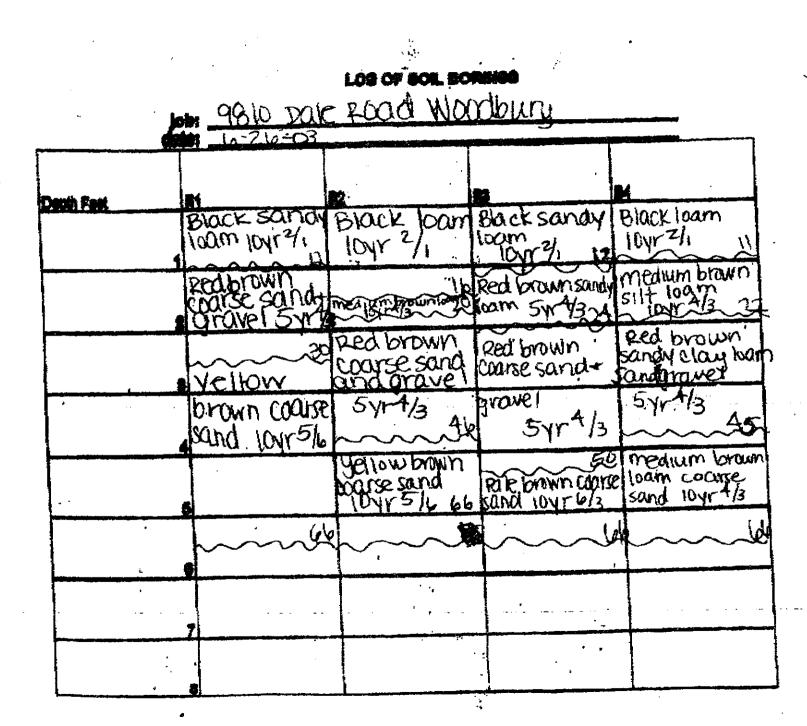
Soil Observations Log

End		Observation At:	70"	End Of		servation At:	
Redox Present At: None				x Present At:			
Standing Water Present At: None			Standi	ng Wate	r Present At:

Bottom Of Distribution Medium At: 30 Inches
