# ZIERKE SOIL TESTING

# Compliance inspection report form

## Existing Subsurface Sewage Treatment System (SSTS)

Property address: 13913 240<sup>th</sup> St Scandia, MN 55073

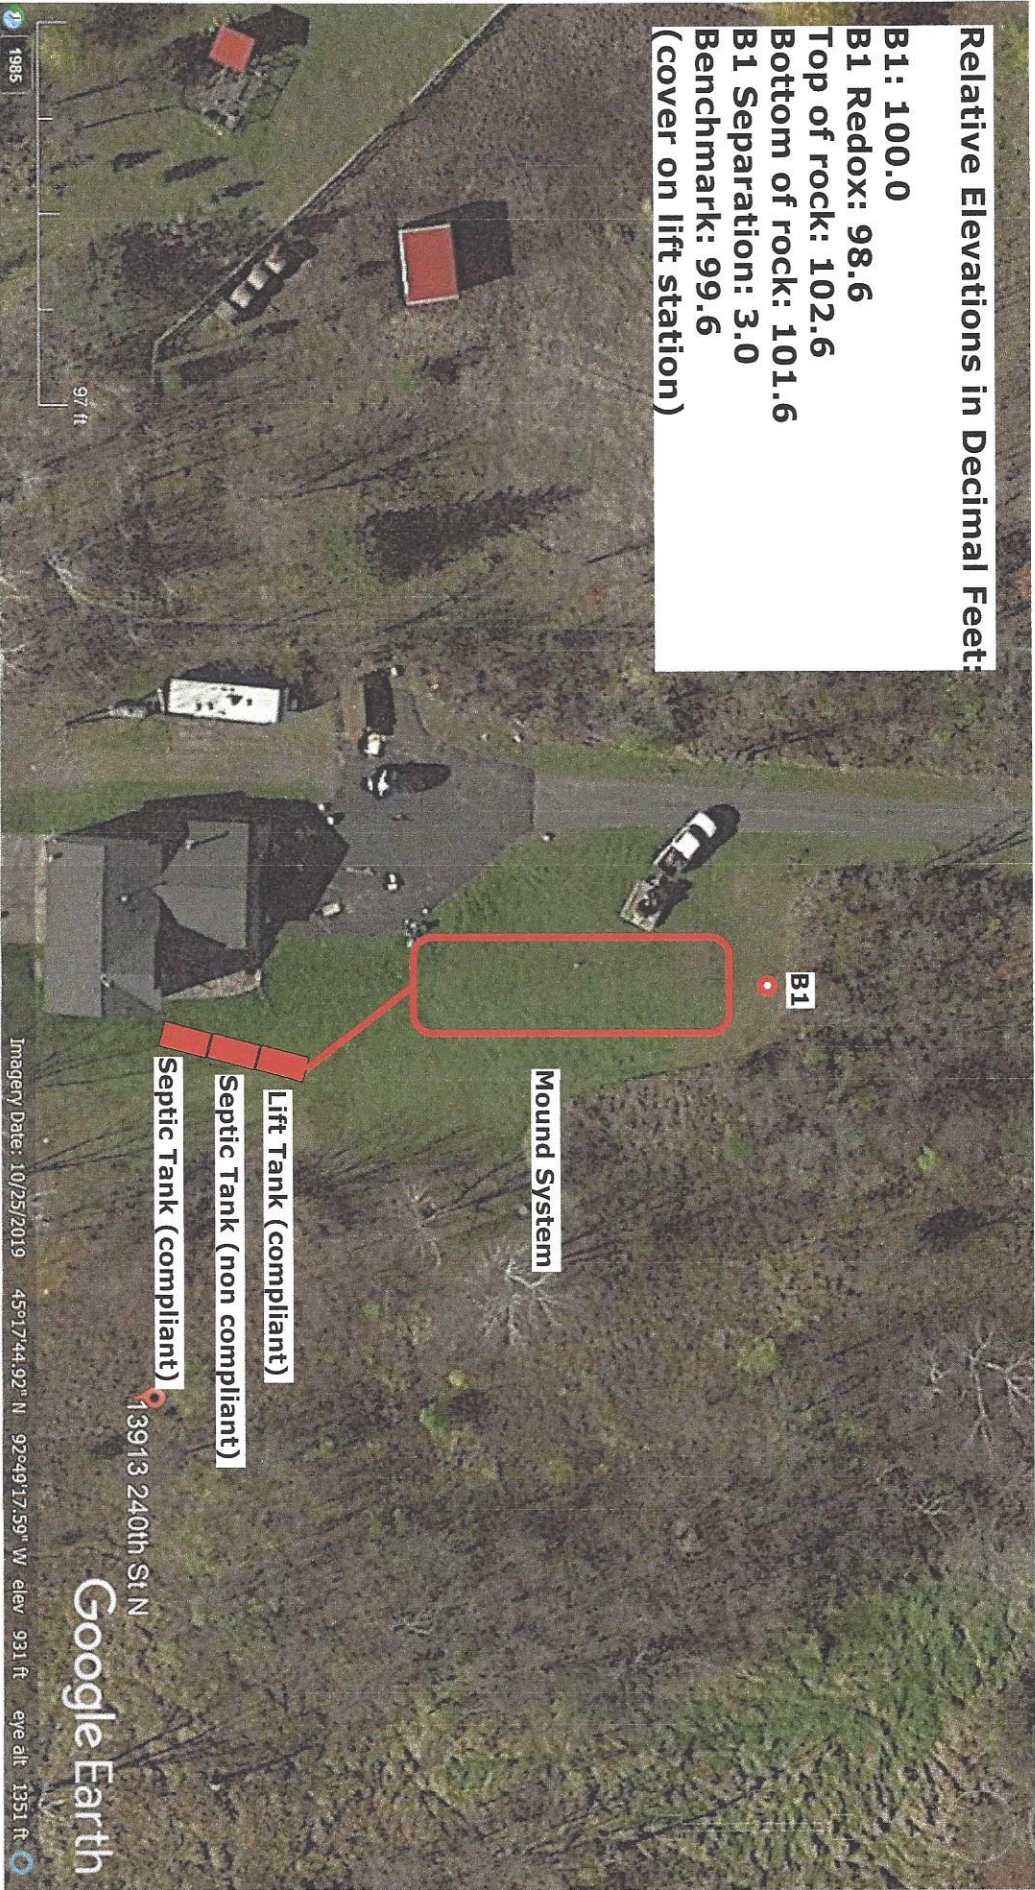
Present for pumping by Smilies Sewer 8/24/2021. Tank 1 watertight and baffles in place. Tank 2 has a tank bottom that is cracked into several pieces and heaved in the middle. A good deal of sand was pumped out of Tank 1 and the lift station - the crack in Tank 2 is the likely source. The lift station was watertight and in good condition.

Lift Tank (compliant)  
Septic Tank (non compliant)  
Septic Tank (compliant)
