# ZIERKE SOIL TESTING

# Compliance inspection report form

## Existing Subsurface Sewage Treatment System (SSTS)

Parcel ID# or Sec/Twp/Range: 12.032.20.31.0010 Reason for Inspection Permit  
Local regulatory authority info: Washington County  
Property address: 15801 Pilar Rd N Scandia, MN 55073  
Owner/representative: Bob Pilz Owner's phone: 651-492-0230  
Brief system description: (2) 1000 gallon septic tanks, 1000 gallon lift station, mound dispersal system

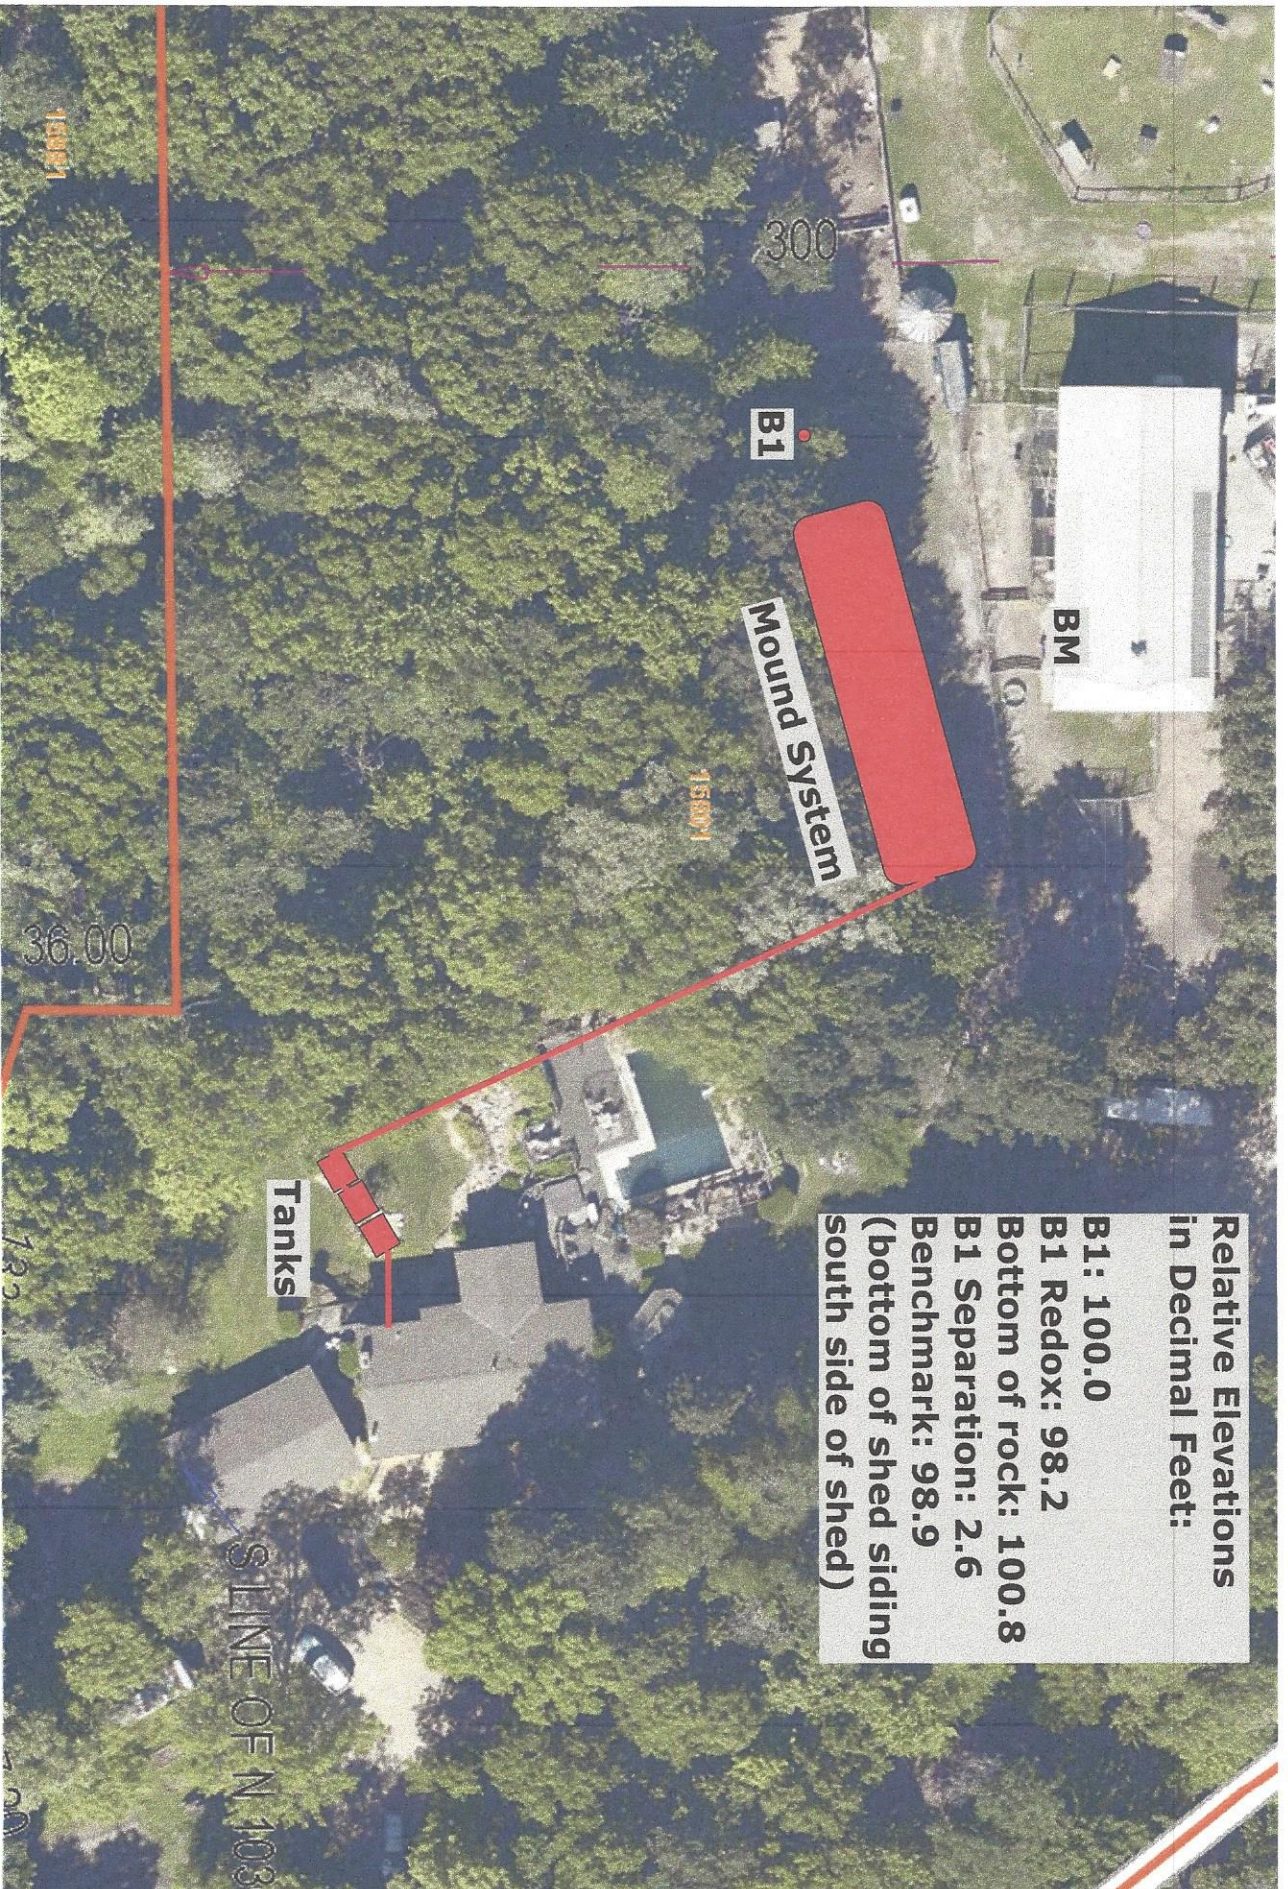
- B1: 100.0**
- B1 Redox: 98.2**
- Bottom of rock: 100.8**
- B1 Separation: 2.6**
- Benchmark: 98.9**  
(bottom of shed siding  
south side of shed)
