# ZIERKE SOIL TESTING

# Compliance inspection report form

## Existing Subsurface Sewage Treatment System (SSTS)

Property address: 23243 St Croix Trl N Scandia, MN 55073

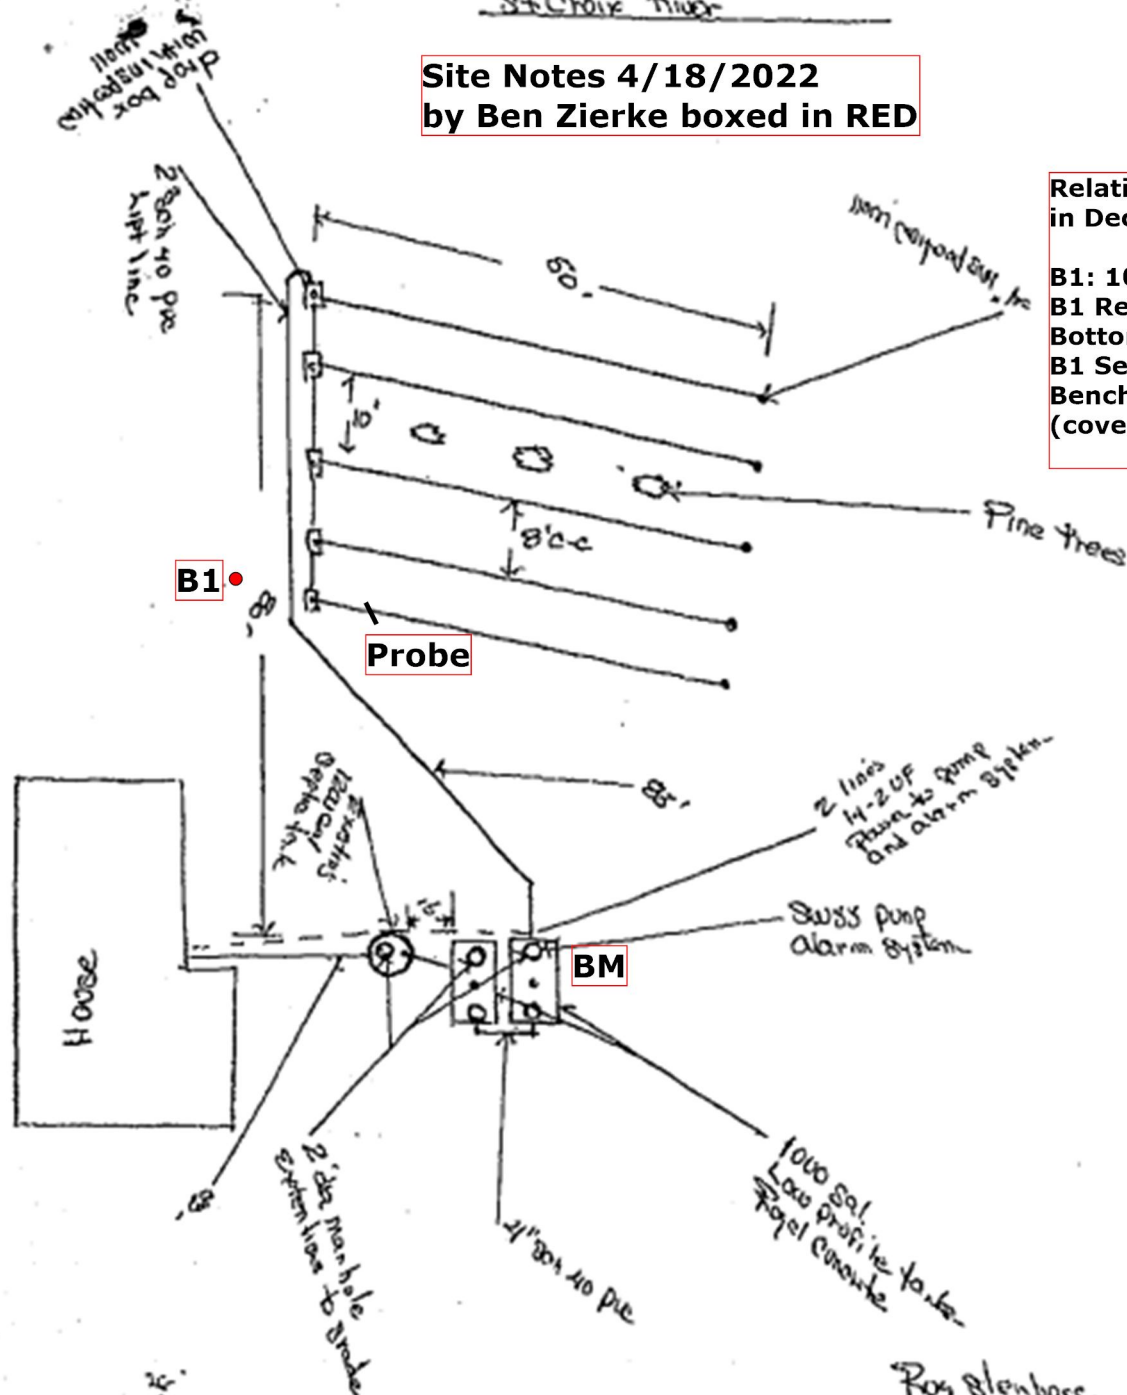
**Site Notes 4/18/2022  
by Ben Zierke boxed in RED**

**Relative Elevations  
in Decimal Feet:**  
B1: 100.0  
B1 Redox: 94.5+  
Bottom of rock: 97.7  
B1 Separation: 3.2+  
Benchmark: 100.1  
(cover on lift station)

Roy Stenborg  
26243 St. Croix St. N.  
Installed 10-22-98  
C&B Excavating & Sewer Inc.  
2 - 1000 gal Lad Profile  
Royal Concrete  
750 sq. ft. - 5 lines @ 60' ea.  
12" Rock Geo Text Fabric.  
Drop boxes -  
2" lift line SWSS.
