# ZIERKE SOIL TESTING

# Compliance inspection report form

## Existing Subsurface Sewage Treatment System (SSTS)

Property address: 9979 Arcola Ct N Stillwater, MN 55082

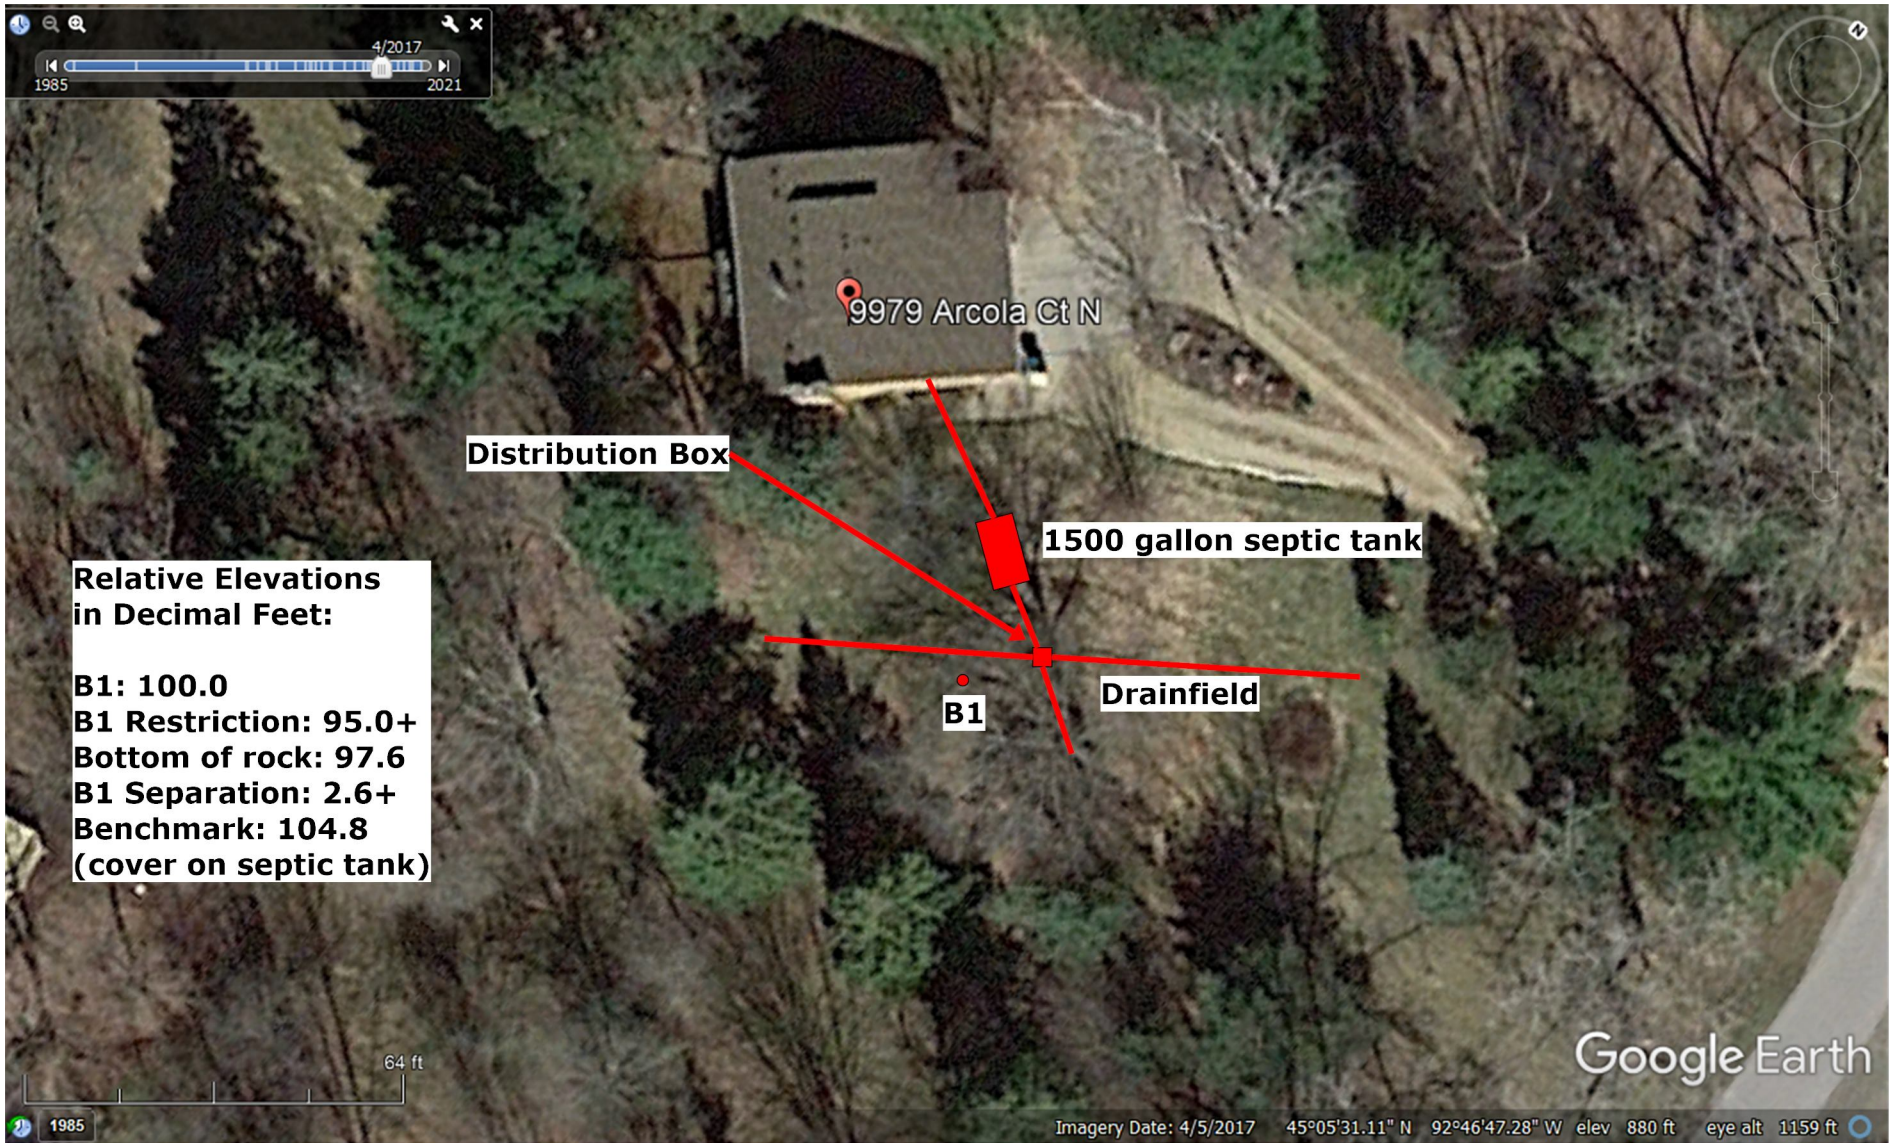
9979 Arcola Ct N

Distribution Box

1500 gallon septic tank

Drainfield

B1

**B1: 100.0**  
**B1 Restriction: 95.0+**  
**Bottom of rock: 97.6**  
**B1 Separation: 2.6+**  
**Benchmark: 104.8**  
**(cover on septic tank)**
