# ZIERKE SOIL TESTING

At your request, I have conducted a septic inspection to determine the compliance status of your septic system pursuant to Minnesota Rules Chapter 7080.1500.

# Compliance inspection report form

Property address: 22750 Olinda Lane N Scandia, MN 55073

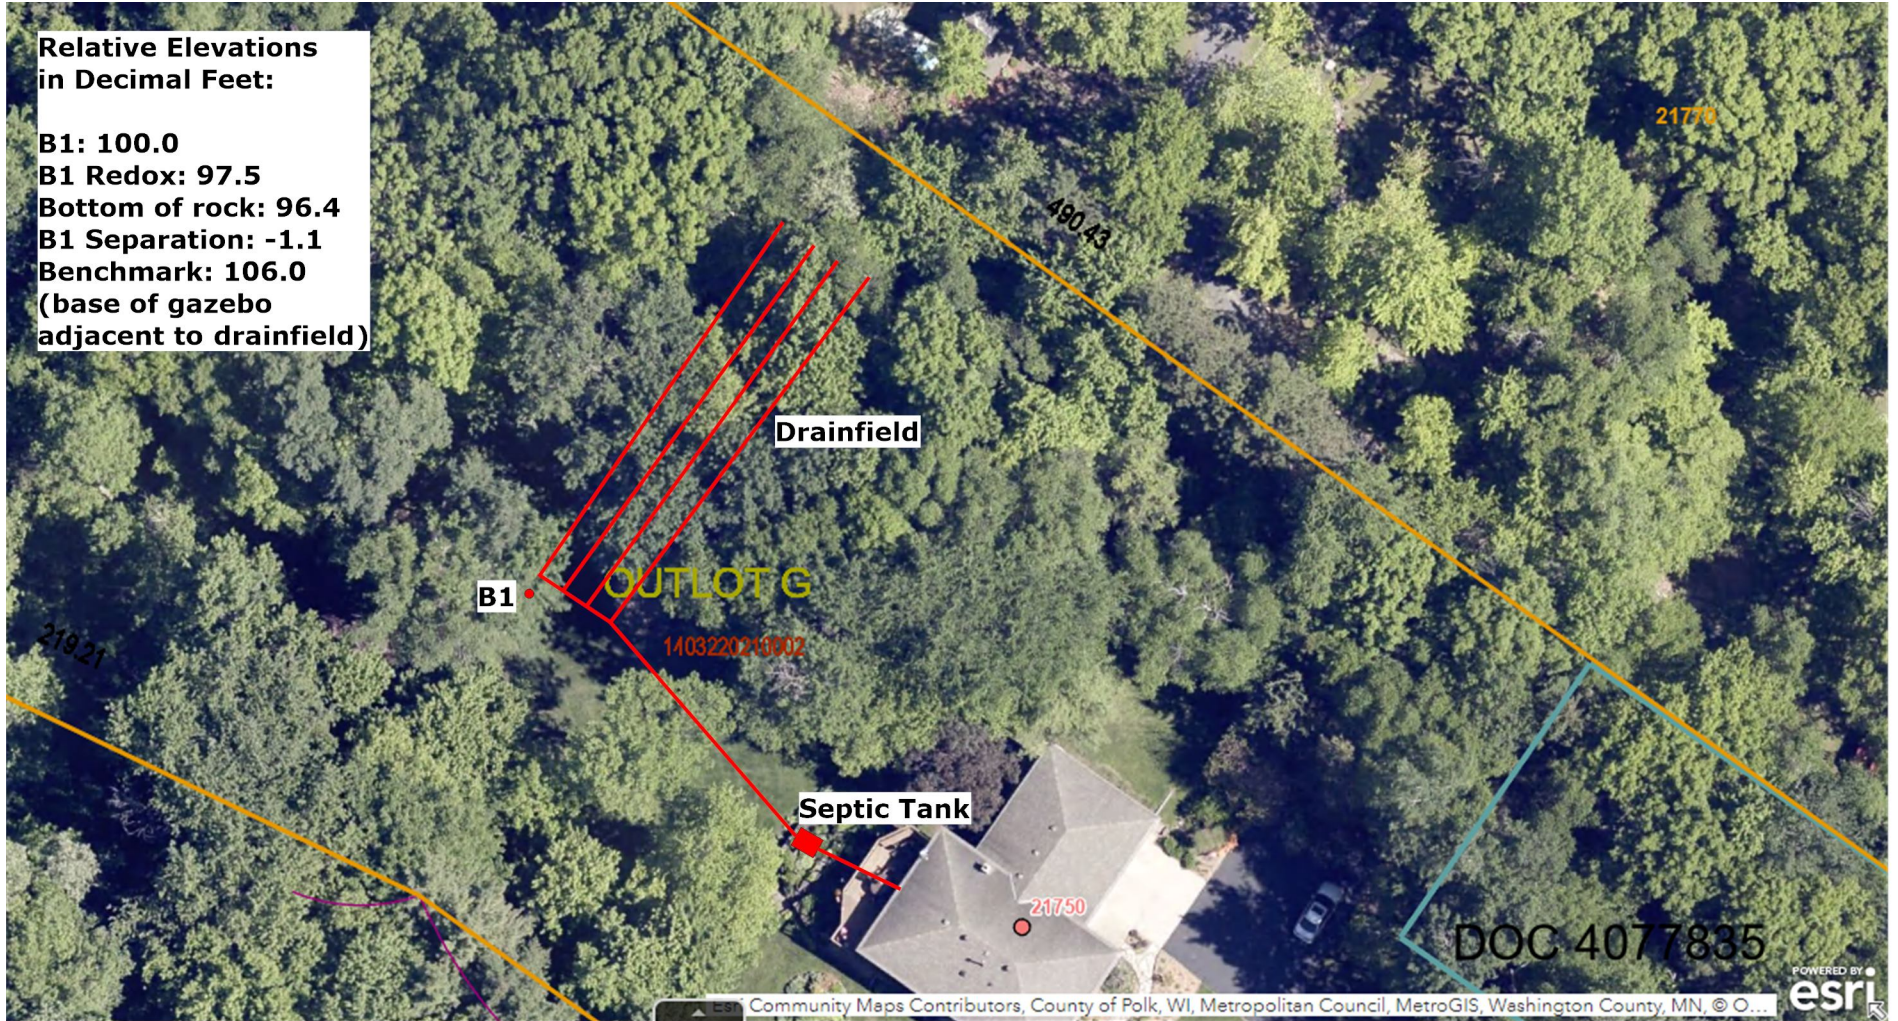
Based off of these criteria, your system is non-compliant due to a lack of vertical separation between the bottom of your drain field and indicators of seasonally wet soil (redoximorphic features). Therefore, this system is considered "failing to protect groundwater" and is not considered an imminent threat to public health. I am required to provide copies of this report to you and to Washington County. You should contact them as to the next steps that will be required to bring the system into compliance.

A. Bottom of distribution media	96.4'
B. Periodically saturated soil/bedrock	97.5'
C. System separation	-1.1'
D. Required compliance separation*	3.0'

**Relative Elevations  
in Decimal Feet:**

**B1: 100.0**  
**B1 Redox: 97.5**  
**Bottom of rock: 96.4**  
**B1 Separation: -1.1**  
**Benchmark: 106.0**  
**(base of gazebo  
adjacent to drainfield)**
