# ZIERKE SOIL TESTING

# Compliance inspection report form

## Existing Subsurface Sewage Treatment System (SSTS)

Parcel ID# or Sec/Twp/Range: 0603220310011 Reason for Inspection Sale  
Local regulatory authority info: Washington County  
Property address: 23000 Manning Lane N Scandia, MN 55073  
Owner/representative: Will St. Germaine Owner's phone: 612-414-3880  
Brief system description: 1250 gallon septic tank, 1000 gallon septic tank, 1000 gallon lift tank, mound dispersal system

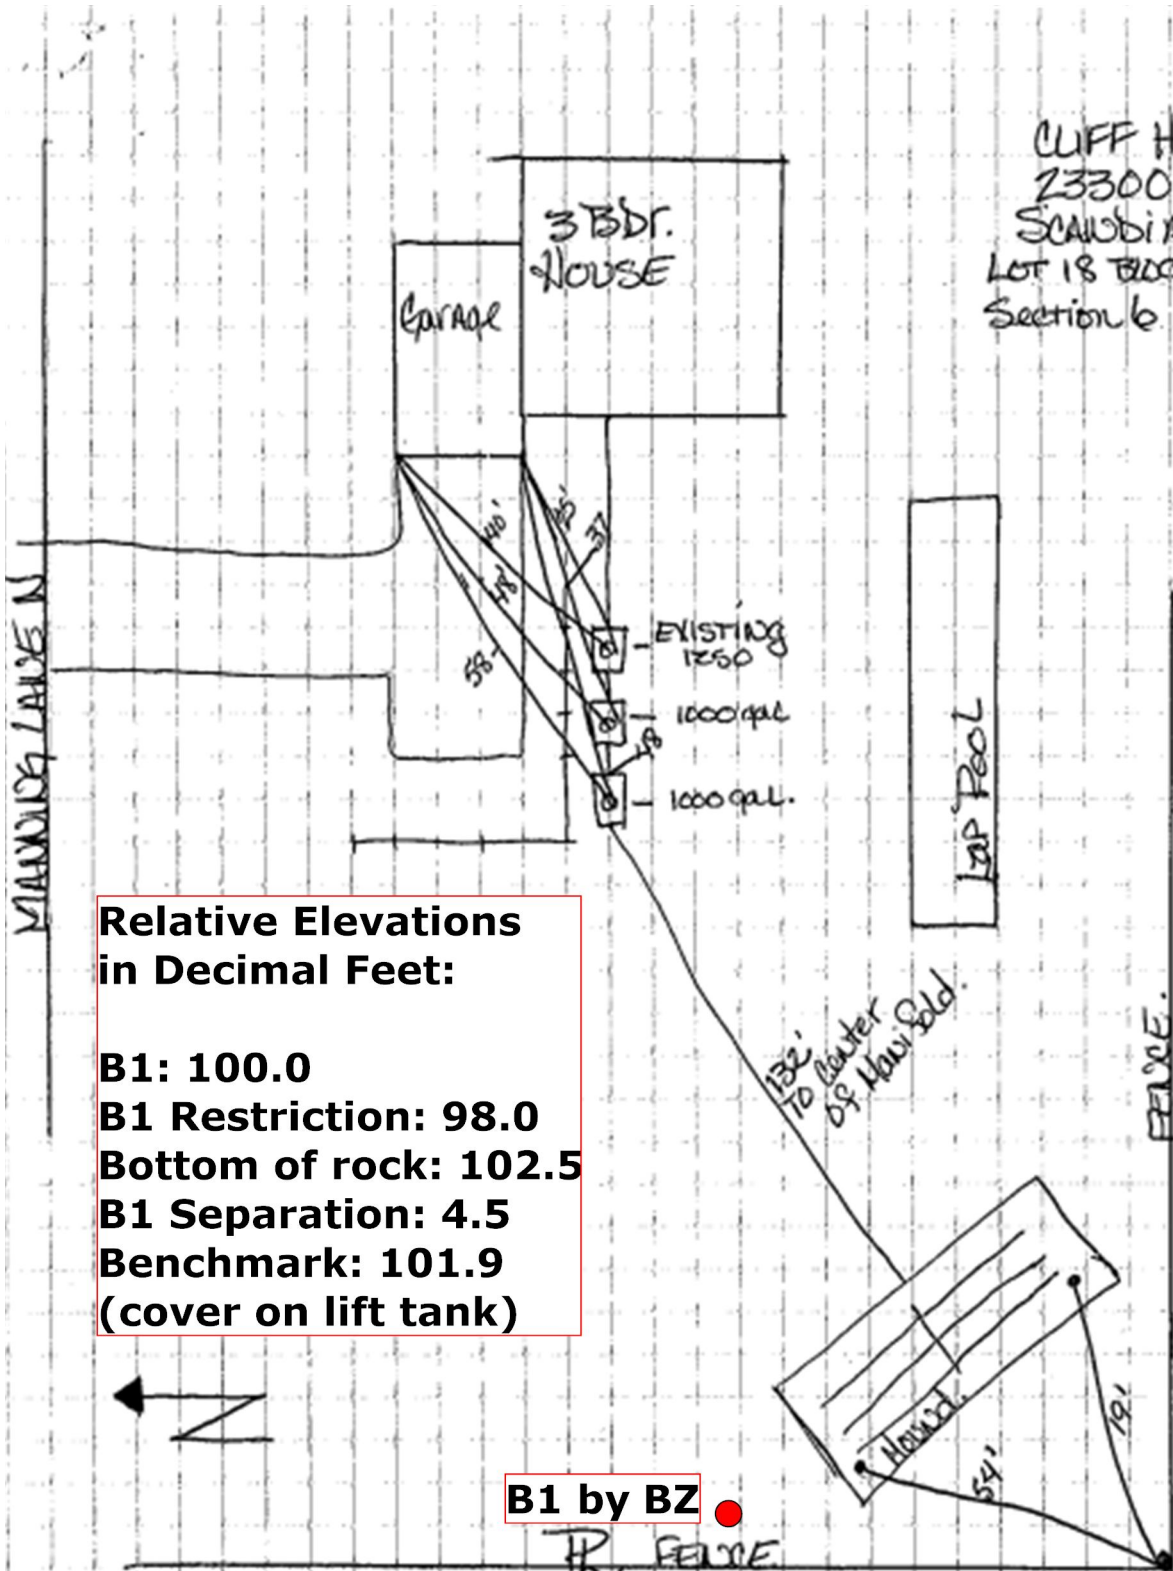
**Relative Elevations  
in Decimal Feet:**

- B1: 100.0**
- B1 Restriction: 98.0**
- Bottom of rock: 102.5**
- B1 Separation: 4.5**
- Benchmark: 101.9  
(cover on lift tank)**
