# ZIERKE SOIL TESTING

# Compliance inspection report form

## Existing Subsurface Sewage Treatment System (SSTS)

Property address: 13569 170<sup>th</sup> St N Marine on St Croix, MN 55047

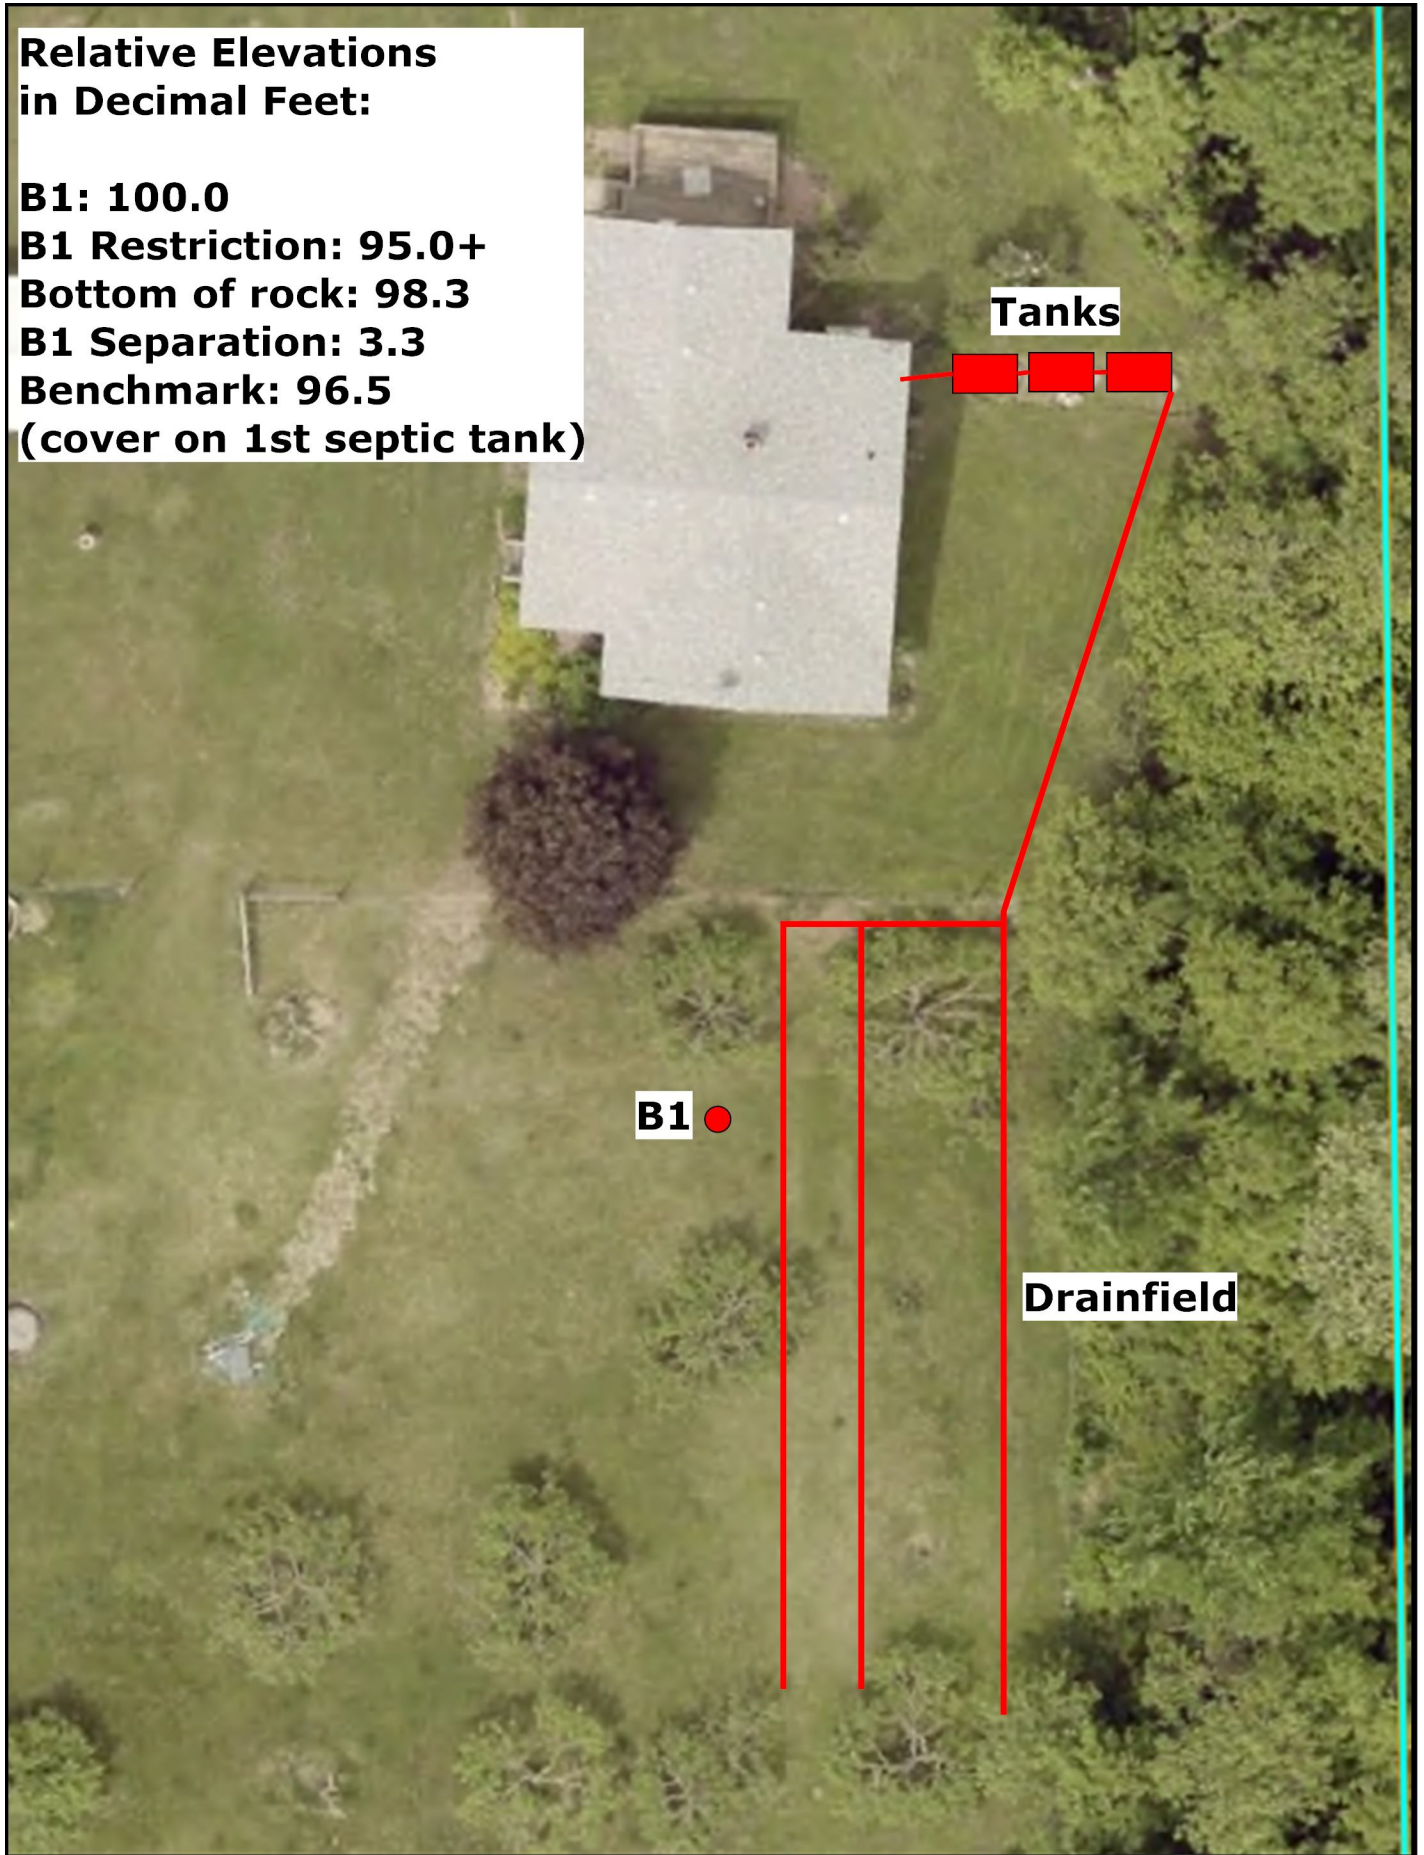
**Relative Elevations  
in Decimal Feet:**

**B1: 100.0**

**B1 Restriction: 95.0+**

**Bottom of rock: 98.3**

**B1 Separation: 3.3**

**Benchmark: 96.5**

**(cover on 1st septic tank)**
