# ZIERKE SOIL TESTING

# Compliance inspection report form

## Existing Subsurface Sewage Treatment System (SSTS)

Property address: 10375 216<sup>th</sup> St N Scandia, MN 55073

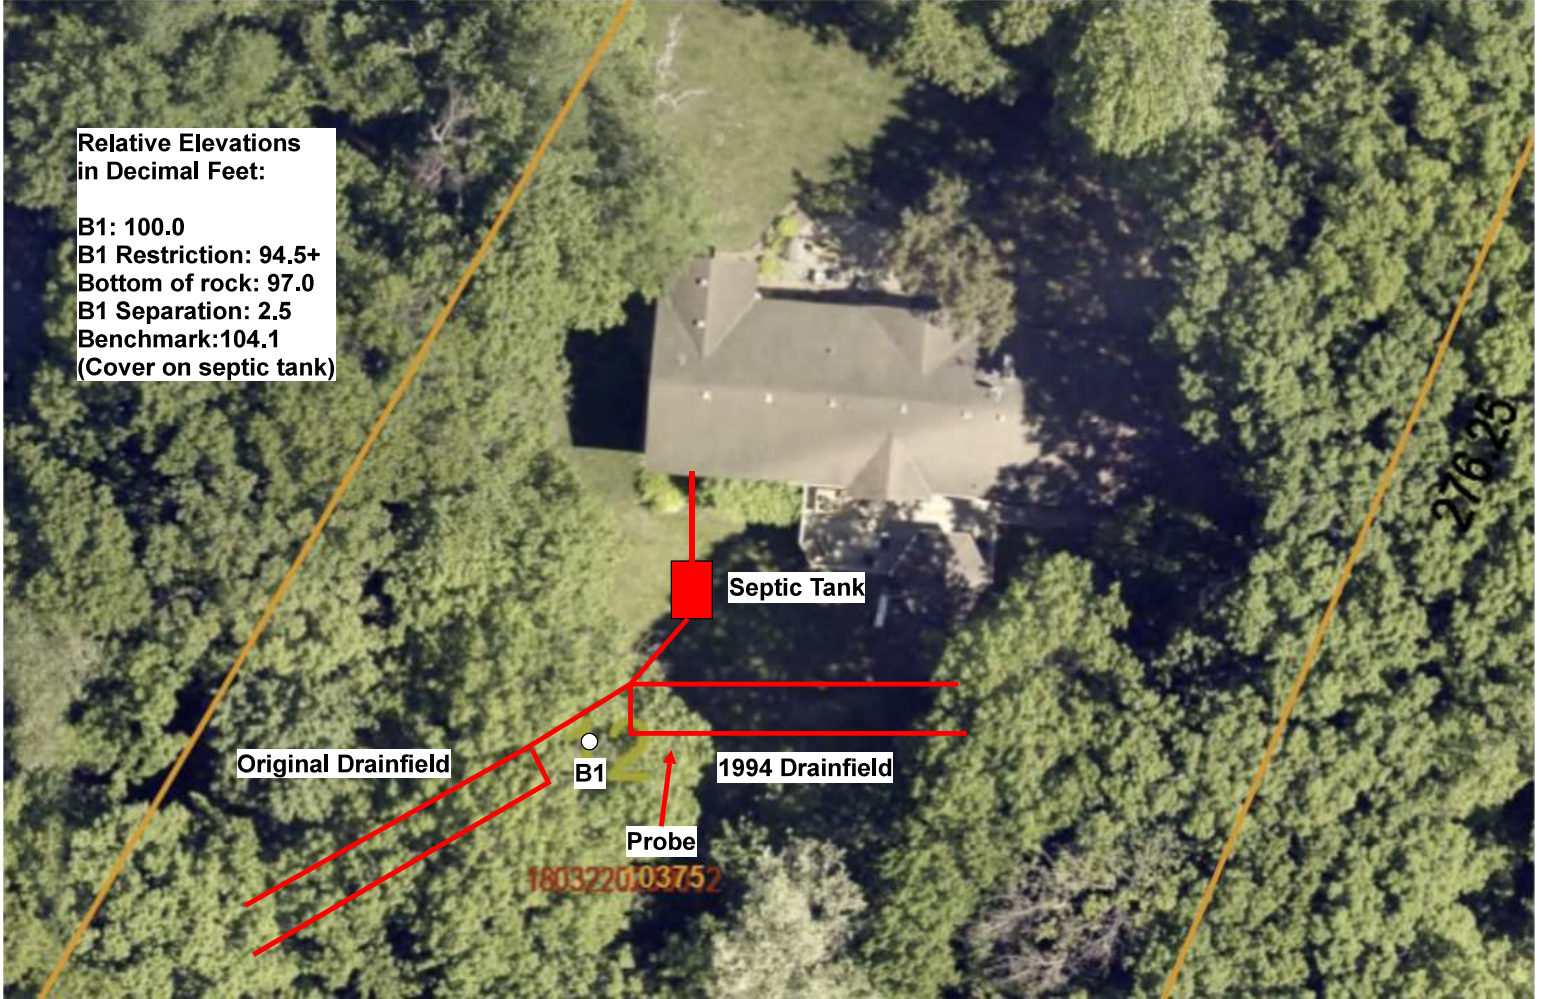
A. Bottom of distribution media	97.0'
B. Periodically saturated soil/bedrock	94.5'
C. System separation	2.5'
D. Required compliance separation*	2.0'

**Relative Elevations  
in Decimal Feet:**

B1: 100.0  
B1 Restriction: 94.5+  
Bottom of rock: 97.0  
B1 Separation: 2.5  
Benchmark: 104.1  
(Cover on septic tank)
