ZIERKE SOIL TESTING

Compliance inspection report form

Existing Subsurface Sewage Treatment System (SSTS)

Property address: 520 Nason Hill Rd N Marine on St Croix, MN 55047

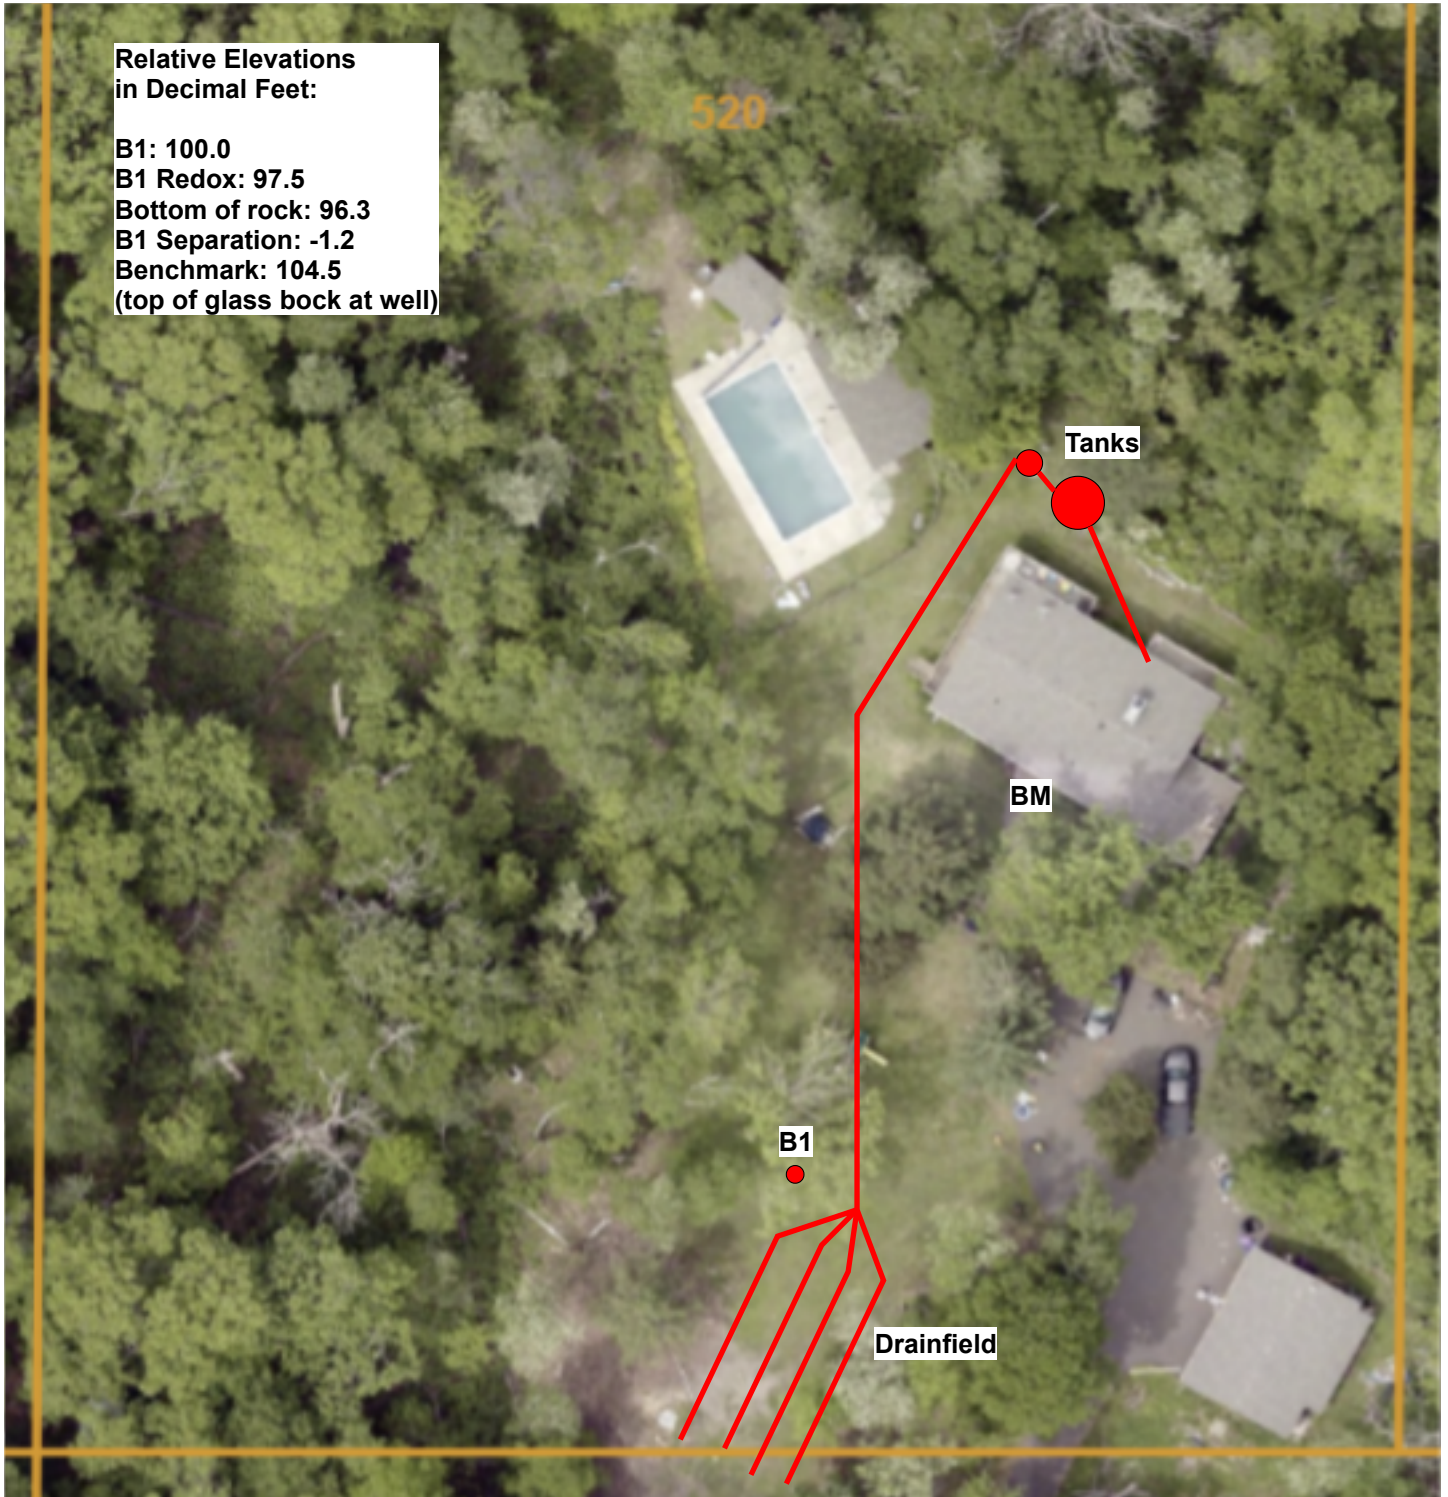
**Relative Elevations
in Decimal Feet:**

A. Bottom of distribution media	96.3'
B. Periodically saturated soil/bedrock	97.5'
C. System separation	-1.2'
D. Required compliance separation*	2.0'

B1: 100.0
B1 Redox: 97.5
Bottom of rock: 96.3
B1 Separation: -1.2
Benchmark: 104.5
(top of glass bock at well)
