SUBSURFACE SEWAGE TREATMENT SYSTEM (SSTS) COMPLIANCE REPORT

Date: 6/12/2023 & 6/19/2023

Inspection Address: 2685 Meadow Point Path, Afton, MN 55001

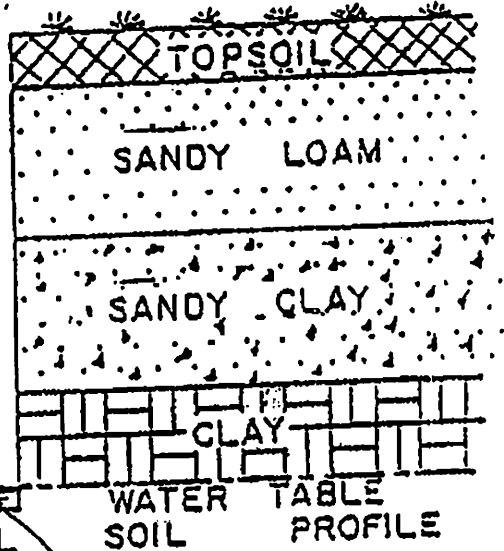
*B5
0-12" TOPSOIL
12-24" BED ROCK*
