Compliance inspection report form

Existing Subsurface Sewage Treatment System (SSTS)

Property address: 23200 MANNING TRL SCANDIA MN

Brief system description: SEPTIC TANK AND GRAVITY TRENCHES

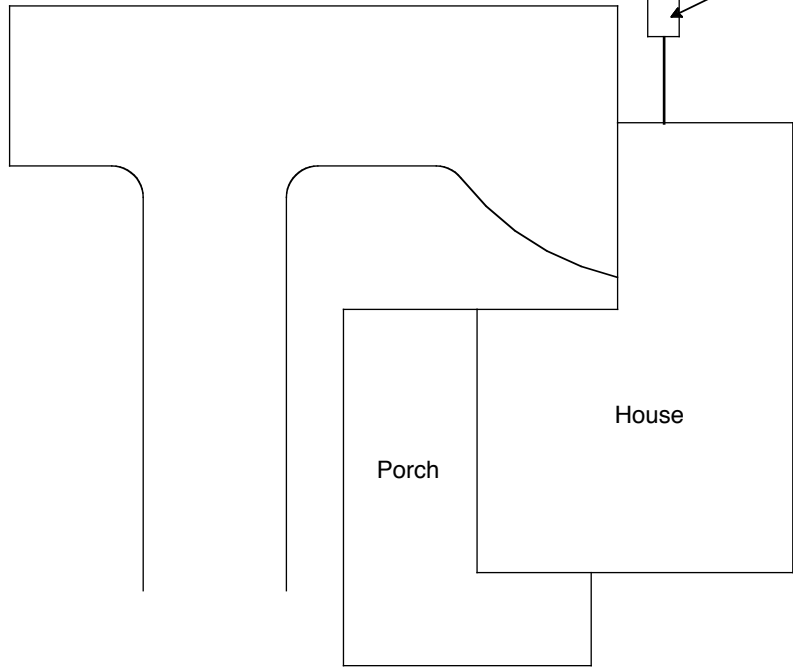
Drainfield Area

○ B-1 By Inspect MN

Lift Tank

Septic Tanks

House
