# ZIERKE SOIL TESTING

# Compliance inspection report form

## Existing Subsurface Sewage Treatment System (SSTS)

Property address: 21100 Olinda Trl N Scandia, MN 55073

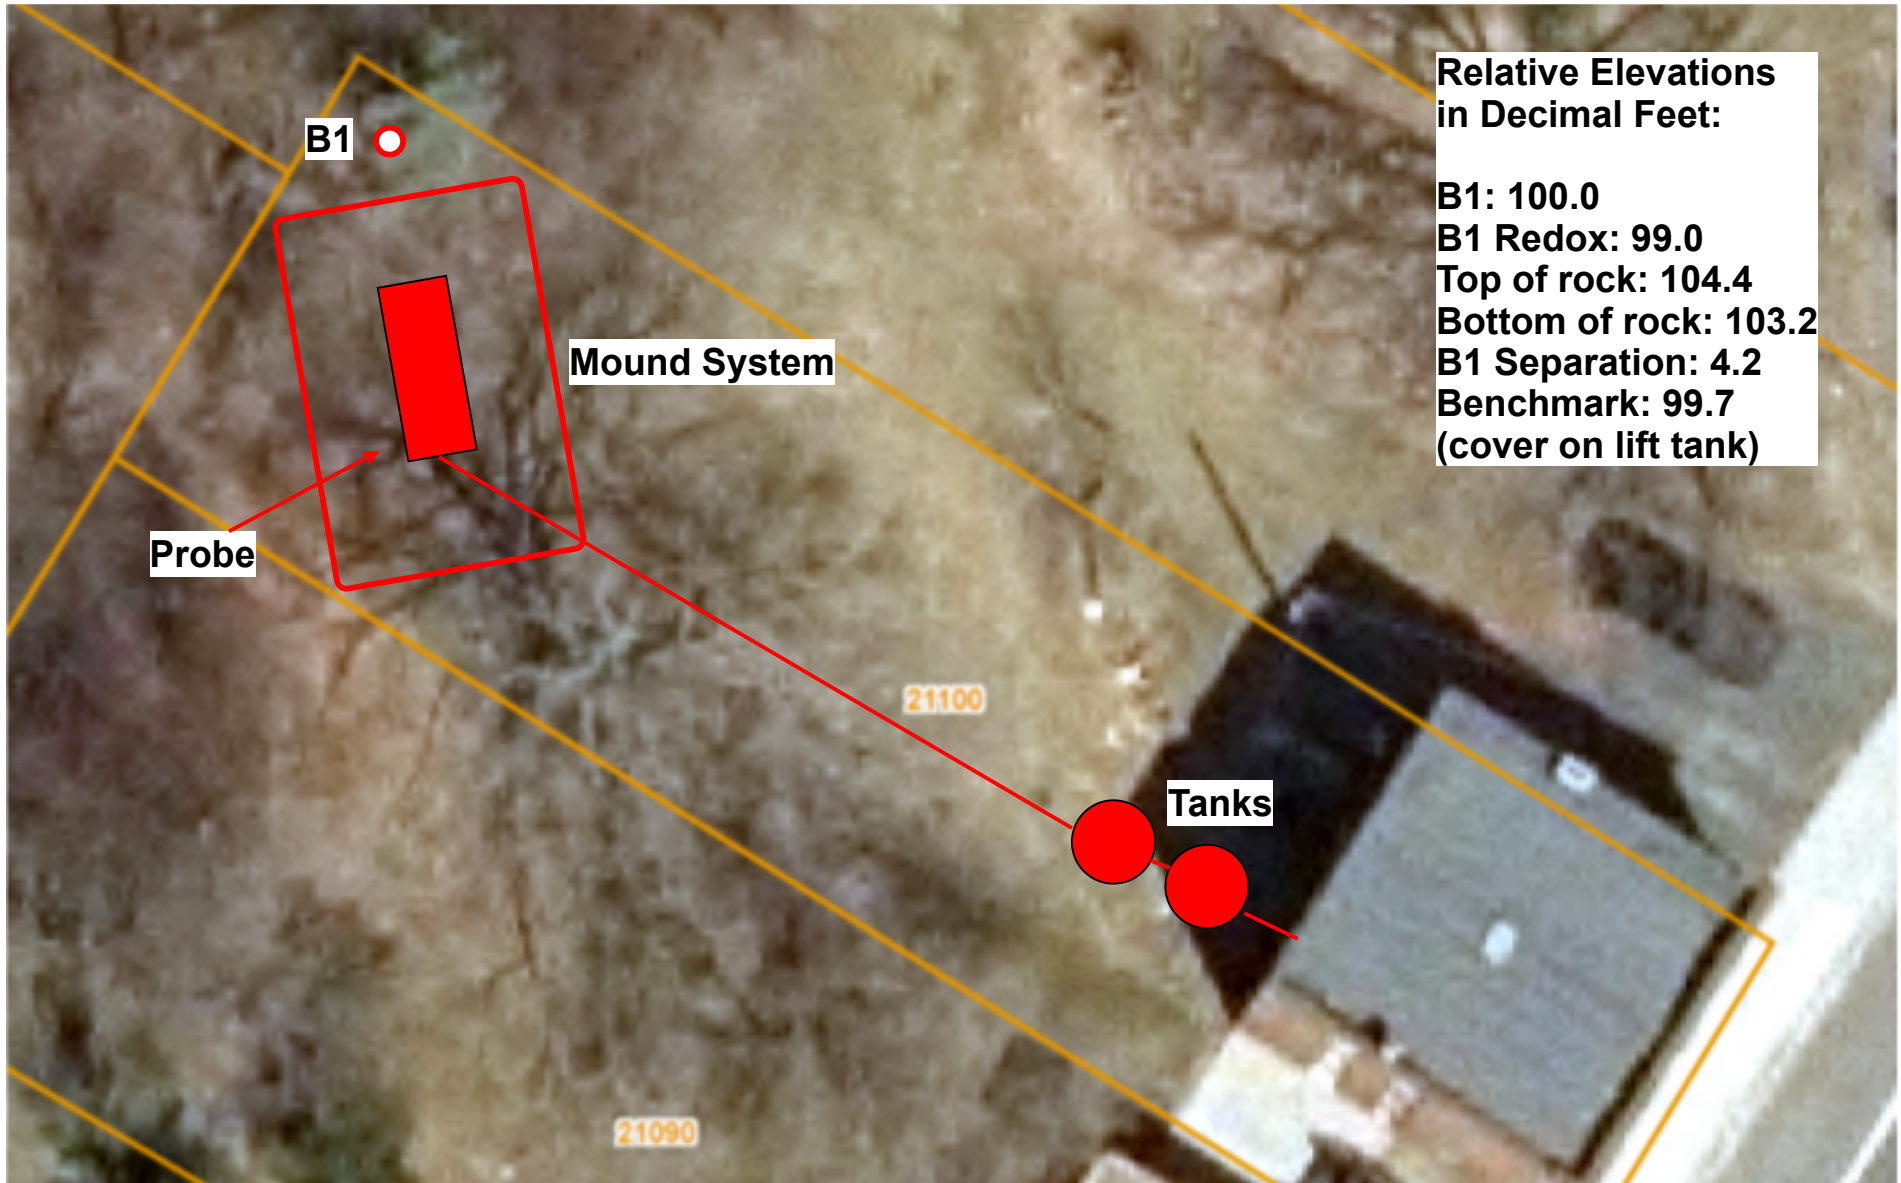
See attached boring log and sketch

B1: 100.0  
B1 Redox: 99.0  
Top of rock: 104.4  
Bottom of rock: 103.2  
B1 Separation: 4.2  
Benchmark: 99.7  
(cover on lift tank)
