# ZIERKE SOIL TESTING

# Compliance inspection report form

## Existing Subsurface Sewage Treatment System (SSTS)

Property address: 932 NW 2<sup>nd</sup> St Forest Lake, MN 55025

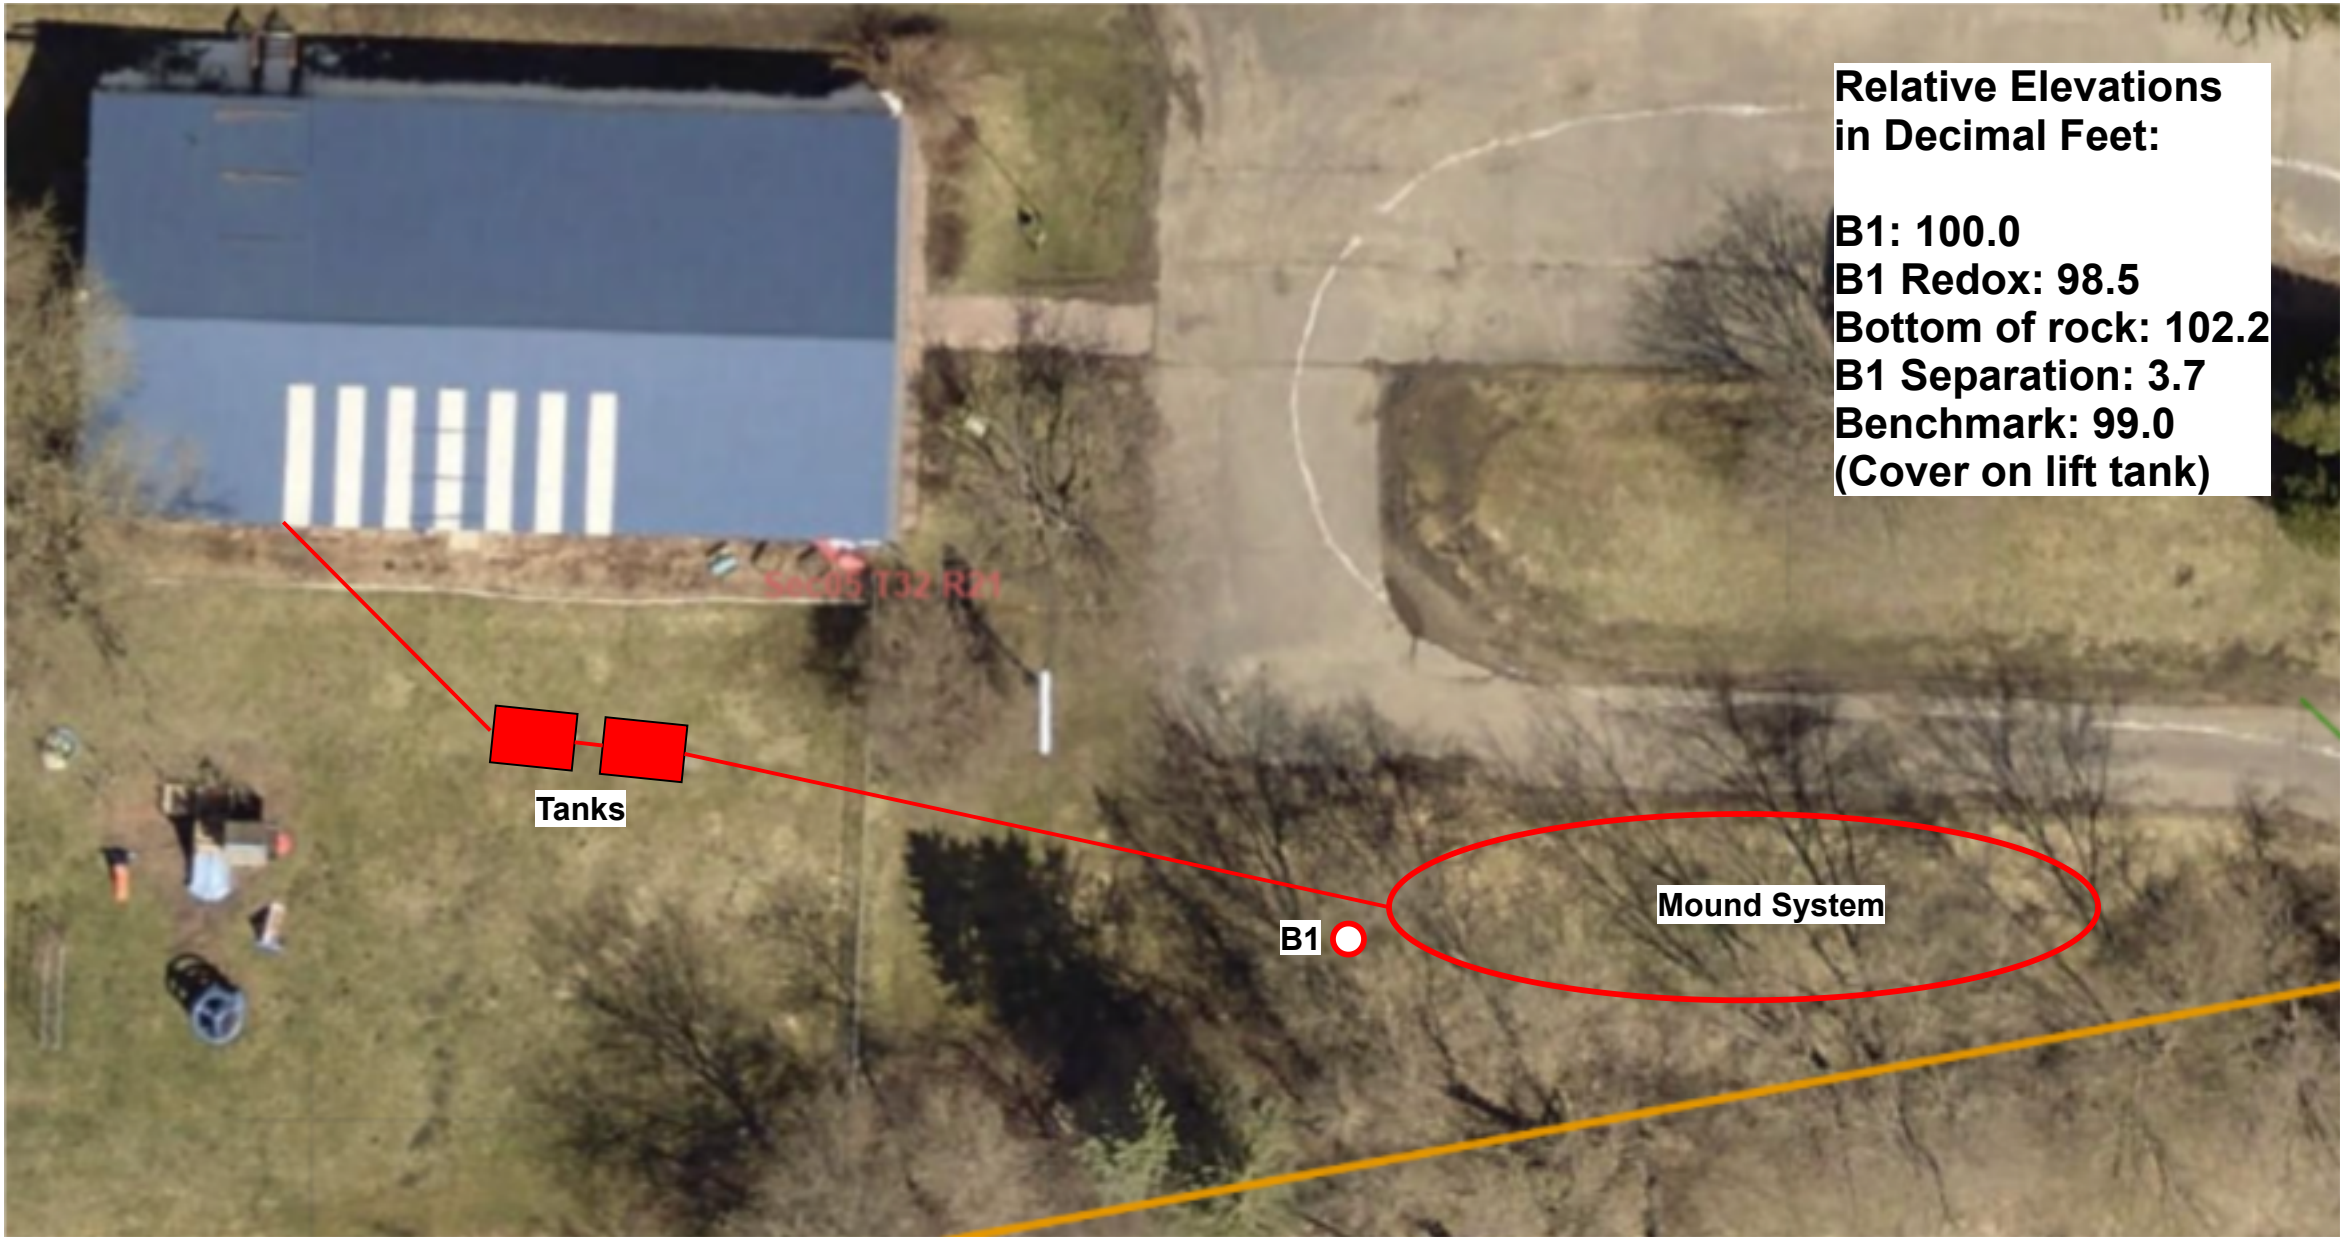
**Relative Elevations  
in Decimal Feet:**

- B1: 100.0**
- B1 Redox: 98.5**
- Bottom of rock: 102.2**
- B1 Separation: 3.7**
- Benchmark: 99.0**
- (Cover on lift tank)**

**Tanks**

**Mound System**

**B1**
