ZIERKE SOIL TESTING

Compliance inspection report form

Existing Subsurface Sewage Treatment System (SSTS)

Property address: 7451 190th St N Forest Lake, MN 55025

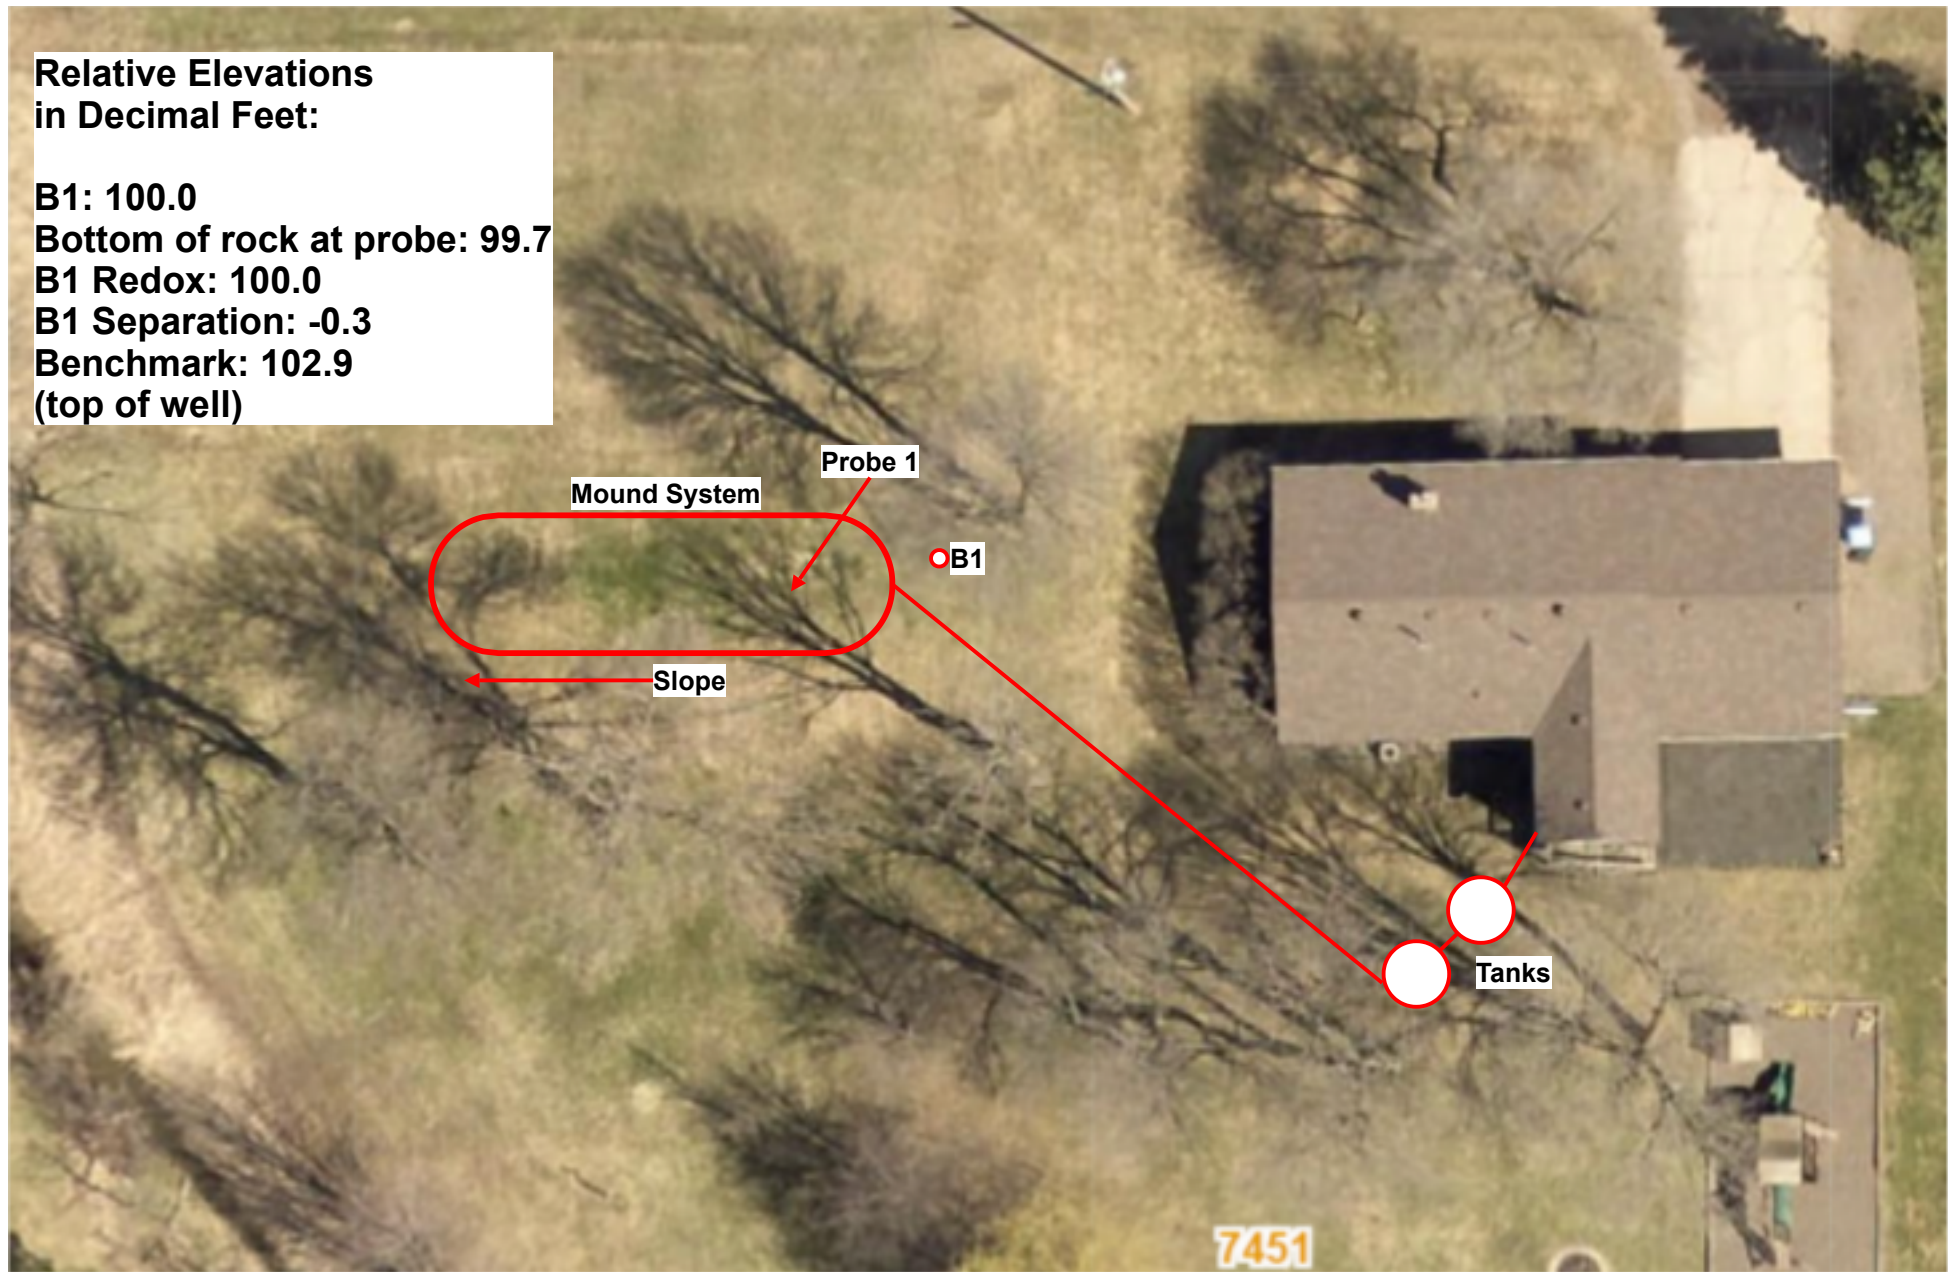
**Relative Elevations
in Decimal Feet:**

B1: 100.0

Bottom of rock at probe: 99.7

B1 Redox: 100.0

B1 Separation: -0.3

Benchmark: 102.9

(top of well)
