# ZIERKE SOIL TESTING

# Compliance inspection report form

## Existing Subsurface Sewage Treatment System (SSTS)

Property address: 10311 230<sup>th</sup> St N Scandia, MN 55073

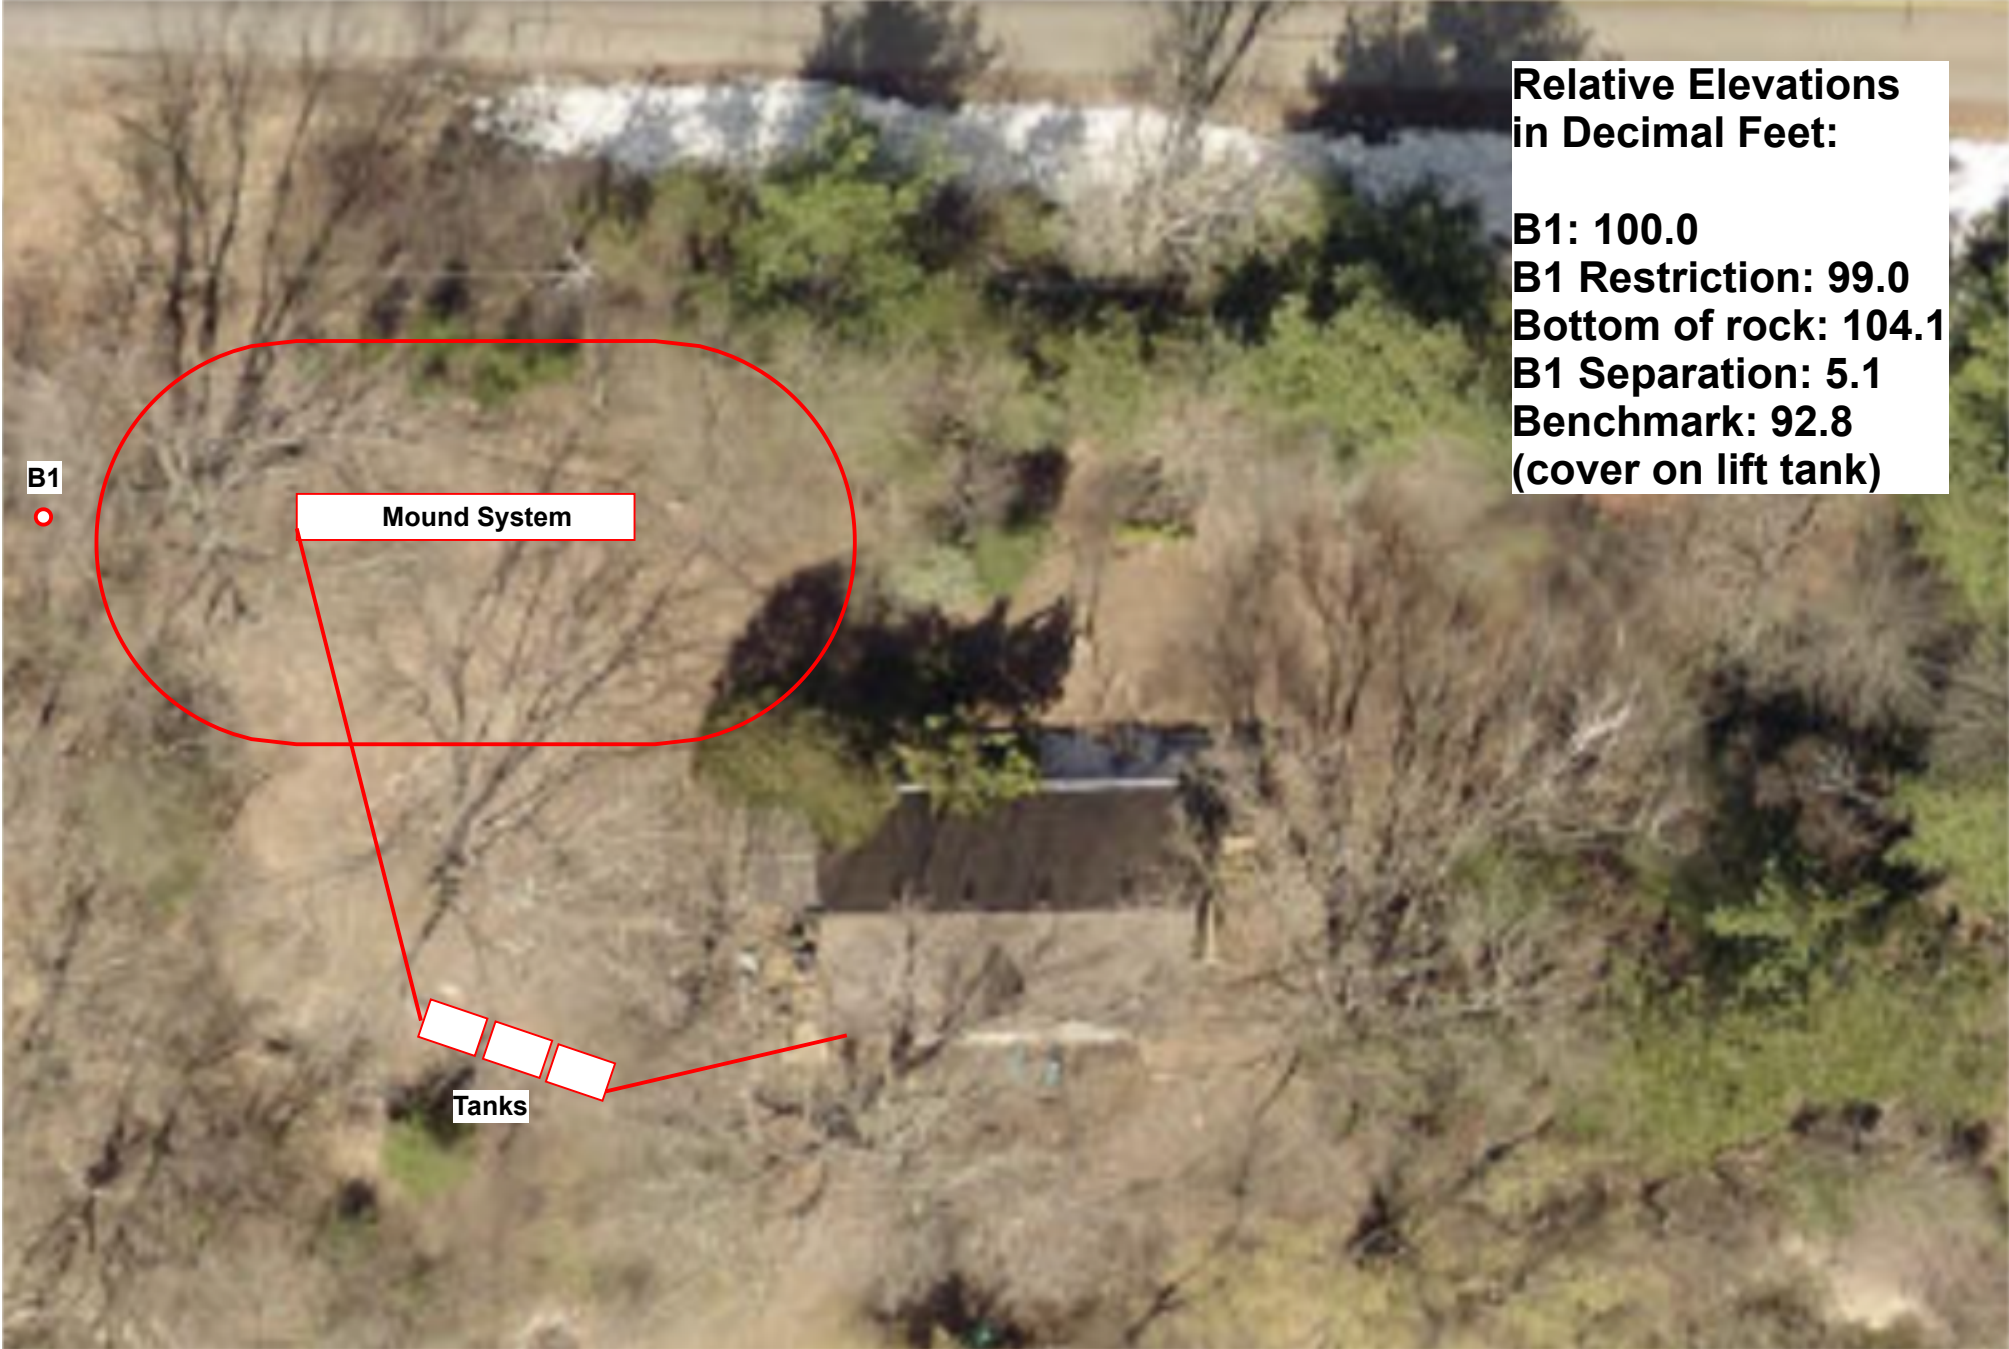
A. Bottom of distribution media	104.1'
B. Periodically saturated soil/bedrock	99.0'
C. System separation	5.1'
D. Required compliance separation*	3.0'

- B1: 100.0**
- B1 Restriction: 99.0**
- Bottom of rock: 104.1**
- B1 Separation: 5.1**
- Benchmark: 92.8**  
**(cover on lift tank)**

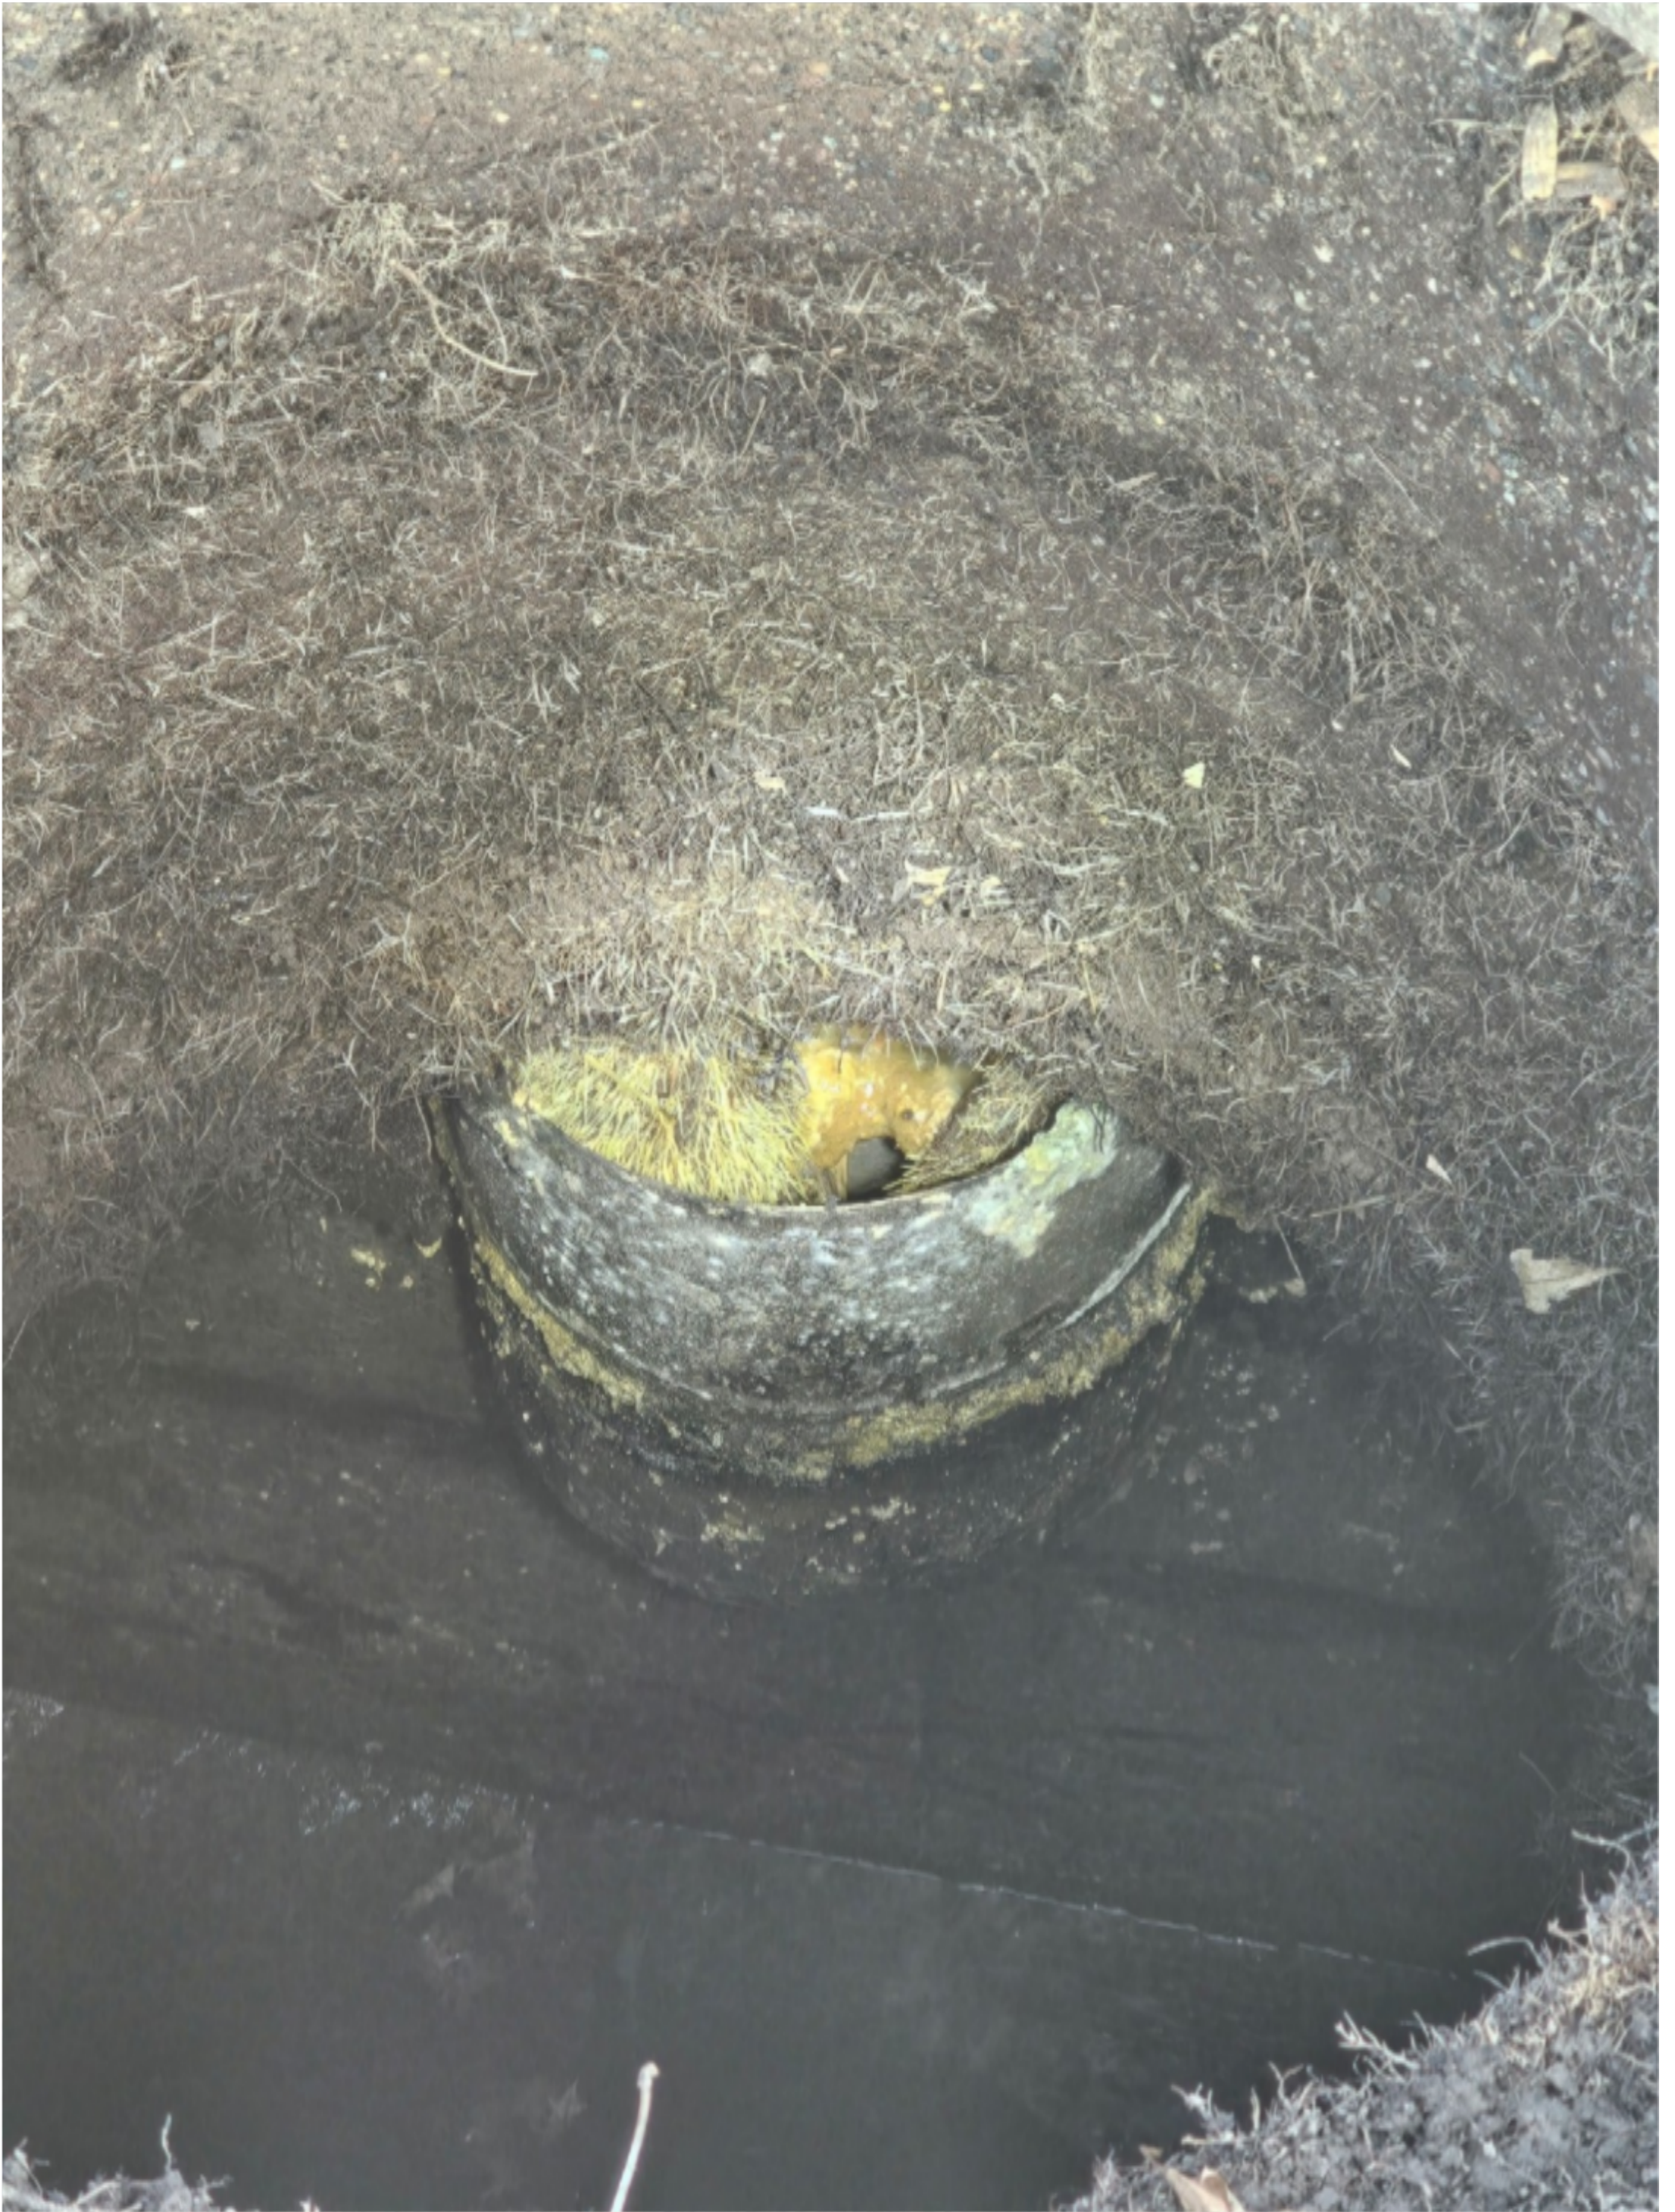
System functioning normally during site visits. Inlet baffle on septic tank is close to clogged with roots - this could present a risk of backup in the future. Recommend having the roots removed as soon as possible.

Present for pumping by Smilies Sewer. Septic tank has extensive root infiltration around the inlet (see attached photo). Tanks watertight below operating level, however would recommend removing the roots.
