ZIERKE SOIL TESTING

Compliance inspection report form

Existing Subsurface Sewage Treatment System (SSTS)

Property address: 9685 228th St N Scandia, MN 55073

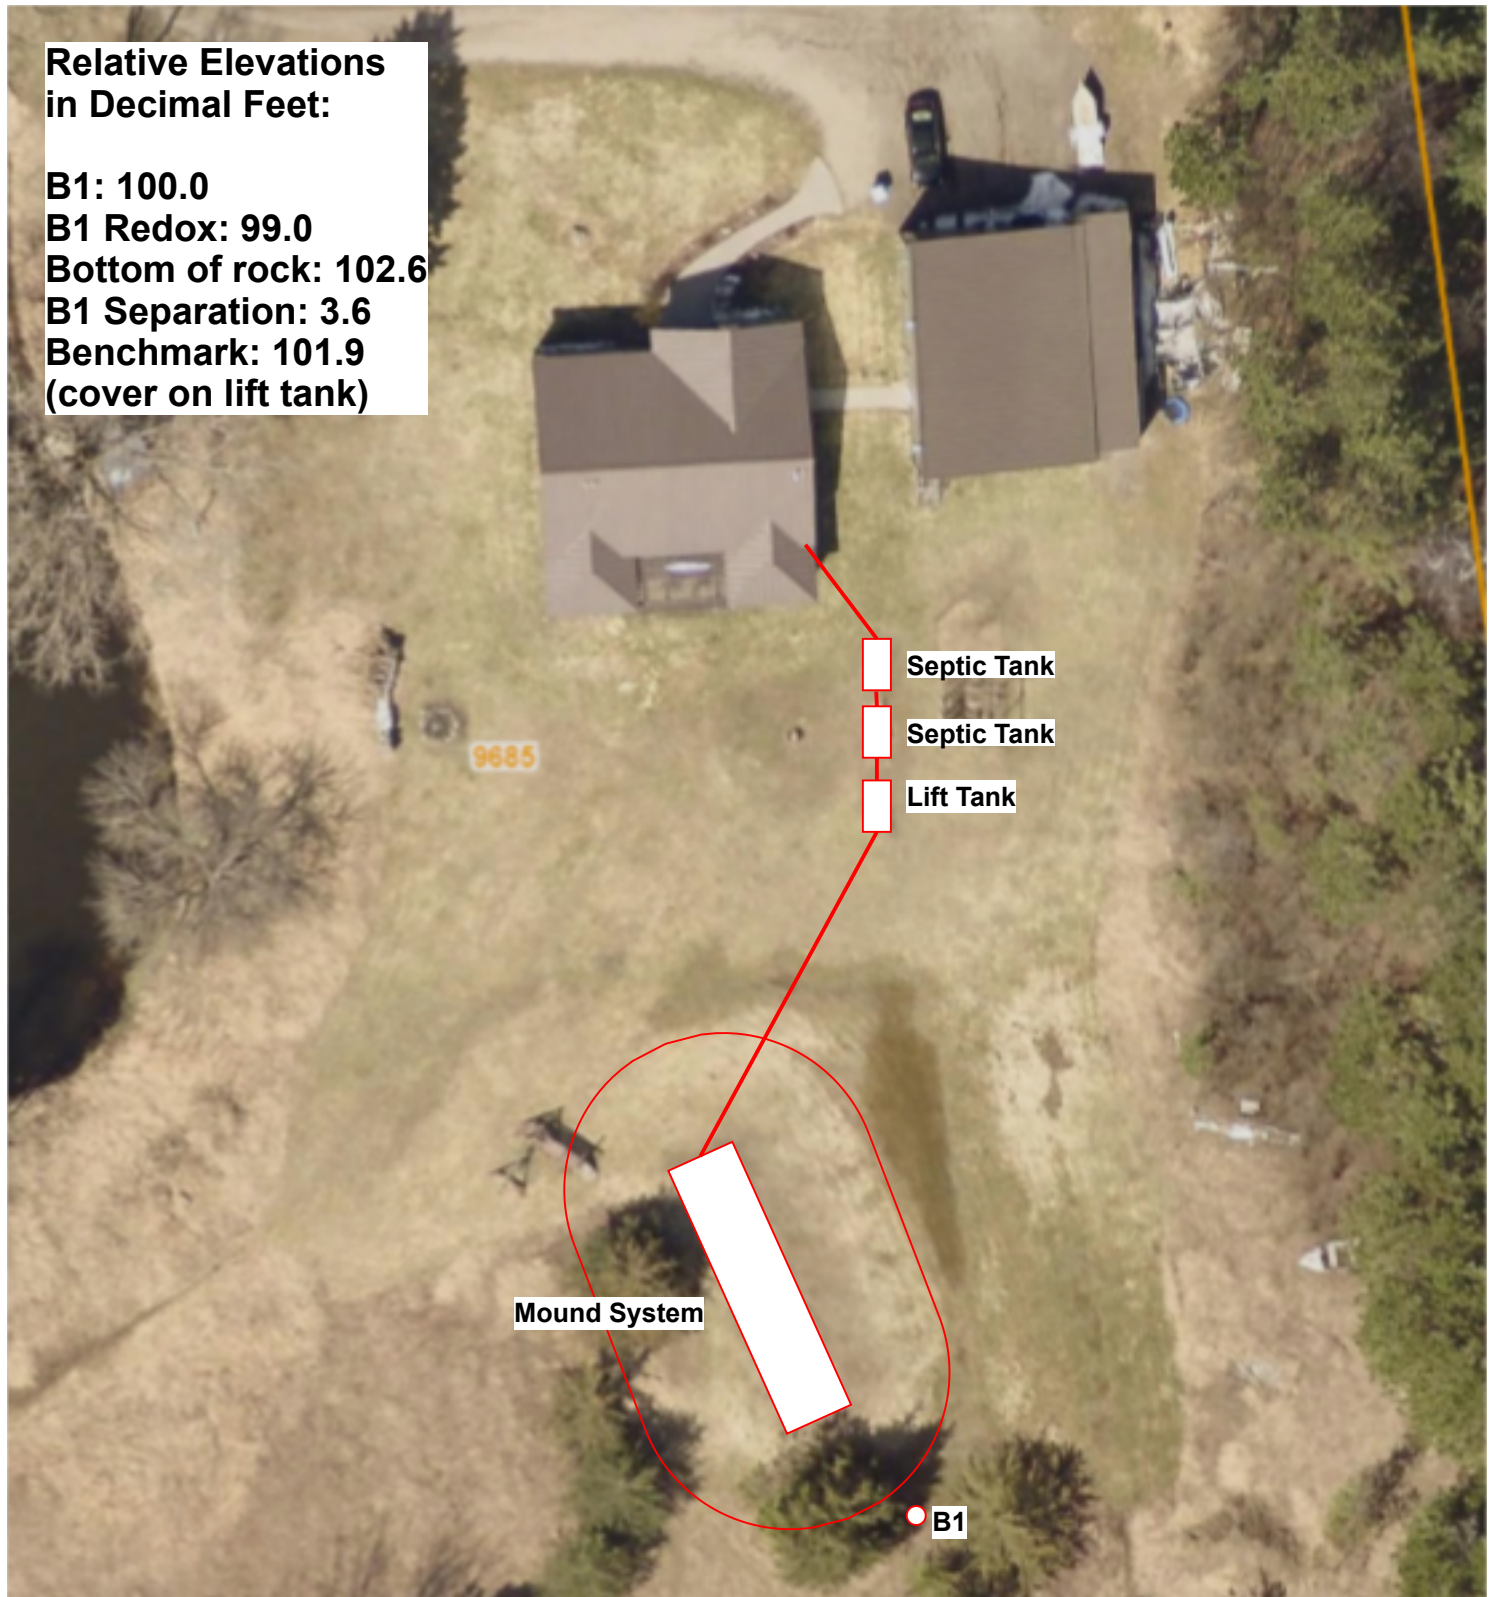
**Relative Elevations
in Decimal Feet:**

B1: 100.0

B1 Redox: 99.0

Bottom of rock: 102.6

B1 Separation: 3.6

**Benchmark: 101.9
(cover on lift tank)**
