ZIERKE SOIL TESTING

Compliance inspection report form

Existing Subsurface Sewage Treatment System (SSTS)

Property address: 23877 Manning Trail N Scandia, MN 55073

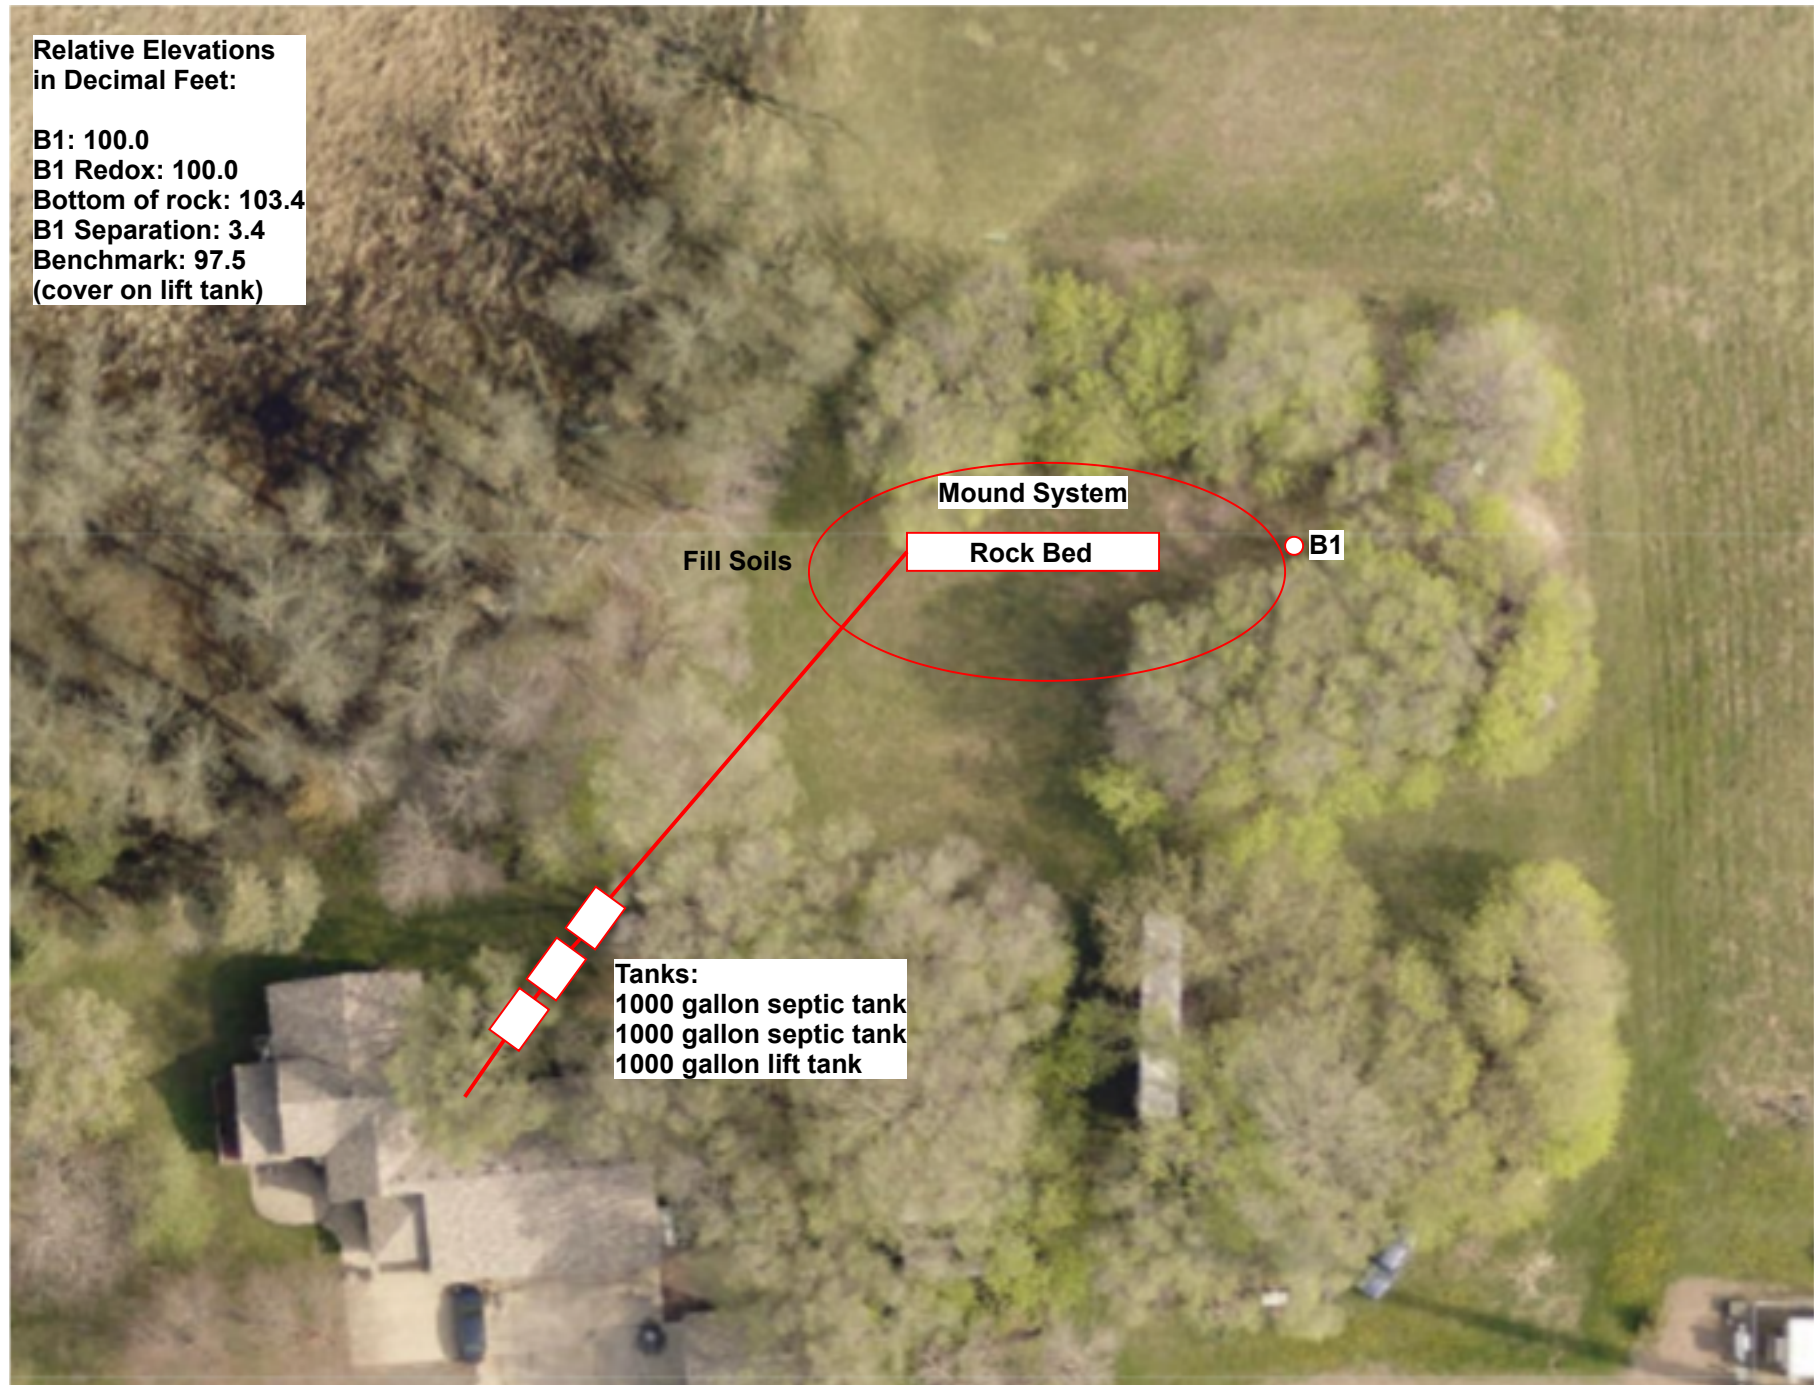
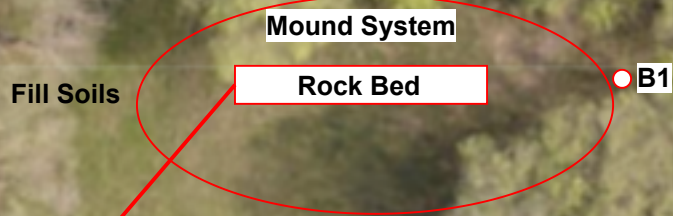
**Relative Elevations
in Decimal Feet:**

Large mound berms installed that taper past original contour - soil sample on west end of mound (supply end) was compacted and consisted of fill. Took a boring at the base of the mound berm on the east end of the mound just off the berm fill. Had 3.4' of separation from base of grade to bottom of rock. Homeowner reported no past issues with the mound system.

B1: 100.0
B1 Redox: 100.0
Bottom of rock: 103.4
B1 Separation: 3.4
Benchmark: 97.5
(cover on lift tank)

Tanks:
1000 gallon septic tank
1000 gallon septic tank
1000 gallon lift tank
