# ZIERKE SOIL TESTING

# Compliance inspection report form

## Existing Subsurface Sewage Treatment System (SSTS)

Property address: 22190 Olinda Trail N Scandia, MN 55073

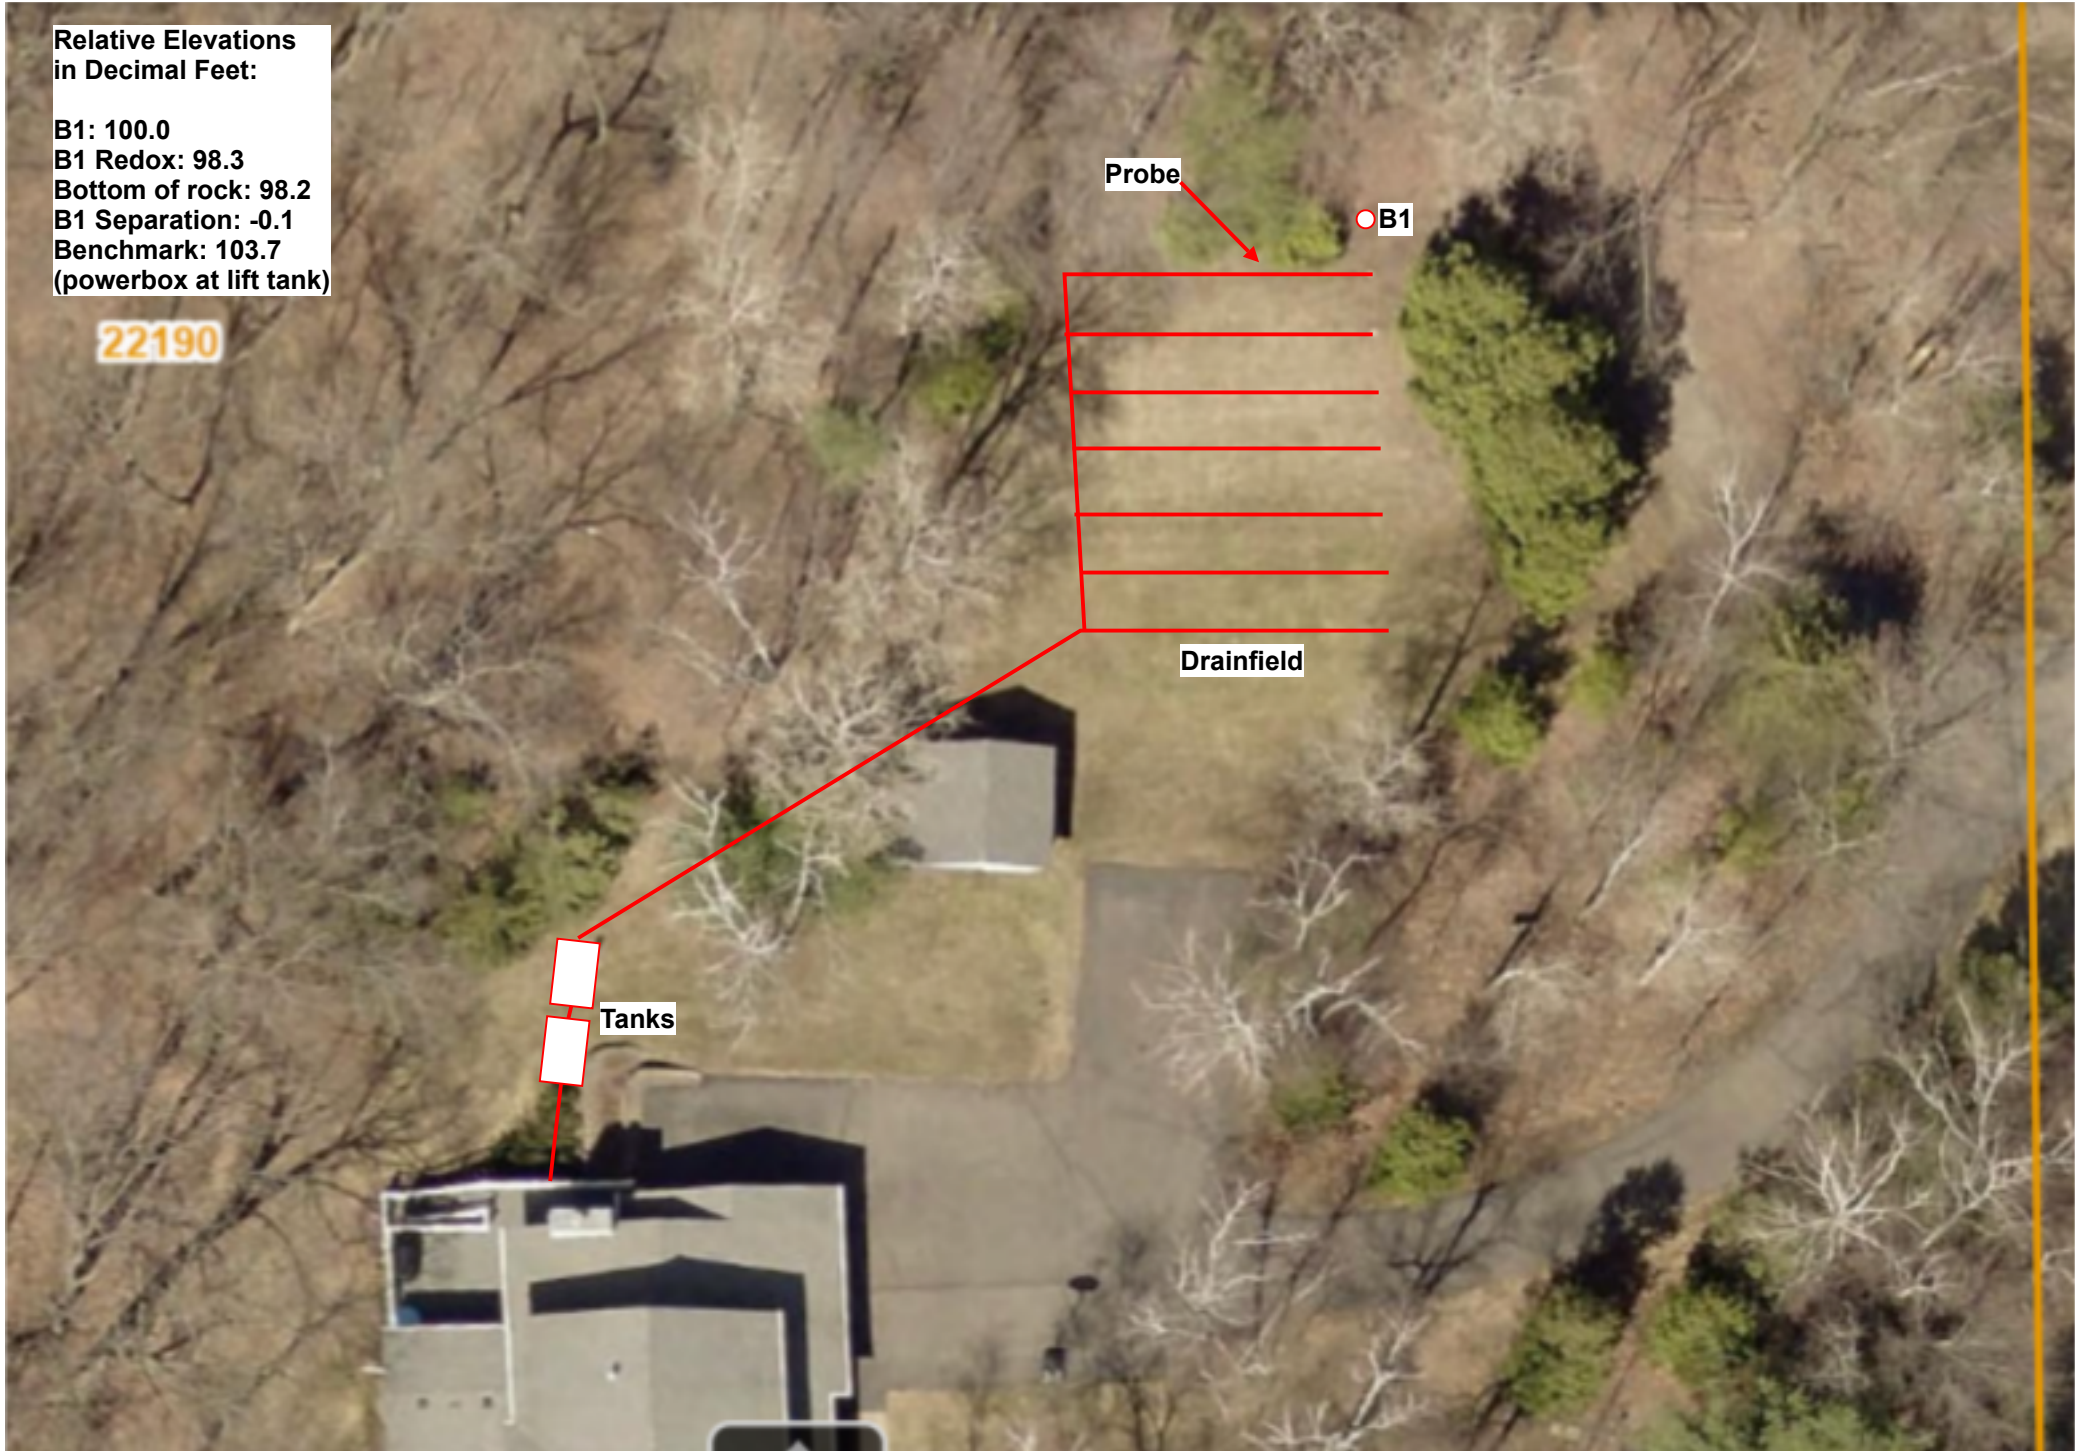
A. Bottom of distribution media	98.2'
B. Periodically saturated soil/bedrock	98.3'
C. System separation	-0.1'
D. Required compliance separation*	3.0'

**B1: 100.0**  
**B1 Redox: 98.3**  
**Bottom of rock: 98.2**  
**B1 Separation: -0.1**  
**Benchmark: 103.7**  
**(powerbox at lift tank)**
