# ZIERKE SOIL TESTING

# Compliance inspection report form

## Existing Subsurface Sewage Treatment System (SSTS)

Property address: 23245 Itasca Ave N Forest Lake, MN 55025

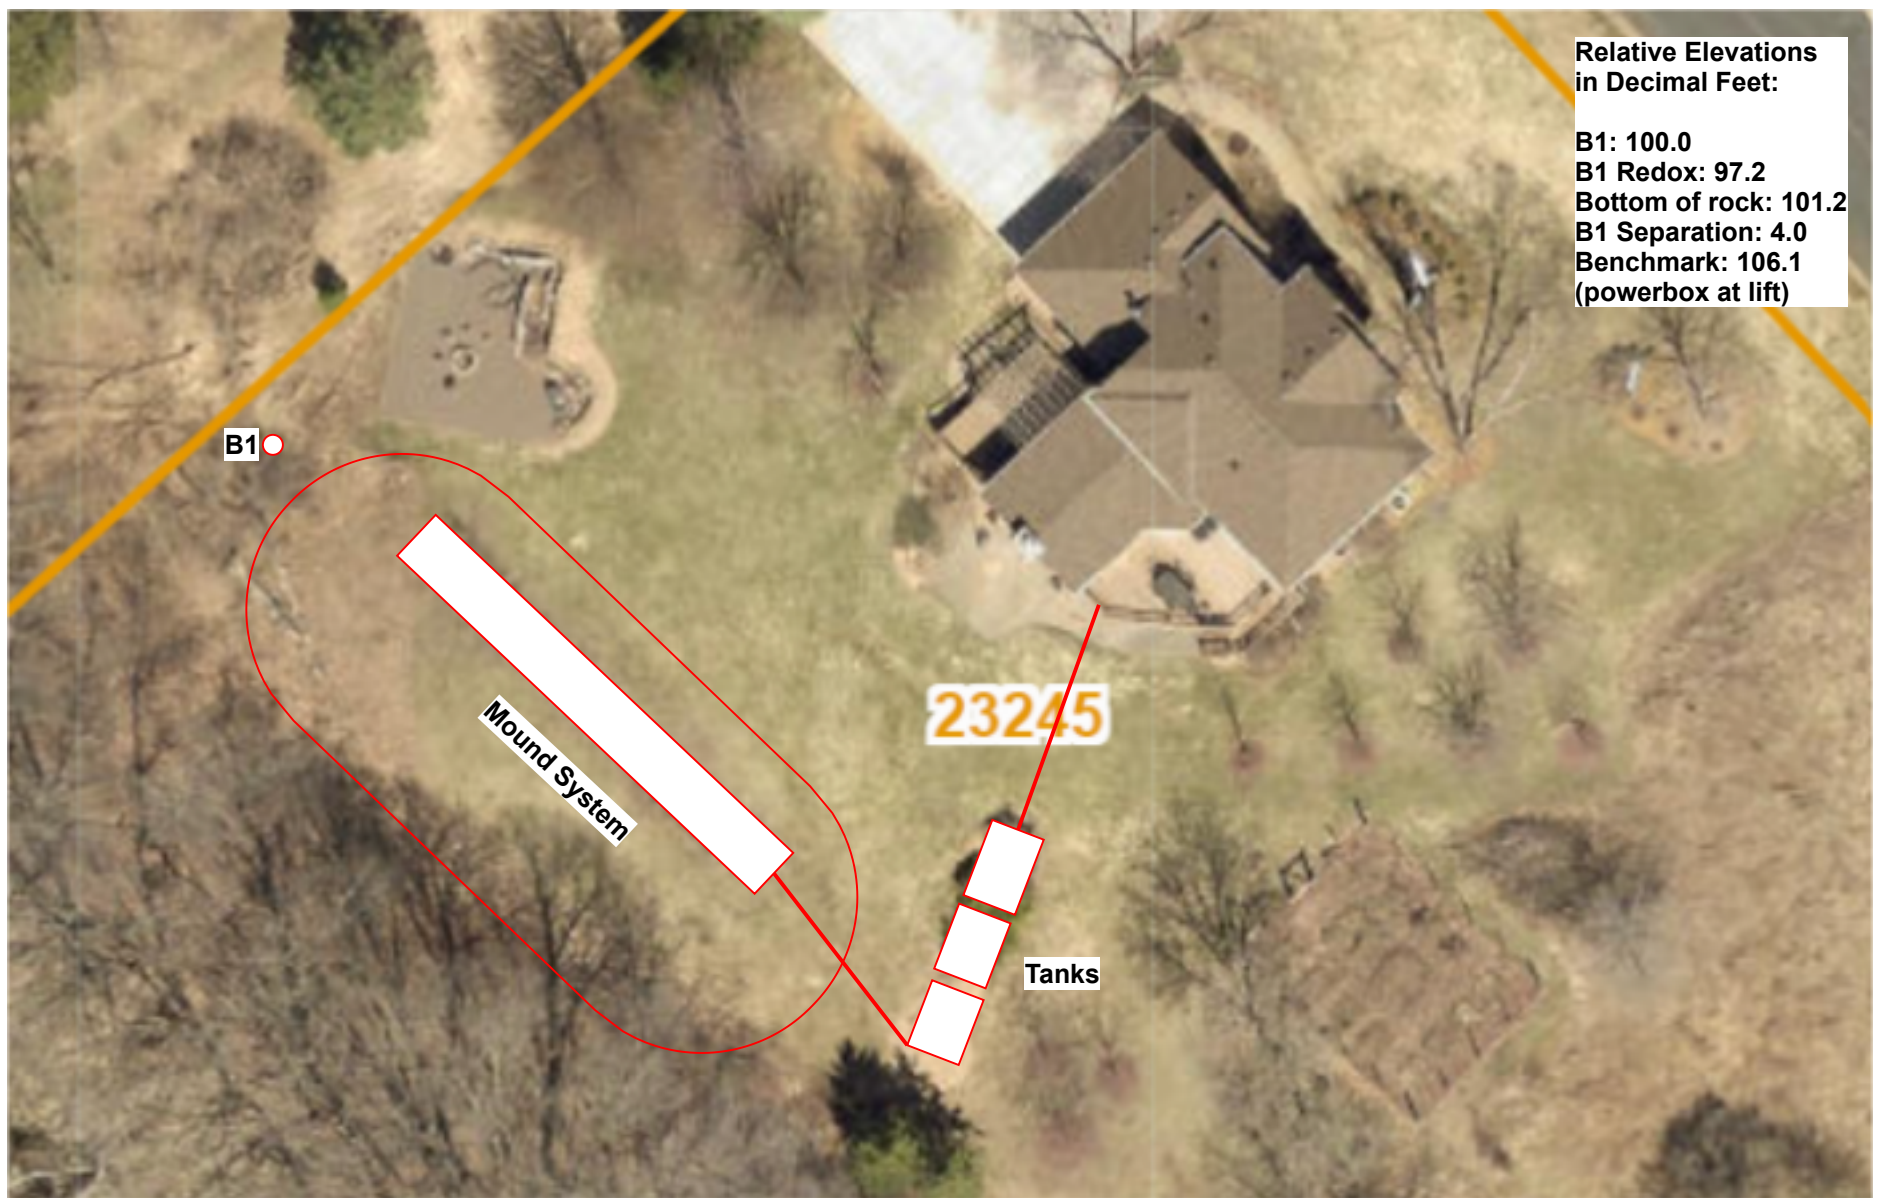
**Relative Elevations  
in Decimal Feet:**  
B1: 100.0  
B1 Redox: 97.2  
Bottom of rock: 101.2  
B1 Separation: 4.0  
Benchmark: 106.1  
(powerbox at lift)

**B1** ●

**Mound System**

**Tanks**
