# Midwest Sewer Services

## **SUBSURFACE SEWAGE TREATMENT SYSTEM (SSTS) COMPLIANCE REPORT**

**Date:** November 27, 2024

**Inspection Address:** 10923 Quinlan Ave N, Stillwater Twp, MN 55082

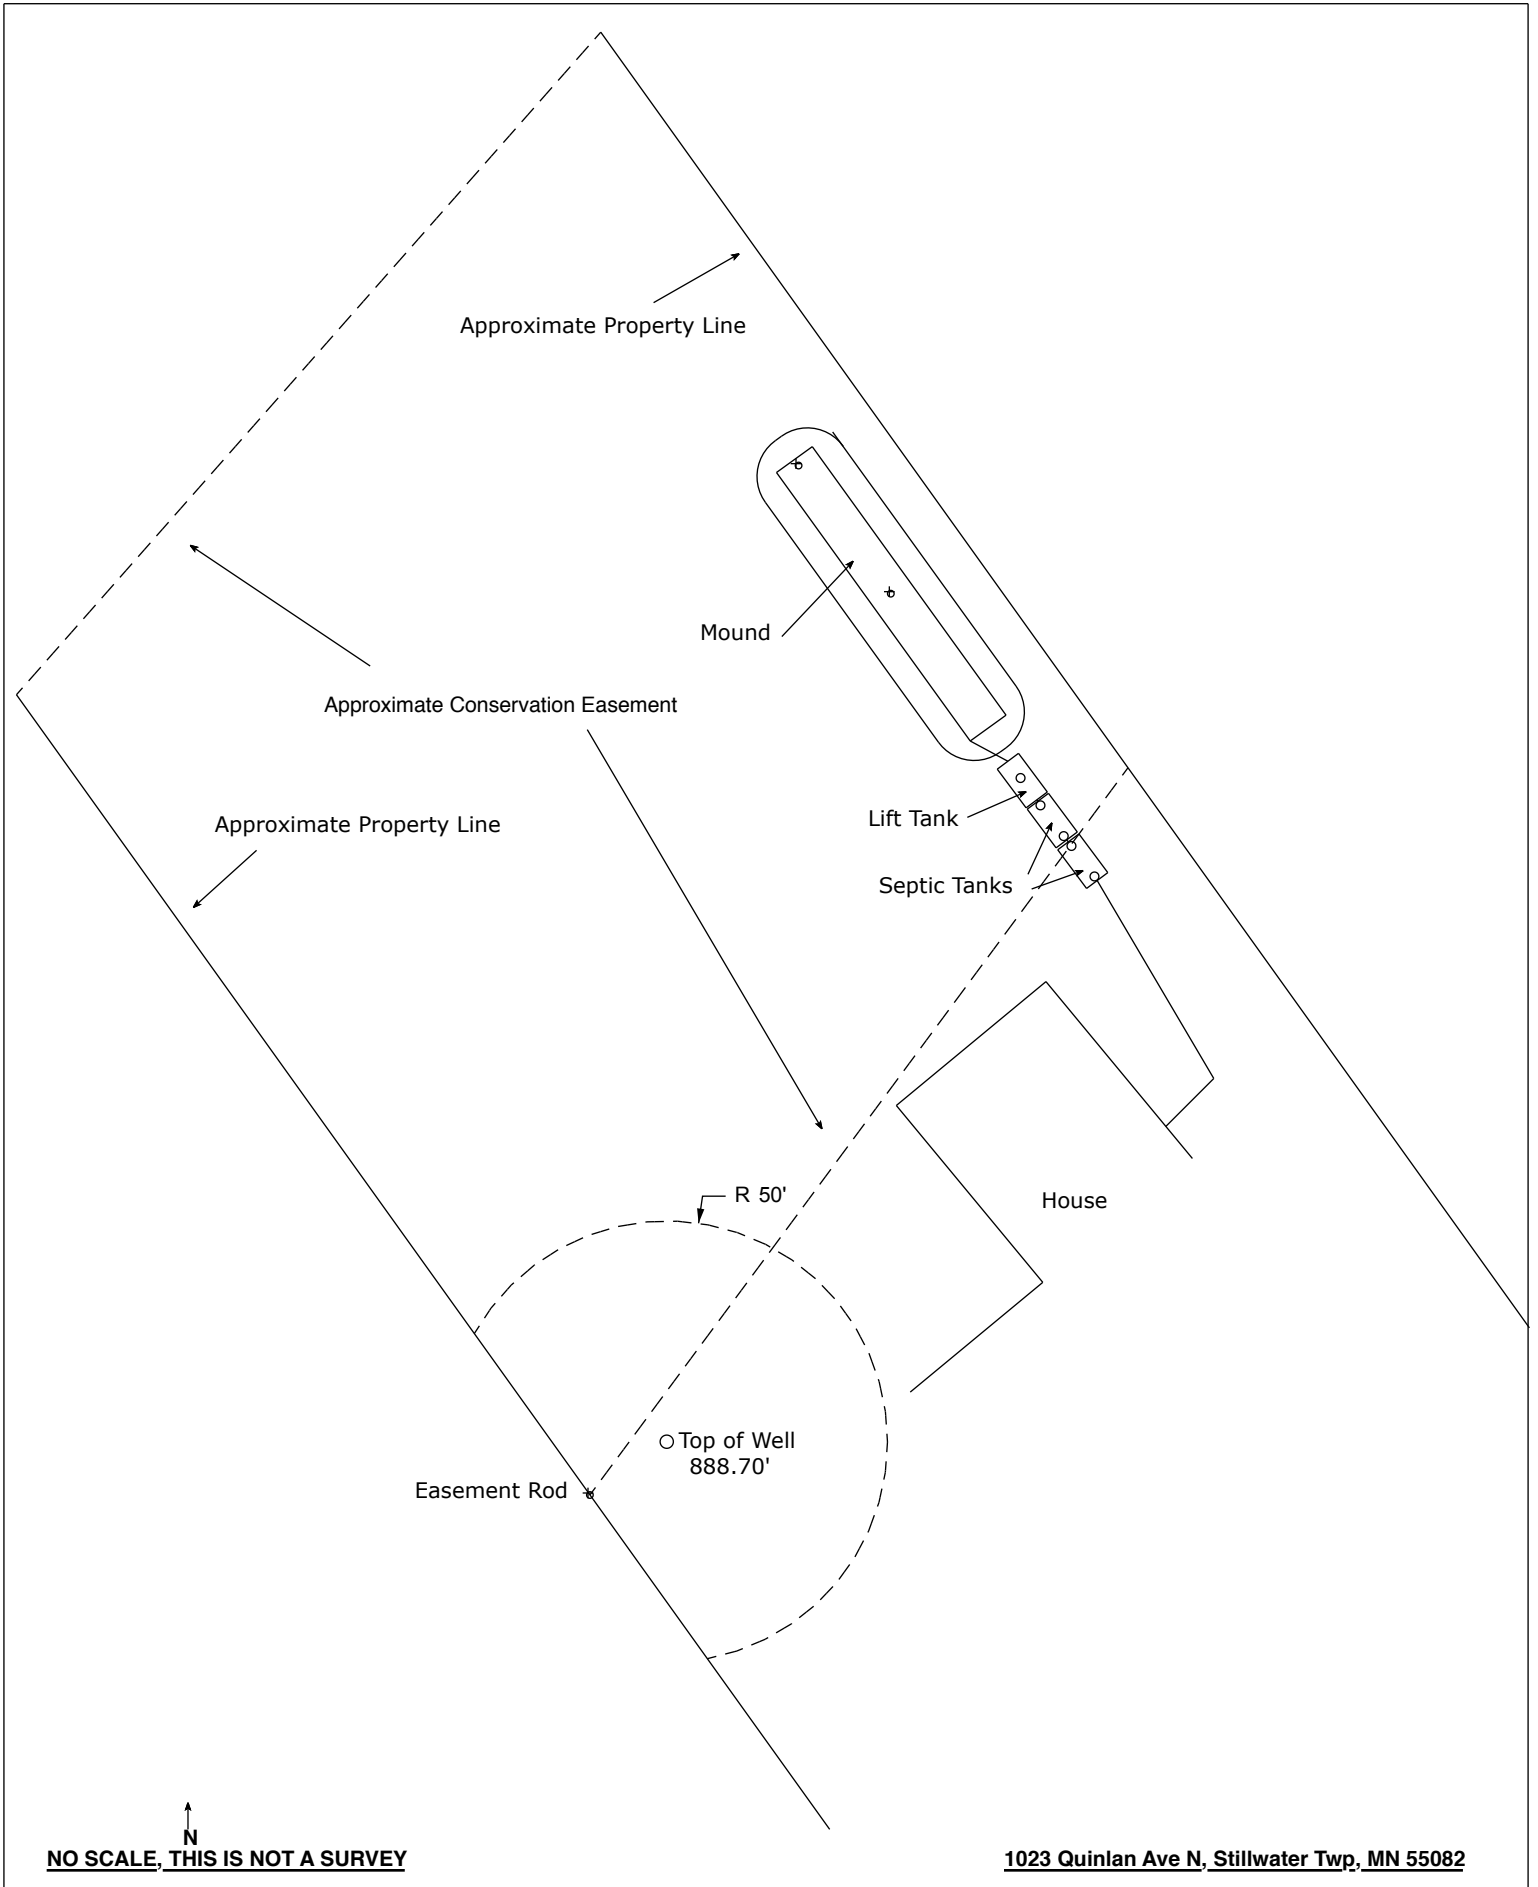
**NO SCALE, THIS IS NOT A SURVEY**

**1023 Quinlan Ave N, Stillwater Twp, MN 55082**
