SUBSURFACE SEWAGE TREATMENT SYSTEM (SSTS) COMPLIANCE REPORT

Date: 1/2/2025

Inspection Address: 13889 Isleton Ave N, Hugo, MN 55038

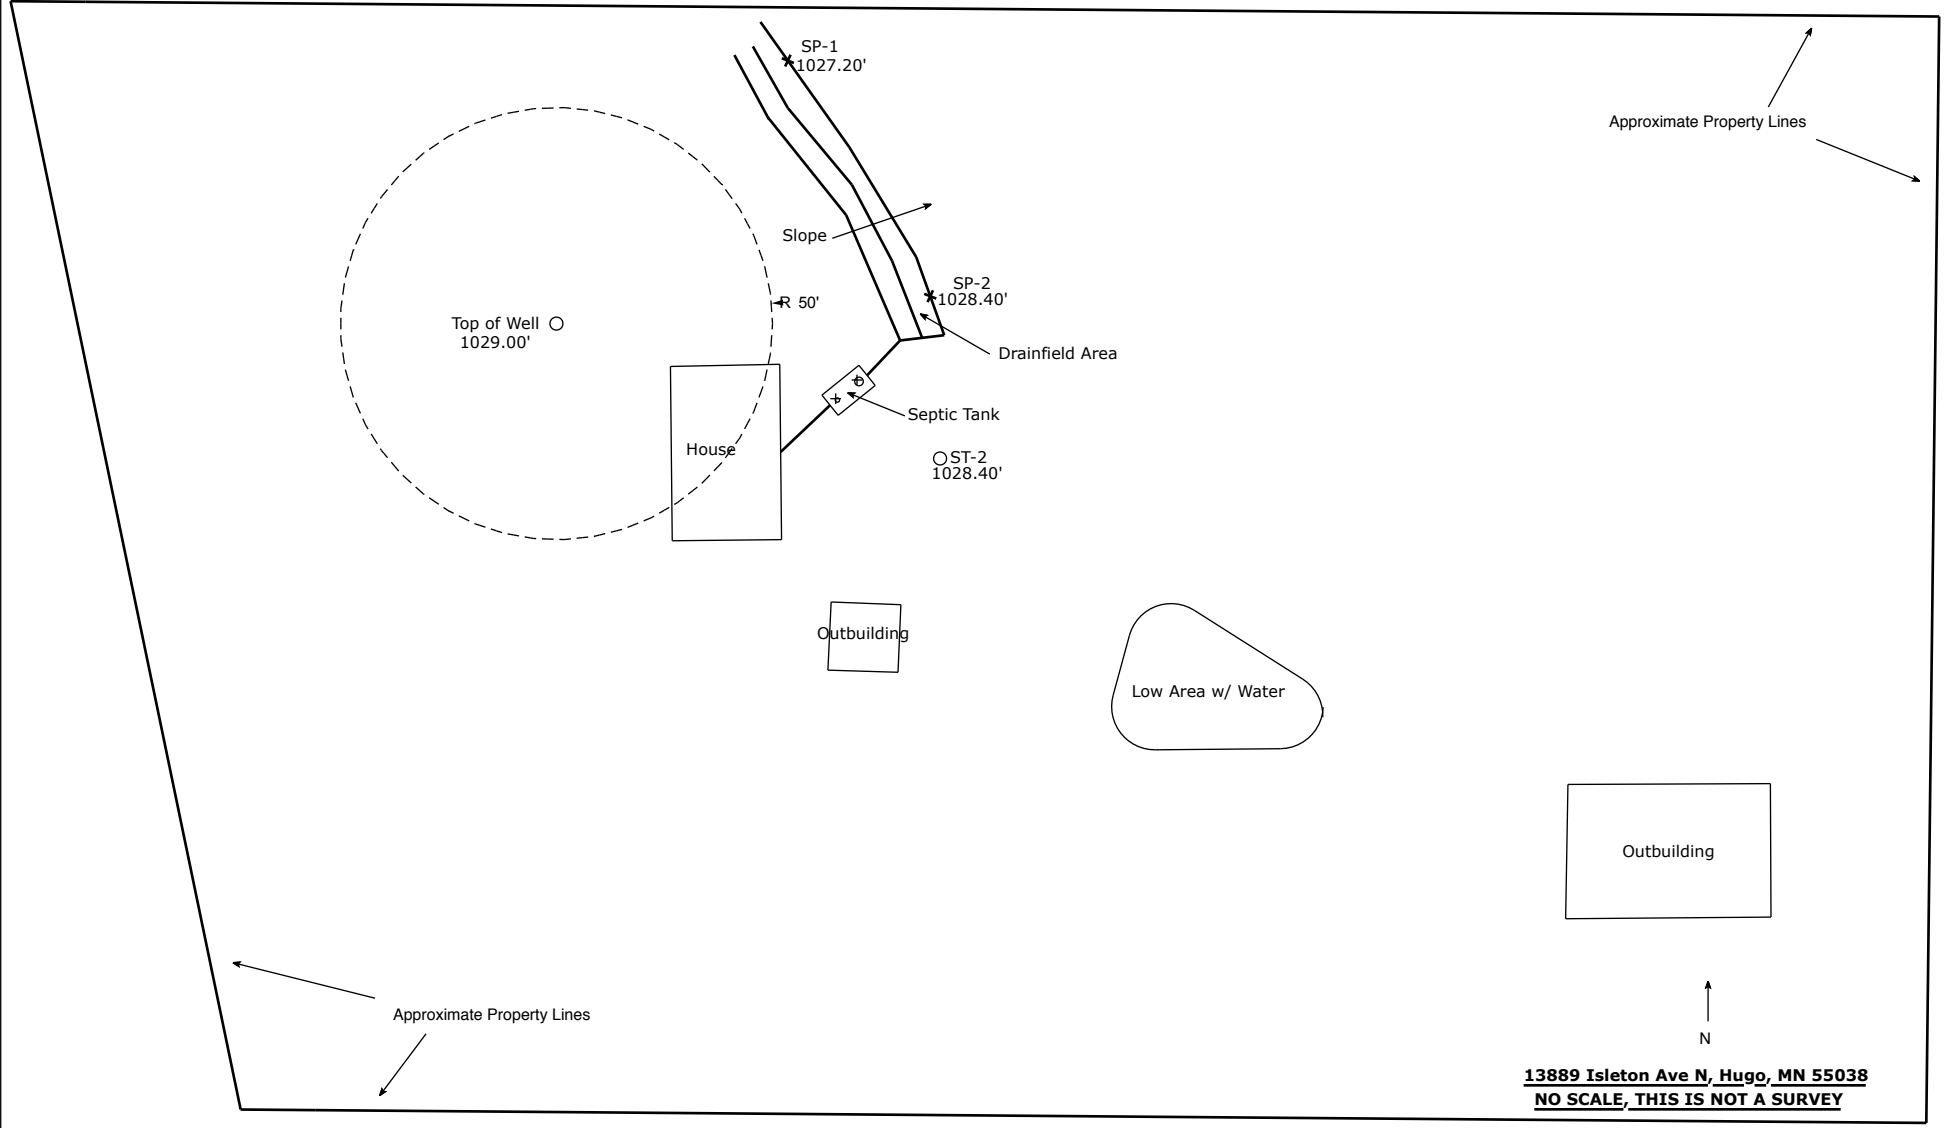
○ ST-1
1027.20'

Drainfield Area

Septic Tank

○ ST-2
1028.40'

Low Area w/ Water

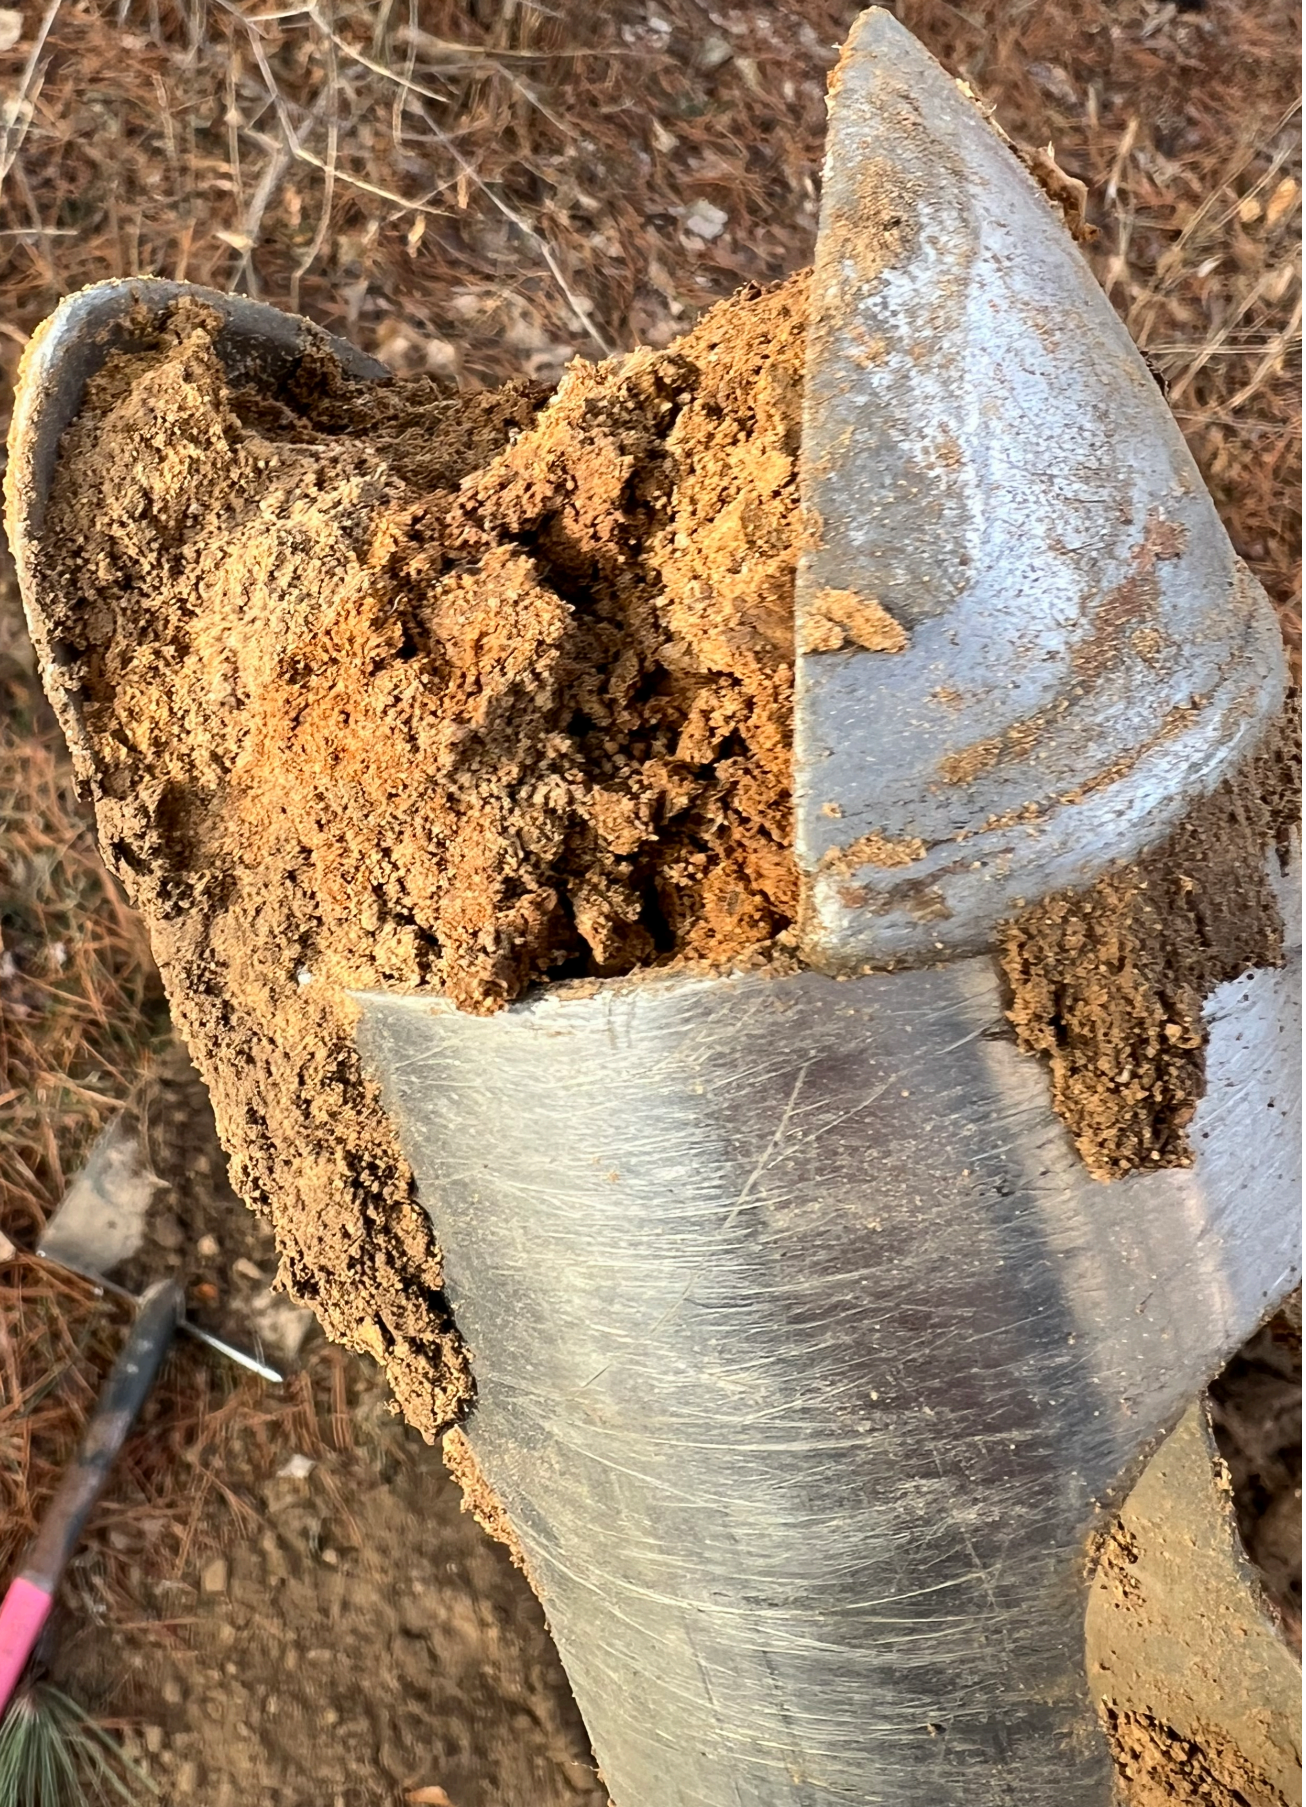
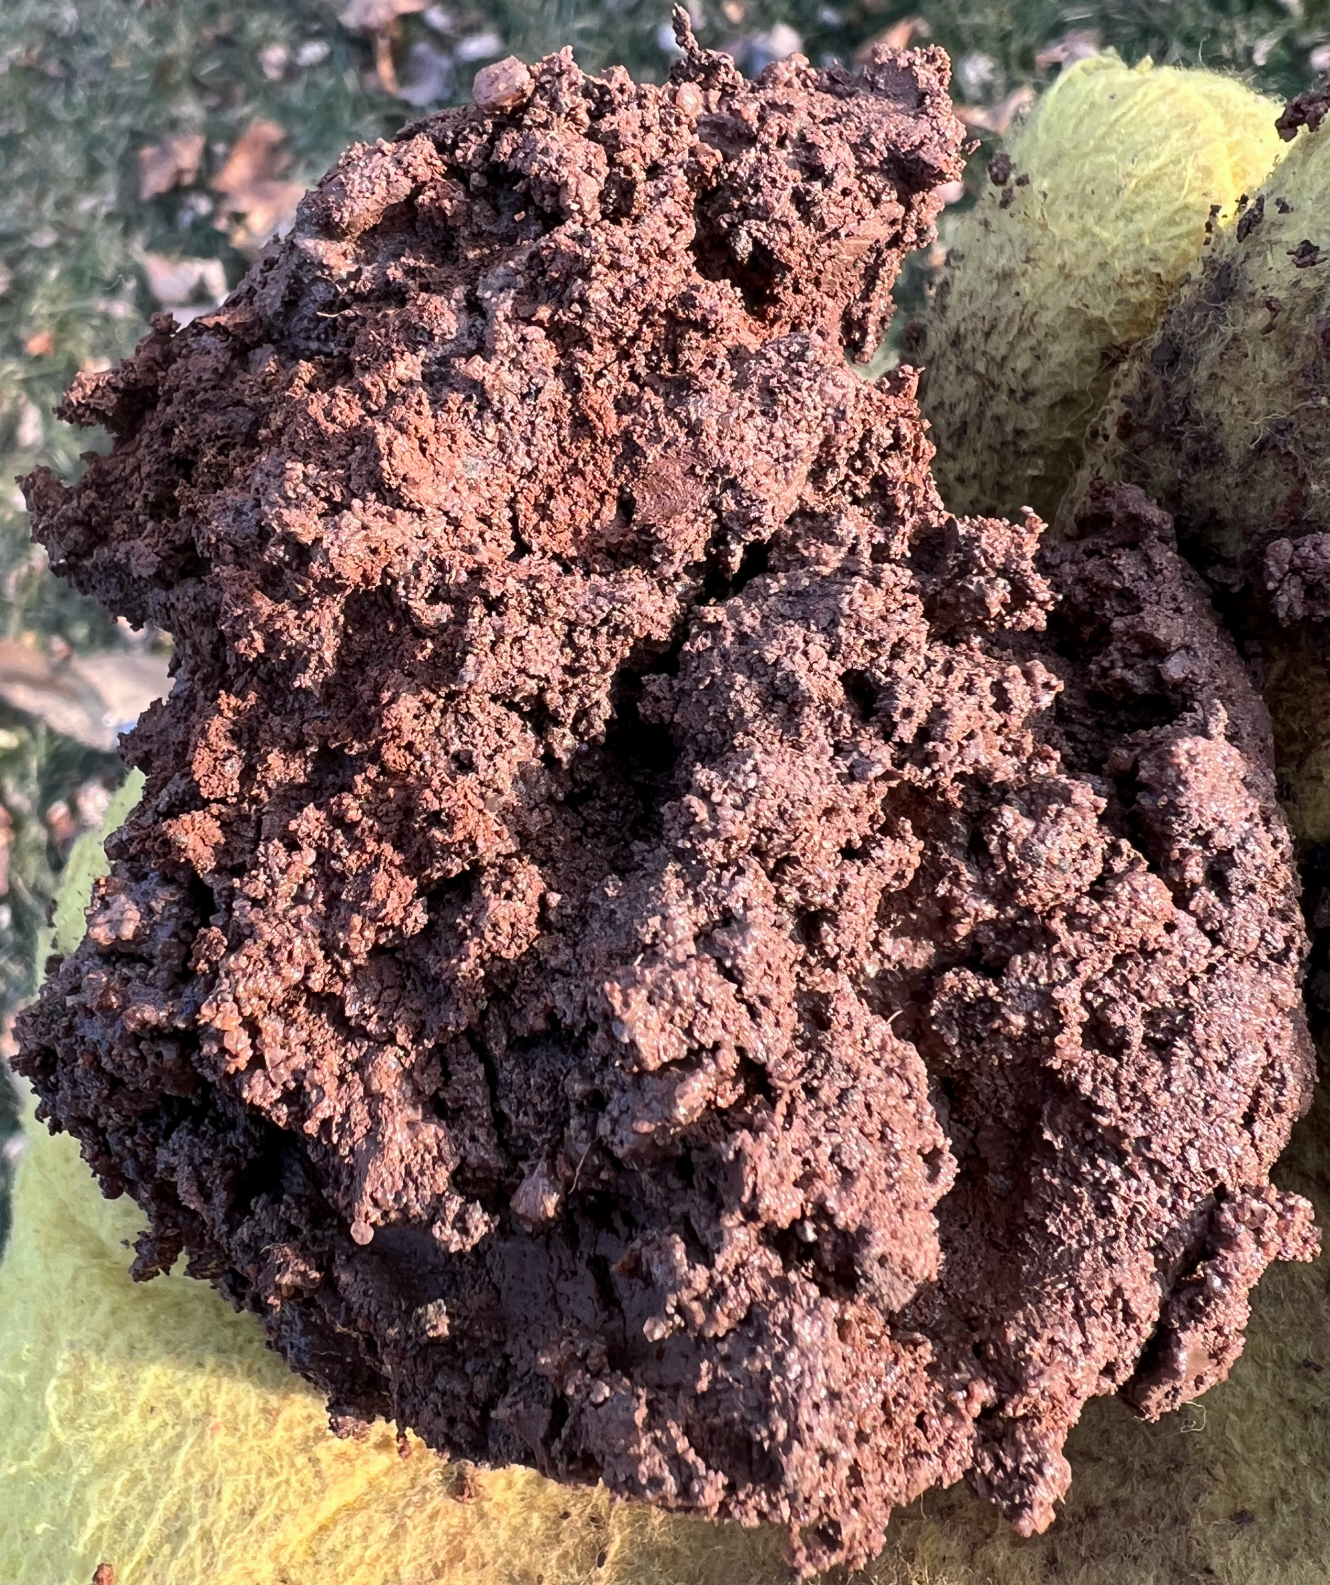
Soil Observations Log

My inspection indicates that this system is presently “non-compliant” in accordance with MPCA rules 7080.1500 Subp.4(B)(D) because of the lack of the required three foot separation between the bottom of the drainfield and seasonally saturated soils.

Location of Project:		13889 Isleton Ave N, Hugo, MN 55038			
Observations Made By:		Midwest Sewer Services		Date:	1/2/2025
Classification System:		USDA			
Soil Observation:		ST-1		Soil Observation:	St-2
Surface Elevation of Observation		1027.20'		Surface Elevation of Observation	1028.40'
		Benchmark Elevation Top of Well is 1029.00'			
Depth In Inches	Rock %	<u>Soils Encountered</u>		Depth In Inches	Rock %
0-12 12-21		10YR 3/3 Silt Loam 10YR 4/4 Silt Loam With 7.5YR 5/8 & 10YR 6/2 Redox		0-3 3-16 16-24	≈ 15

7.5YR 2.5/2 Loam 7.5YR 2.5/3 Fine Sandy Loam With Gravel 7.5YR 4/4 Clay Loam With 5YR 4/6 Redox	
1025.45'	Elevation To Bottom Of Distribution Media		1026.32'	Elevation To Bottom Of Distribution Media	
-1026.20'	Depth To Redox Or End Of Observation		-1027.07'	Depth To Redox Or End Of Observation	
=0'/0"	Of Separation		=0'/0"	Of Separation	
End Of Soil Observation At:		1025.45'/21"	End Of Soil Observation At:		1026.40'/24"
Limiting Soil Conditions At:		1026.20'/12"	Limiting Soil Conditions At:		1027.07'/16"
Standing Water Present At:		None	Standing Water Present At:		None
If no rock content was indicated, rock was less than or equal to five percent. Elevations are based on vertical datum NAVD88 EPSG:6360 Bottom Of Distribution Medium At: 21" Inches Or Elevation 1025.45' At Soil Probe 1. 25" Inches Or Elevation 1026.32' At Soil Probe 2.
