SUBSURFACE SEWAGE TREATMENT SYSTEM (SSTS) COMPLIANCE REPORT

Date: June 10, 2017

Inspection Address: 23269 Lofton Ct N, Scandia, MN 55073

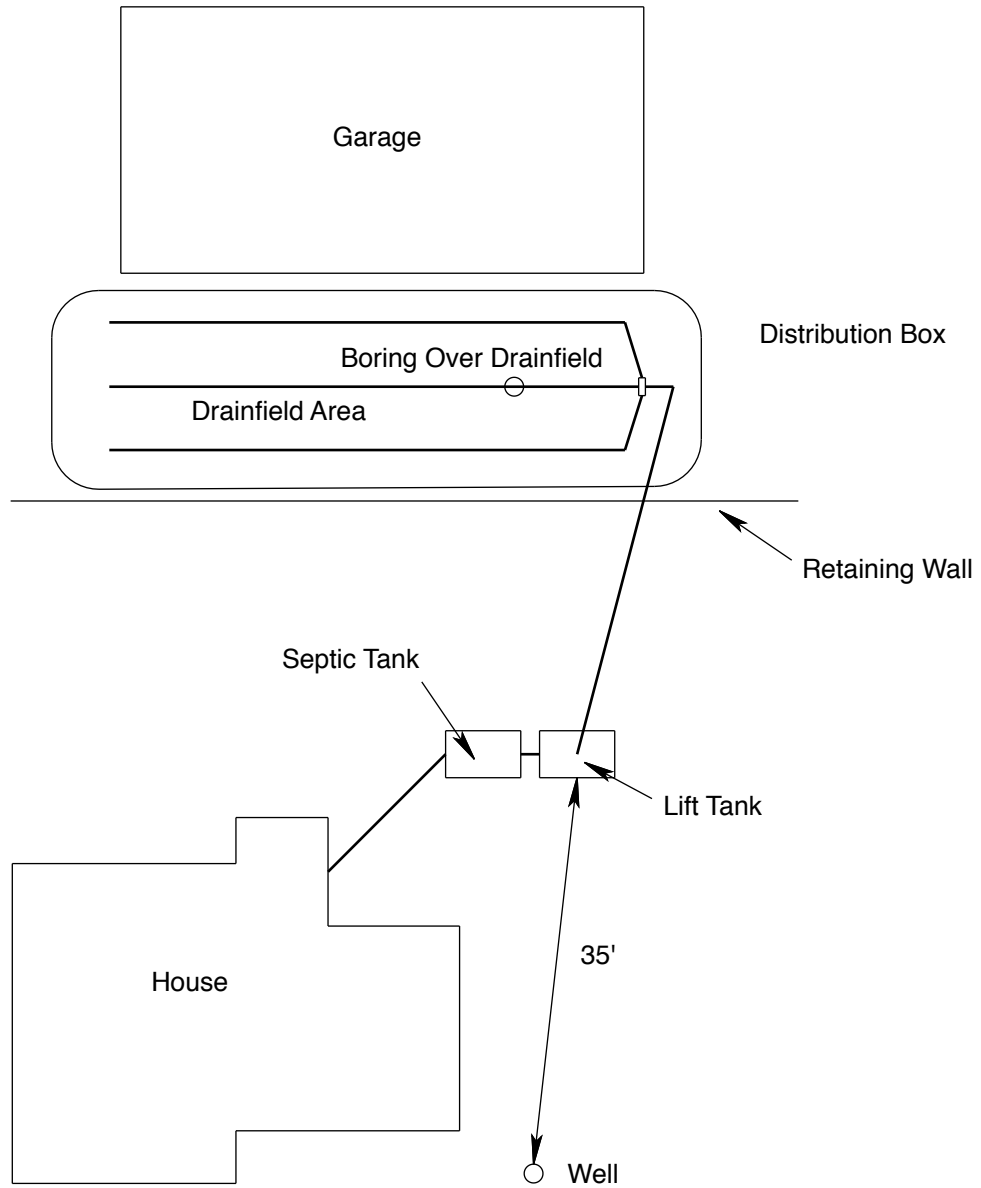
23269 Lofton Ct N, Scandia, MN 55073

Although not compliance criteria, it should be noted the septic tank and lift tank do not meet the 50 foot set-back to the deep well

Brief system description: A pre-cast septic tank, a pre-cast lift tank, and a rock trench drainfield installed in sandy fill similar to mound (gravity mound)..
