## **Compliance Inspection Form**

## **Existing Subsurface Sewage Treatment Systems (SSTS)**

Property Information Parcel ID# or Sec/Twp/R	ange: 2303021130016
	ange: 2303021130016
Property address: 8570 Kimbro Lane N. Grant, MN 55082 Reason	on for inspection: Failing System
Property address: 8570 Kimbro Lane N. Grant, MN 55082 Reason Property owner: Michael and Ann Felipe Owner	
Property address: 8570 Kimbro Lane N. Grant, MN 55082 Reason Michael and Ann Felipe Owner  Or  Owner's representative: Representative:	on for inspection: Failing System r's phone: sentative phone:
Property address: 8570 Kimbro Lane N. Grant, MN 55082 Reason Property owner: Michael and Ann Felipe Owner Or  Owner's representative: Representative:	n for inspection: Failing System c's phone:
Property address: 8570 Kimbro Lane N. Grant, MN 55082 Reason Property owner: Michael and Ann Felipe Owner  Owner's representative: Representative:	on for inspection: Failing System r's phone: sentative phone:
Property address: 8570 Kimbro Lane N. Grant, MN 55082  Property owner: Michael and Ann Felipe  Owner  Owner's representative: Repre Local regulatory authority: Washington County  Brief system description: System consi

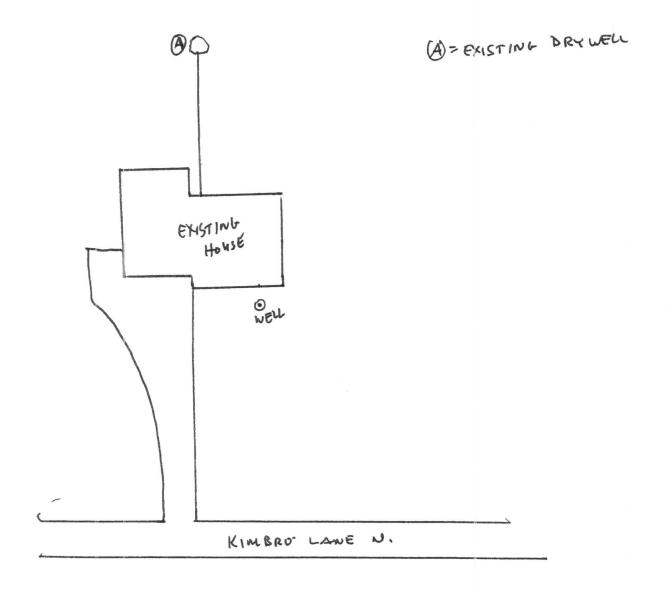
NT 1"=40"

Property address: 8570 Kimbro Lane N. Grant, MN 55082  Property owner: Michael and Ann Felipe  Owner  Owner's representative: Representative: Washington County  Brief system description: System consists of dry wells  Comments or recommendations:  There is no evidence of a drainfield.  Certification  I hereby certify that all the necessary information has been gathered to determine the determination of future system performance has been nor can be made due to unknown possible abuse of the system, inadequate maintenance, or future water usage.	r's phone:  sentative phone: atory authority phone: 651-430-6655
Property address: 8570 Kimbro Lane N. Grant, MN 55082  Property owner: Michael and Ann Felipe  Owner  Owner's representative:  Local regulatory authority: Washington County  Brief system description: System consists of dry wells  Comments or recommendations:  There is no evidence of a drainfield.  Certification  I hereby certify that all the necessary information has been gathered to determine the determination of future system performance has been nor can be made due to unknown possible abuse of the system, inadequate maintenance, or future water usage.  Inspector name: Dave Brown  Certification  C	r's phone:  sentative phone:  atory authority phone:  651-430-6655  the compliance status of this system. No nown conditions during system construction,
