**Instructions: Inspector must submit completed form to Local Governmental Unit (LGU) and system owner within 15 days of final determination of compliance or noncompliance.** Instructions for filling out this form are located on the Minnesota Pollution Control Agency (MPCA) website at <https://www.pca.state.mn.us/sites/default/files/wq-wwists4-31a.pdf>.

Property address: 12657 40<sup>th</sup> St N Baytown Township, MN 55082

Brief system description: One 1200 gallon septic tank and a rock trench drainfield.

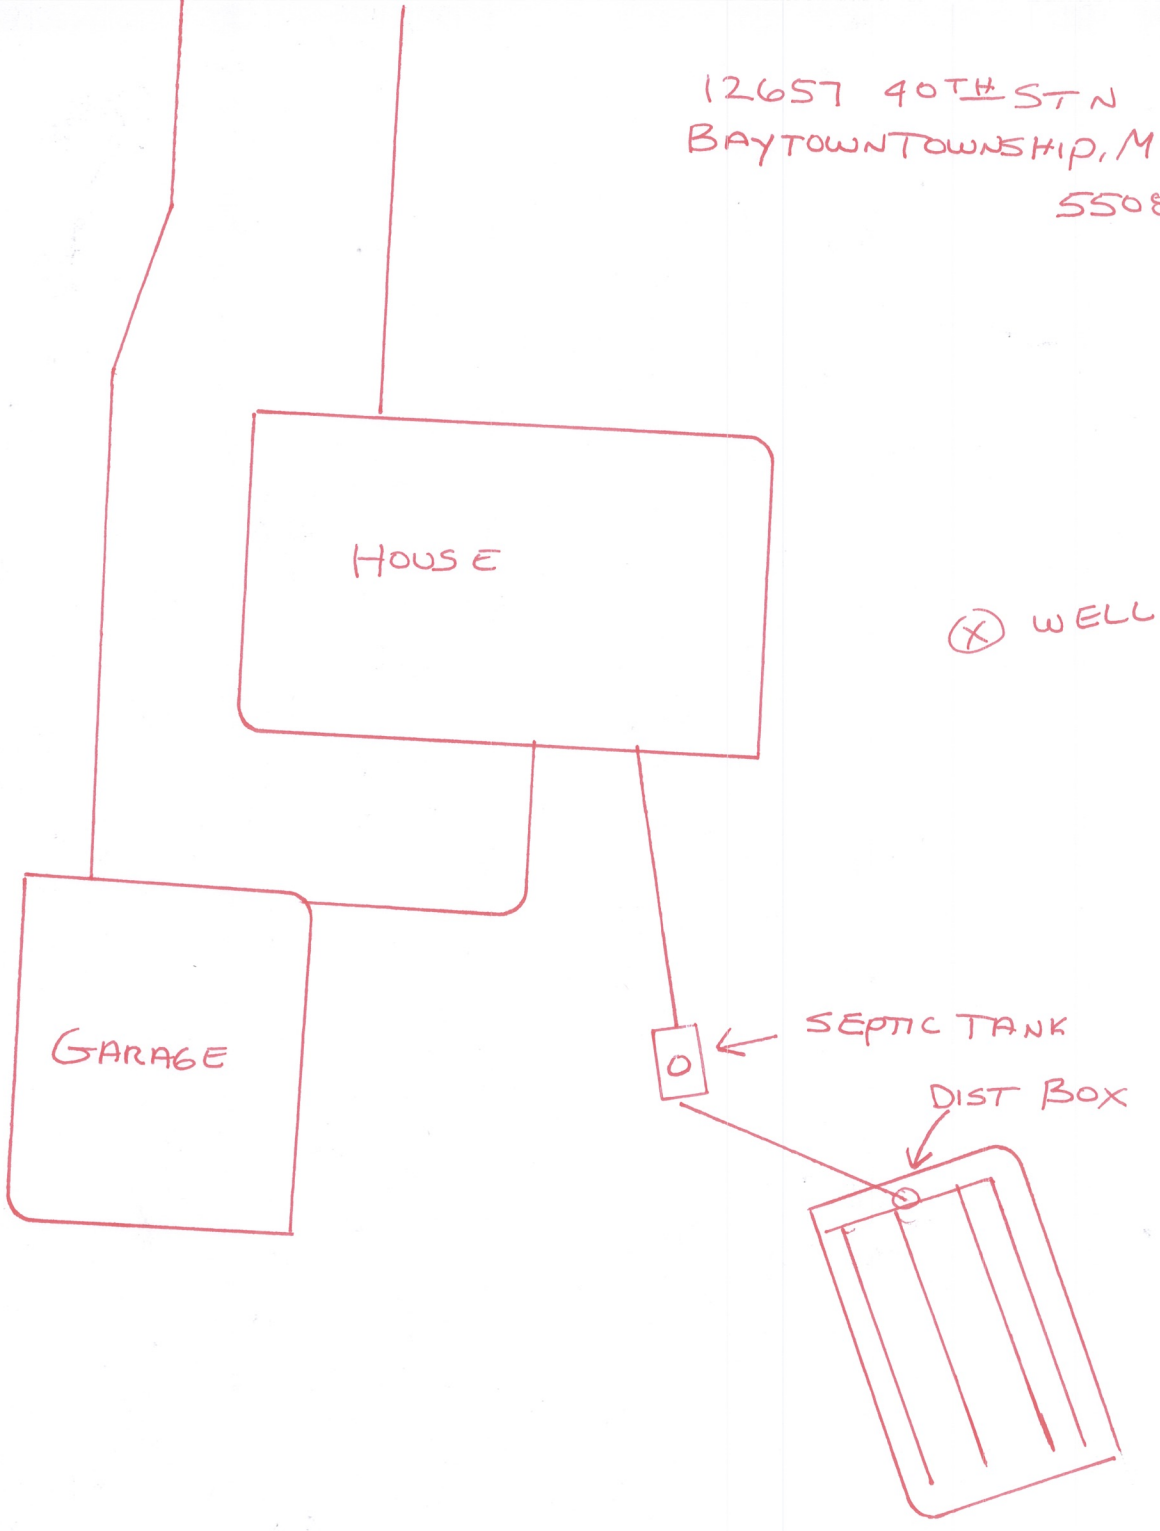
12657 40TH ST N  
BAYTOWN TOWNSHIP, MN  
55082

The drainfield is located in a low area and is unable to accept effluent due to saturation. A soil boring was completed outside of the failing drainfield area.

⊗  
B-1  
5-6-22
