Compliance Inspection Form
Existing Subsurface Sewage Treatment Systems (SSTS)

Property address: 22739 Olgilvie Ave N Scandia, MN 55073 Reason for inspection: Sale

Brief system description: 1500 gallon septic tank, 1000 gallon septic tank, 1000 gallon lift station, mound dispersal system

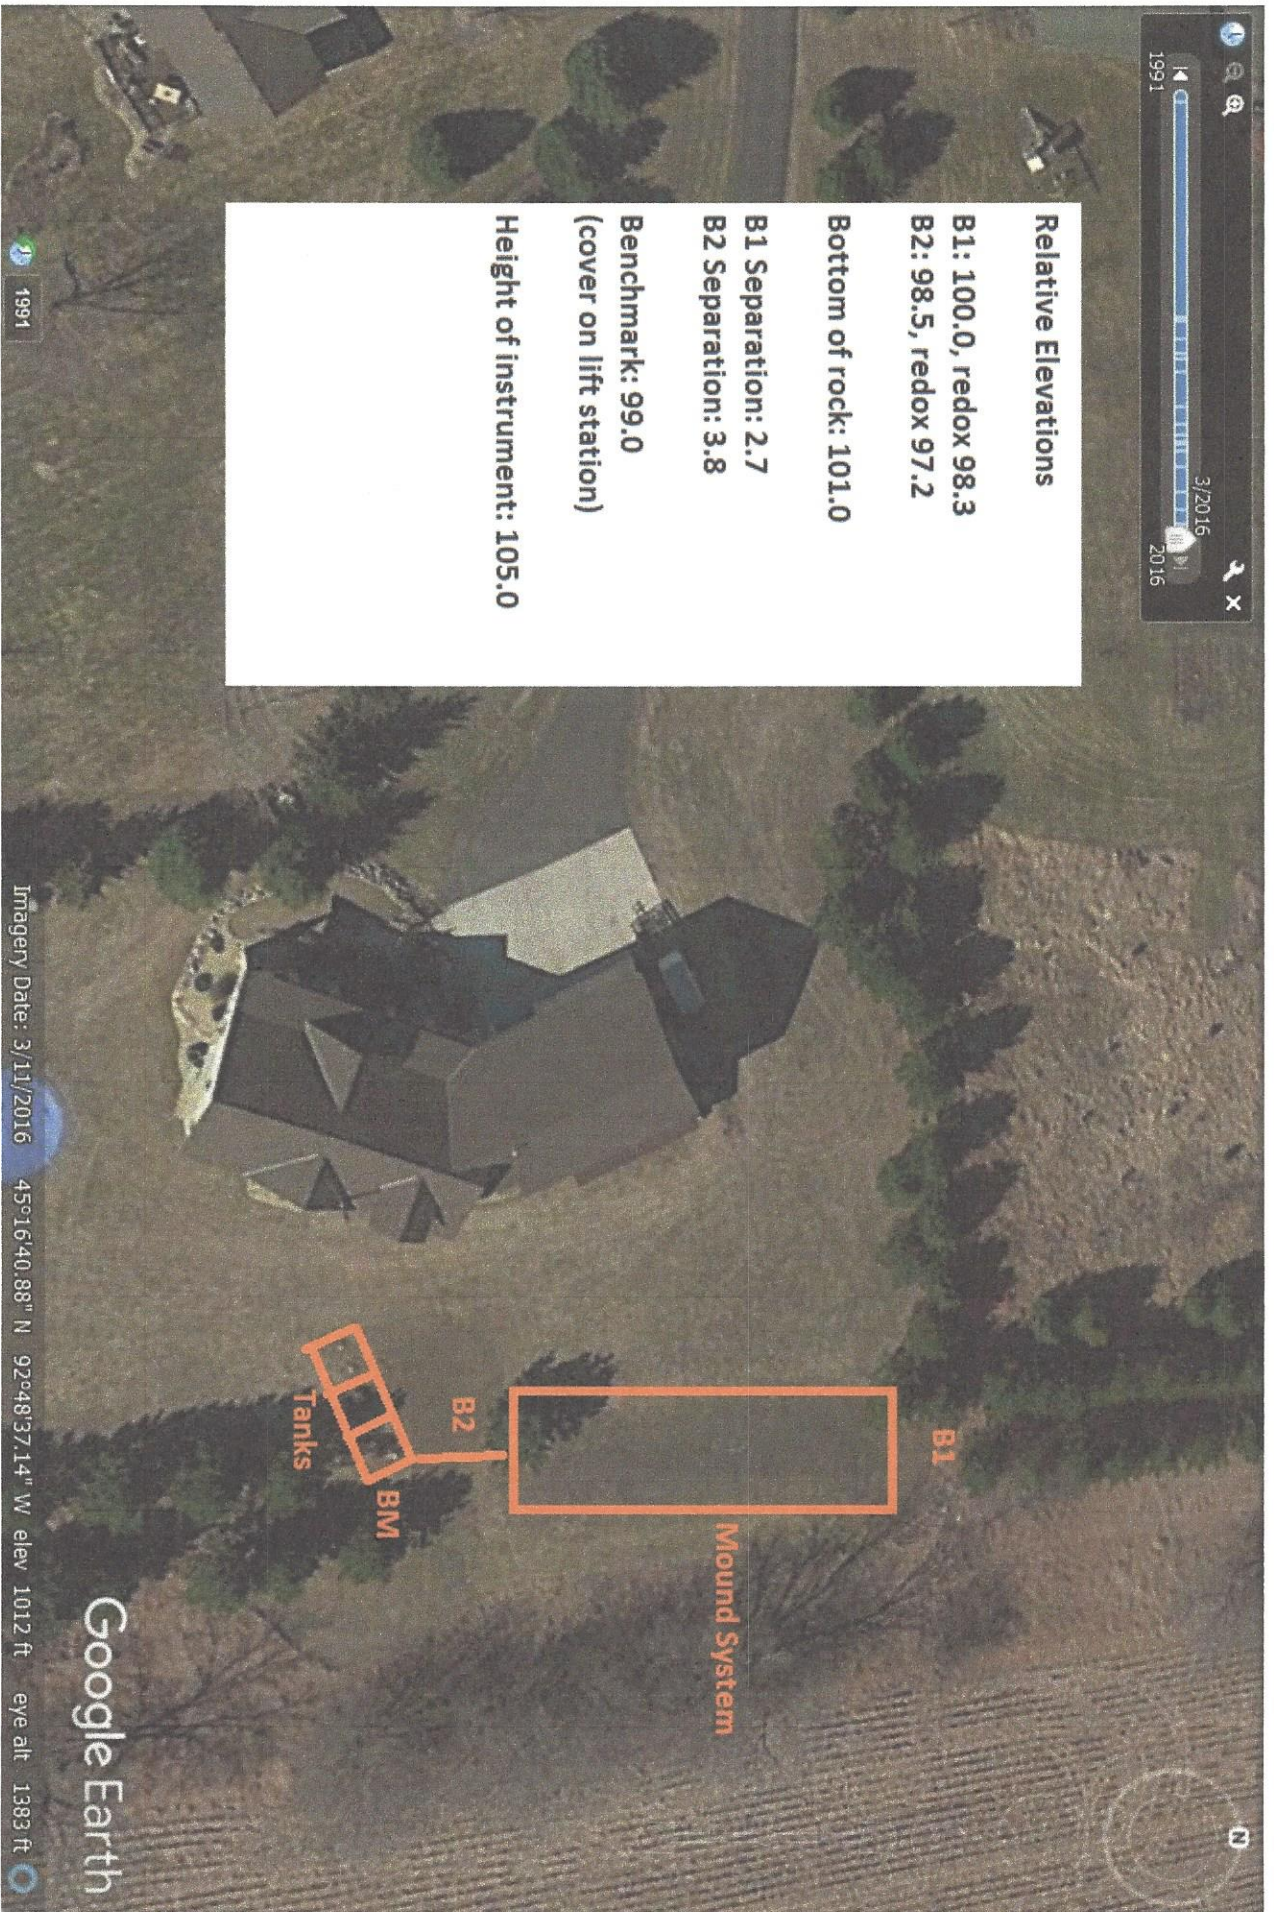
Relative Elevations

- B1: 100.0, redox 98.3
- B2: 98.5, redox 97.2
- Bottom of rock: 101.0
- B1 Separation: 2.7
- B2 Separation: 3.8
- Benchmark: 99.0
(cover on lift station)
- Height of instrument: 105.0
