SUBSURFACE SEWAGE TREATMENT SYSTEM (SSTS) COMPLIANCE REPORT

Date: April 11, 2016 **Time:** 8:45 PM **Owner:** Rob & Diana Orantes

Inspection Address: 9955 Perkins Ave N, Stillwater Twp, MN 55082

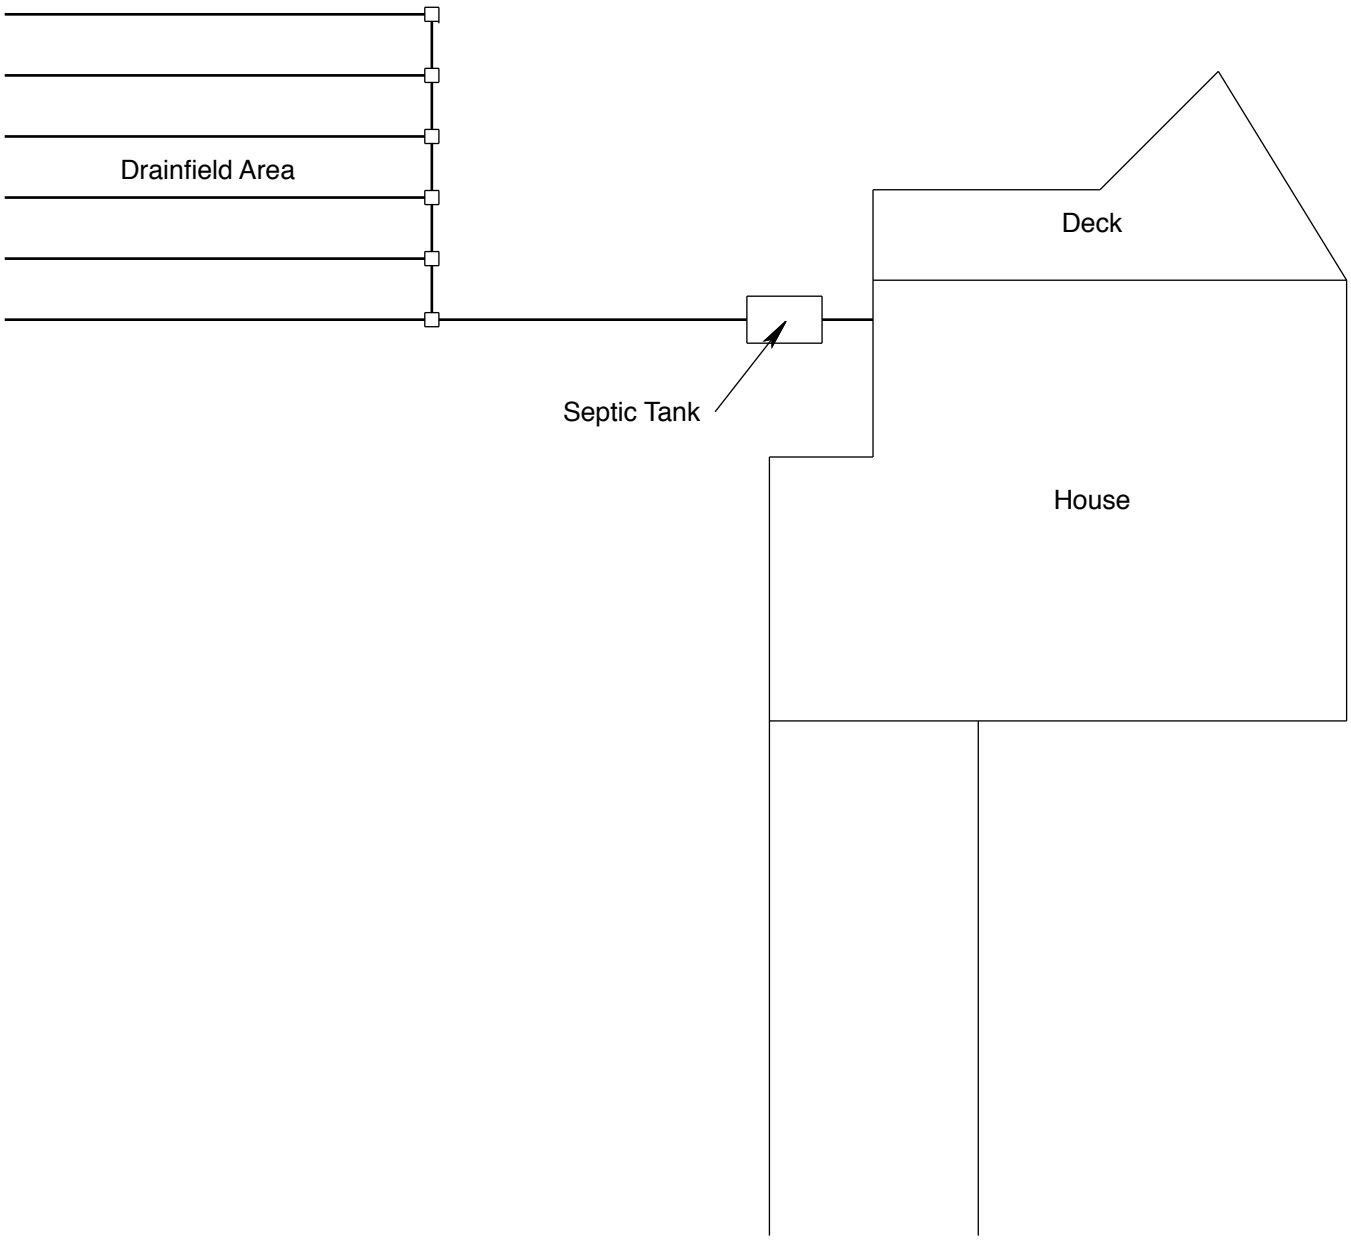
9955 Perkins Ave N, Stillwater Twp, MN 55082

I have performed an "MPCA Compliance Inspection" on this system and have reviewed the original design/permit records on file at Washington County. This older system (installed in 1988) consists of a pre-cast septic tank and a rock trench drainfield.
