Inspect Minnesota & Midwest Soil Testing

SUBSURFACE SEWAGE TREATMENT SYSTEM (SSTS) COMPLIANCE REPORT

Date: May 3, 2018 **Time:** 12:30 PM **Owner:** Mason Sorenson

Inspection Address: 8335 Dale Rd, Woodbury, MN 55129

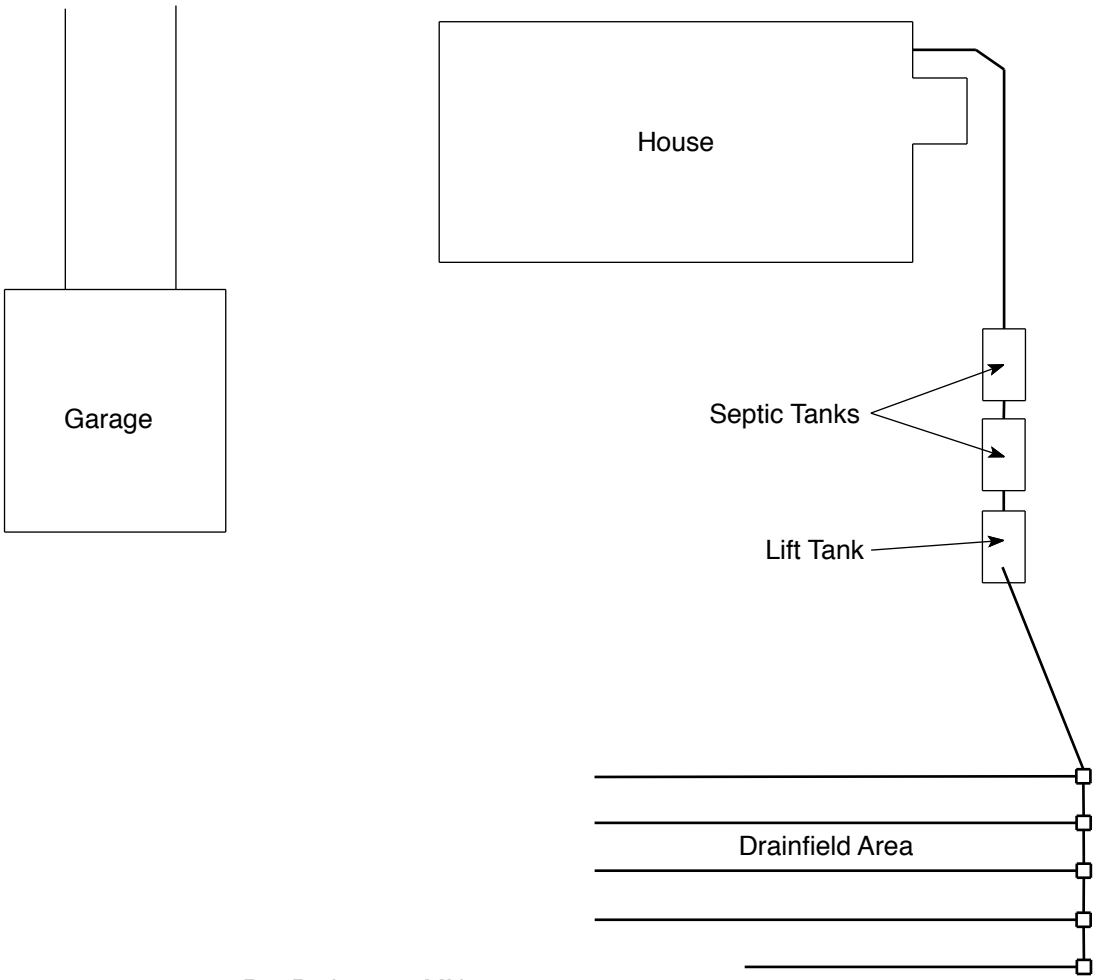
B-1 By Inspect MN ○

8335 Dale Rd, Woodbury, MN 55129
