Inspect Minnesota & Midwest Soil Testing

SUBSURFACE SEWAGE TREATMENT SYSTEM (SSTS) COMPLIANCE REPORT

Inspection Address: 16120 Harrow Ave N, Hugo, MN 55038

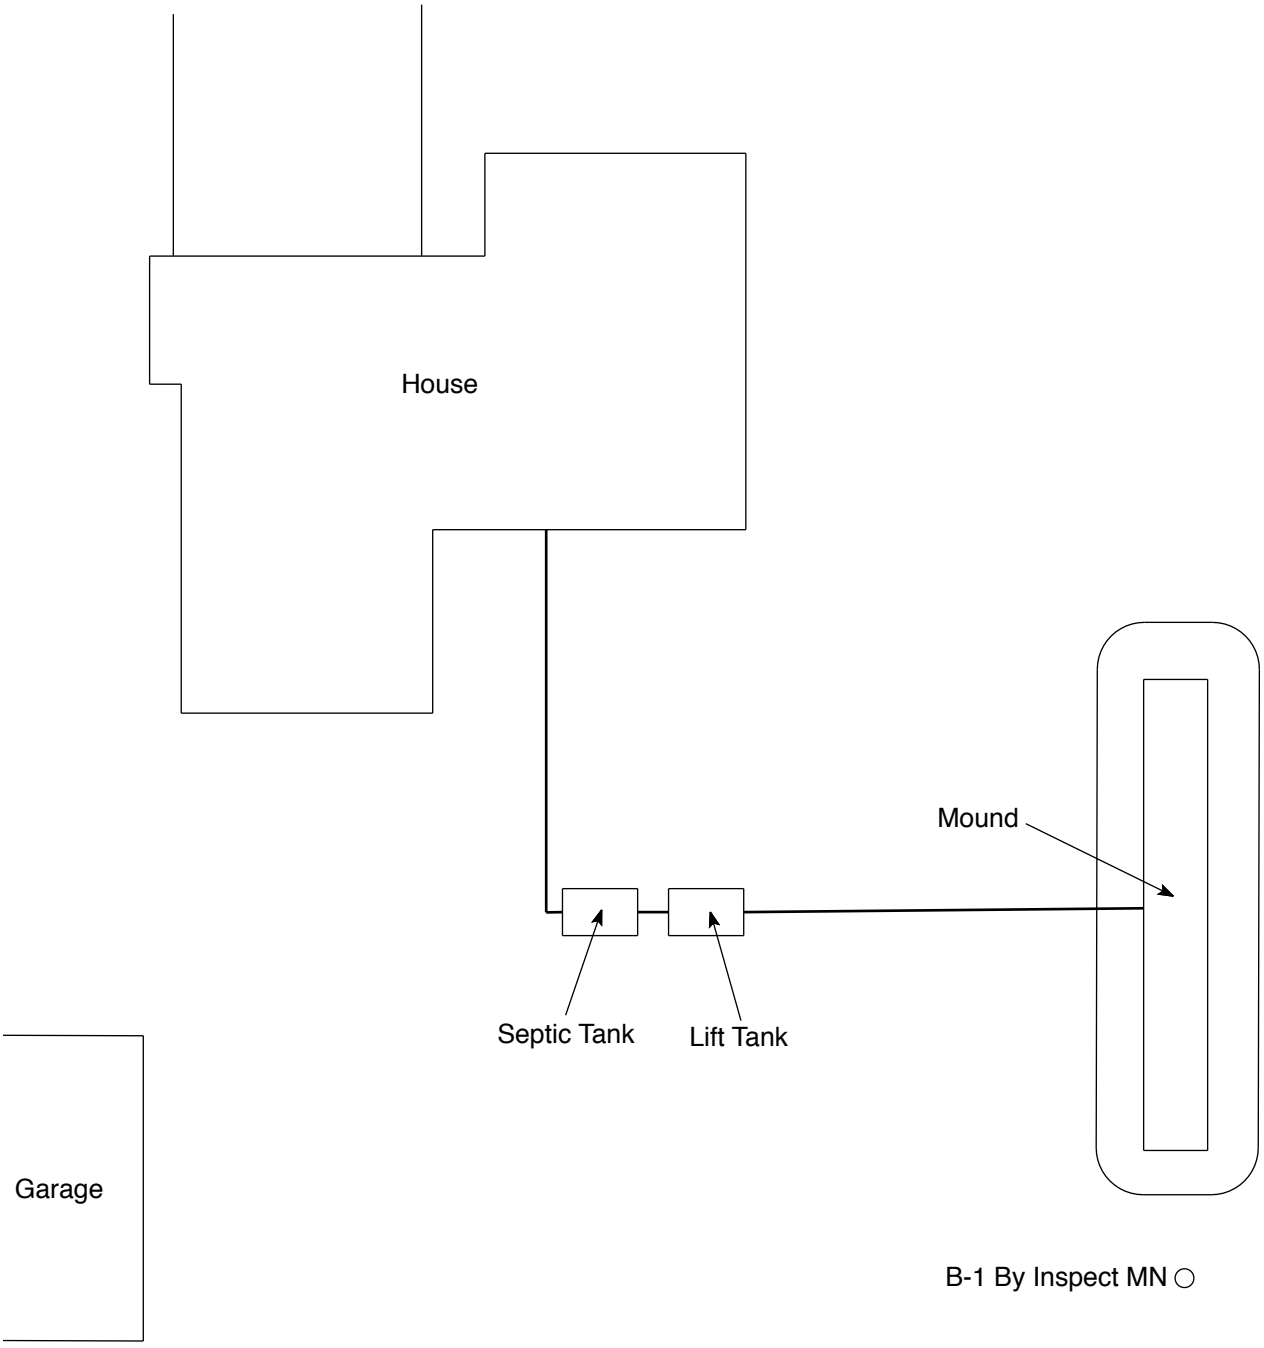
16120 Harrow Ave N, Hugo, MN 55038

B-1 By Inspect MN ○
