SUBSURFACE SEWAGE TREATMENT SYSTEM (SSTS) COMPLIANCE REPORT

Inspection Address: 13937 Tomahawk Dr S, Afton, MN 55001

Compliance Inspection Form

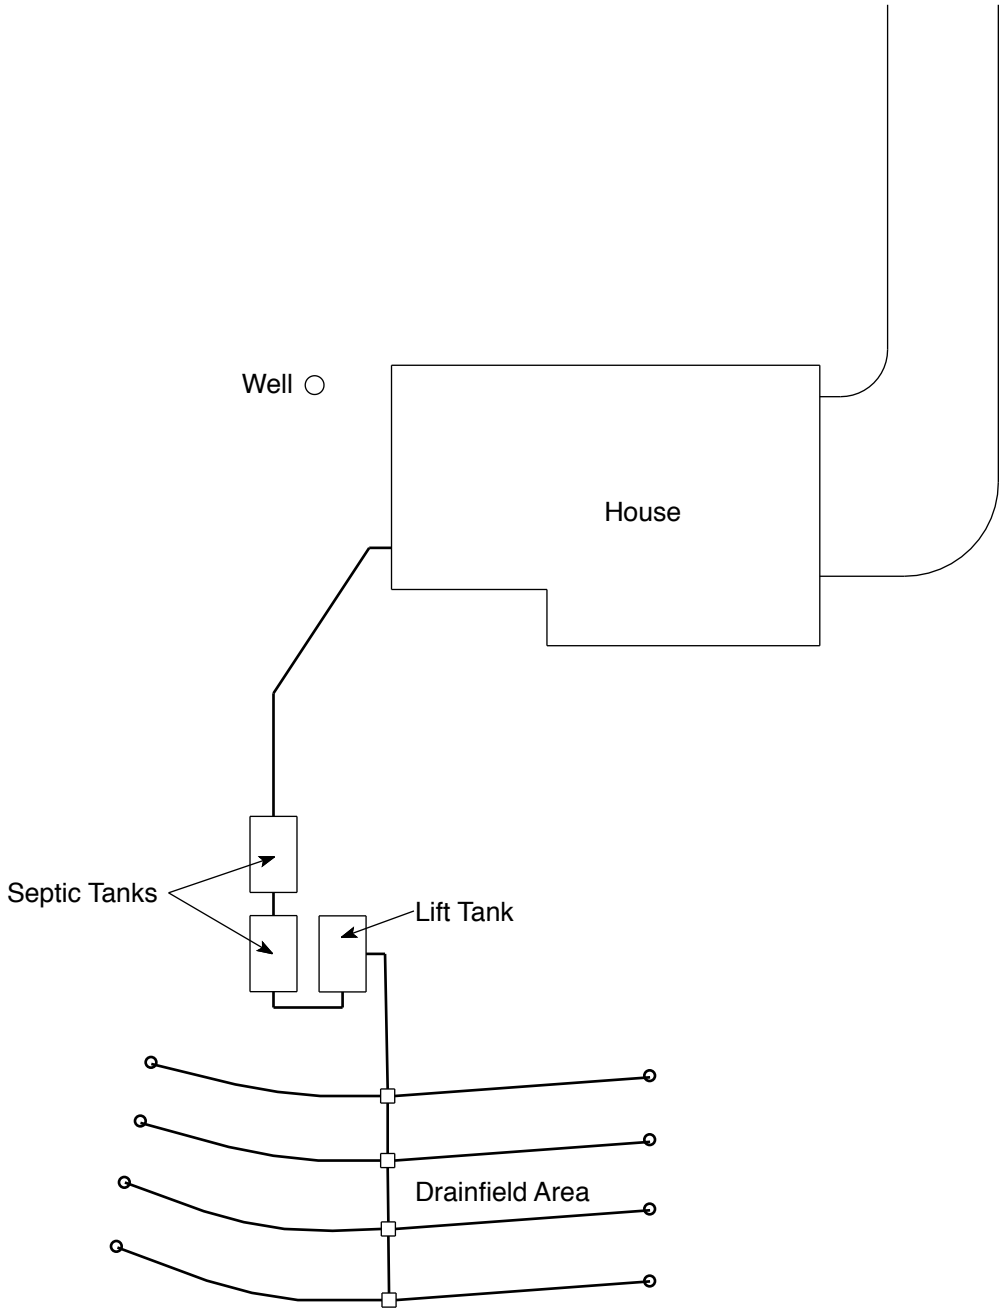
13937 Tomahawk Dr S, Afton, MN 55001

I have performed an "MPCA Compliance Inspection" on this system and have reviewed the original design/permit records on file at Washington County. This system consists of two pre-cast septic tanks, a pre-cast lift tank, and a rock trench drainfield.
