SUBSURFACE SEWAGE TREATMENT SYSTEM (SSTS) COMPLIANCE REPORT

Date: November 25, 2019 **Time:** 9:45 AM **Owner:** Kim Chapman

Inspection Address: 10475 110th St N, Grant, MN 55082

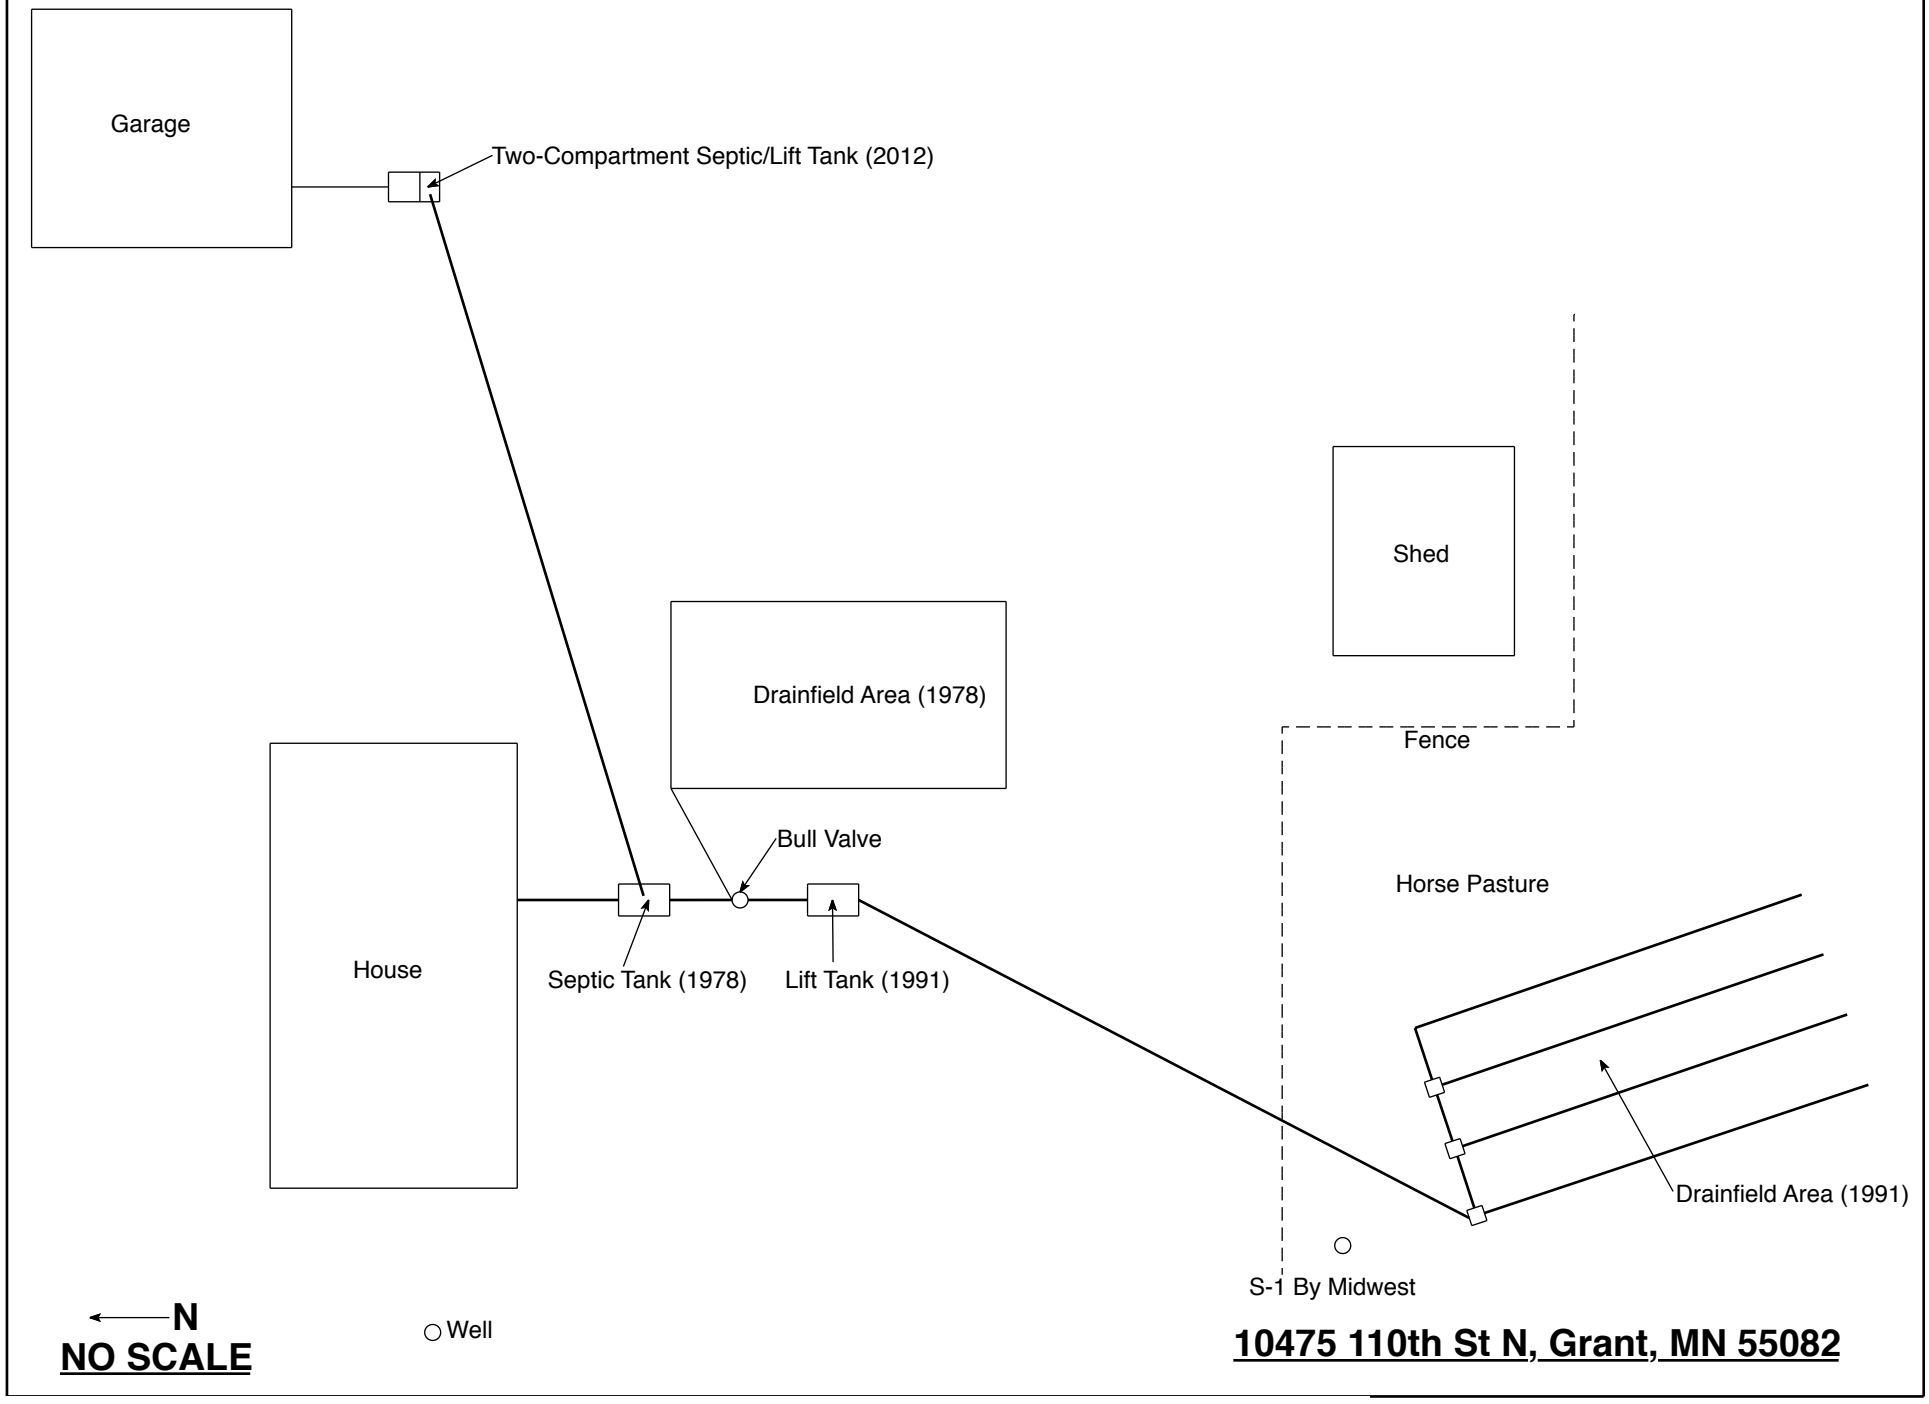
A compliance was not performed on the original 1978 system, but the bull valve should be permanently removed to prevent flow of effluent to this system. In addition, the drainfield is located within a horse pasture. The drainfield should be fenced off to prevent damage and/or freezing during winter months. The inlet baffle is starting to deteriorate in the septic tank.

Garage
Two-Compartment Septic/Lift Tank (2012)
Shed
Drainfield Area (1978)
Fence
Bull Valve
Horse Pasture
House
Septic Tank (1978)
Lift Tank (1991)
Drainfield Area (1991)
S-1 By Midwest
N
NO SCALE
Well
10475 110th St N, Grant, MN 55082
