Midwest Sewer Services

SUBSURFACE SEWAGE TREATMENT SYSTEM (SSTS) COMPLIANCE REPORT

Inspection Address: 1835 Ramada Ave S, Lake St Croix Beach, MN 55043

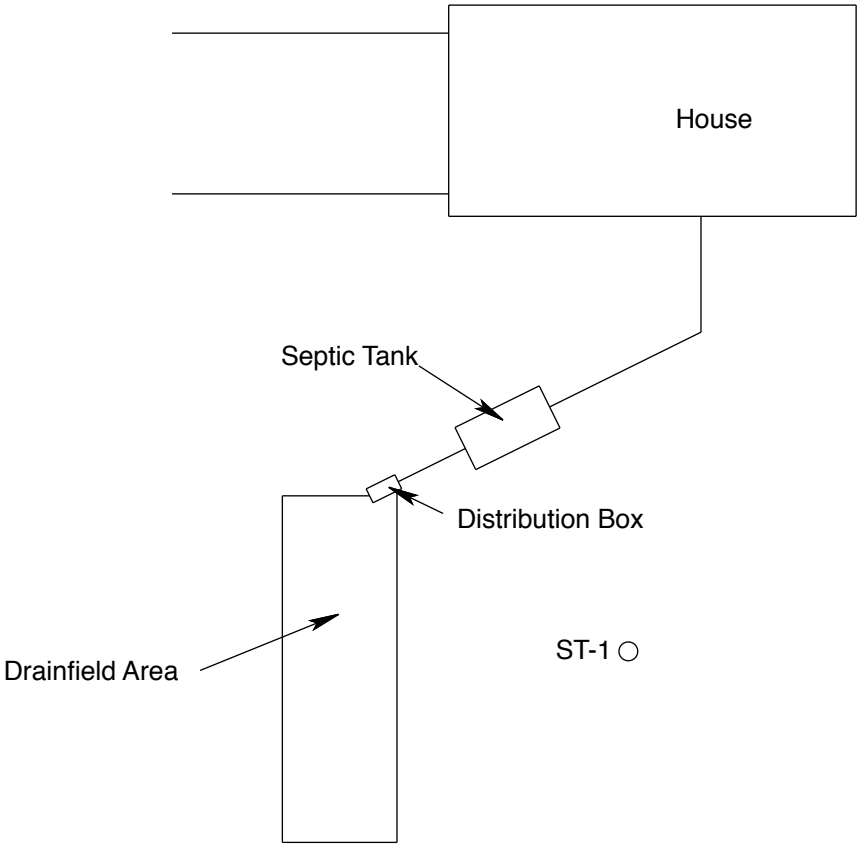
NO SCALE

1835 Ramada Ave S, Lake St Croix Beach, MN 55043
