Midwest Sewer Services

SUBSURFACE SEWAGE TREATMENT SYSTEM (SSTS) COMPLIANCE REPORT

Date: June 18, 2020 **Time:** 12:15 PM **Owner:** Tom Berry

Inspection Address: 6261 Hilton Ct N, Pine Springs, MN 55115

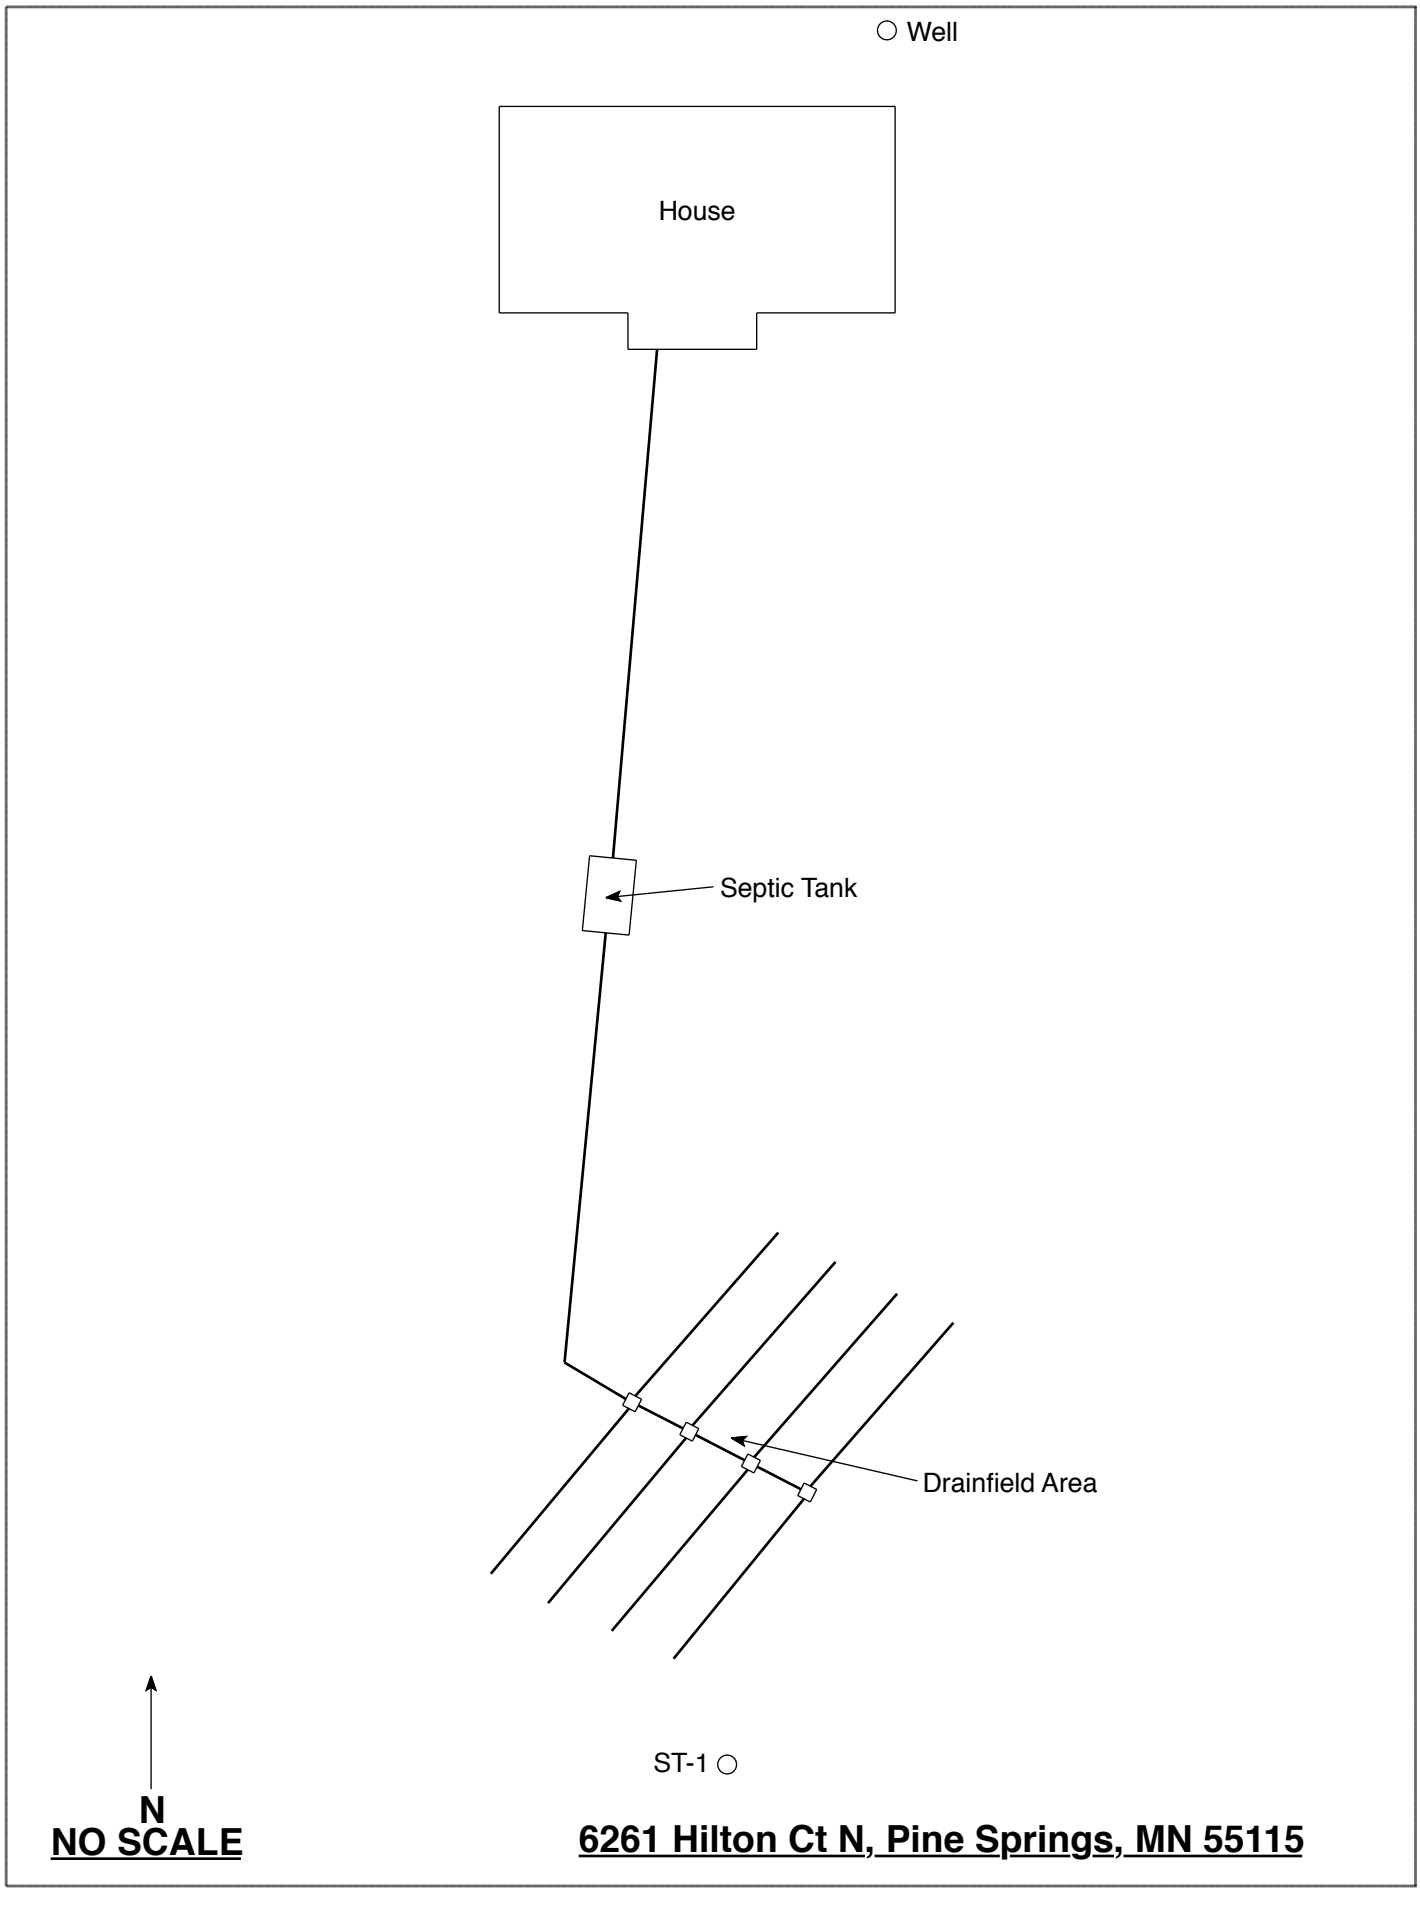
○ Well
House
Septic Tank
Drainfield Area
ST-1 ○
N
NO SCALE
6261 Hilton Ct N, Pine Springs, MN 55115
