Compliance Inspection Form

Existing Subsurface Sewage Treatment Systems (SSTS)

Property address: 14710 118th St N Stillwater, MN 55082
Reason for inspection: property sale

Brief system description: Two 1000 gallon septic tanks and 765 sf of gravity rock trench drainfield.

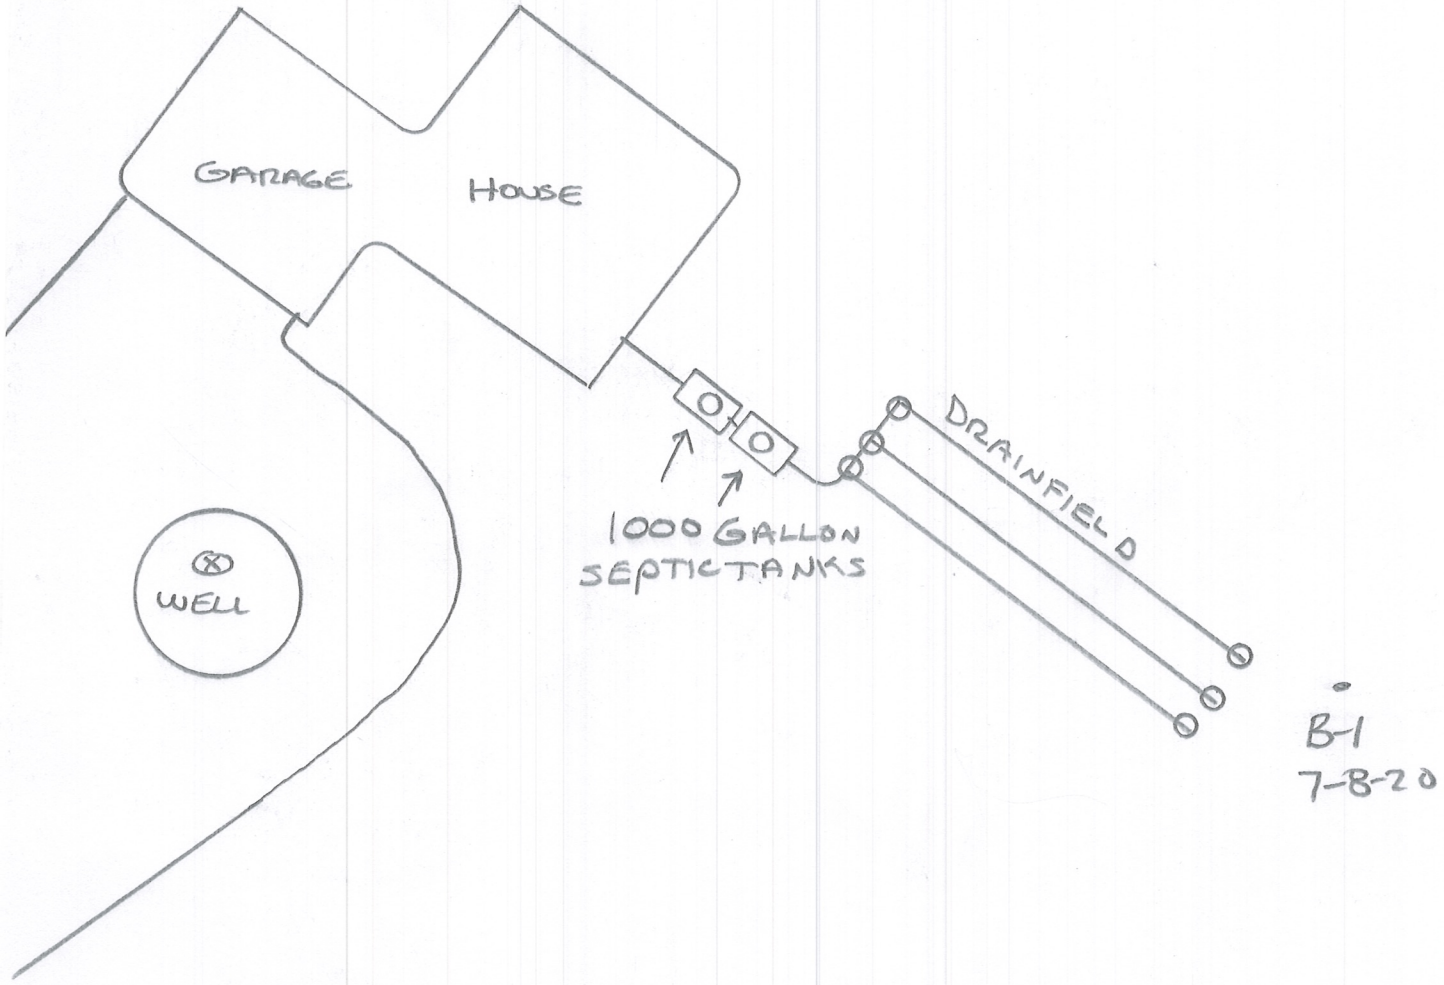
14710 118TH ST N
STILLWATER, MN
55082

B-1
7-8-20
