Midwest Sewer Services

SUBSURFACE SEWAGE TREATMENT SYSTEM (SSTS) COMPLIANCE REPORT

Date: September 24, 2020 **Time:** 1:15 PM **Owner:** Estate of Violet French
Inspection Address: 13155 177th St N, May Twp, MN 55047

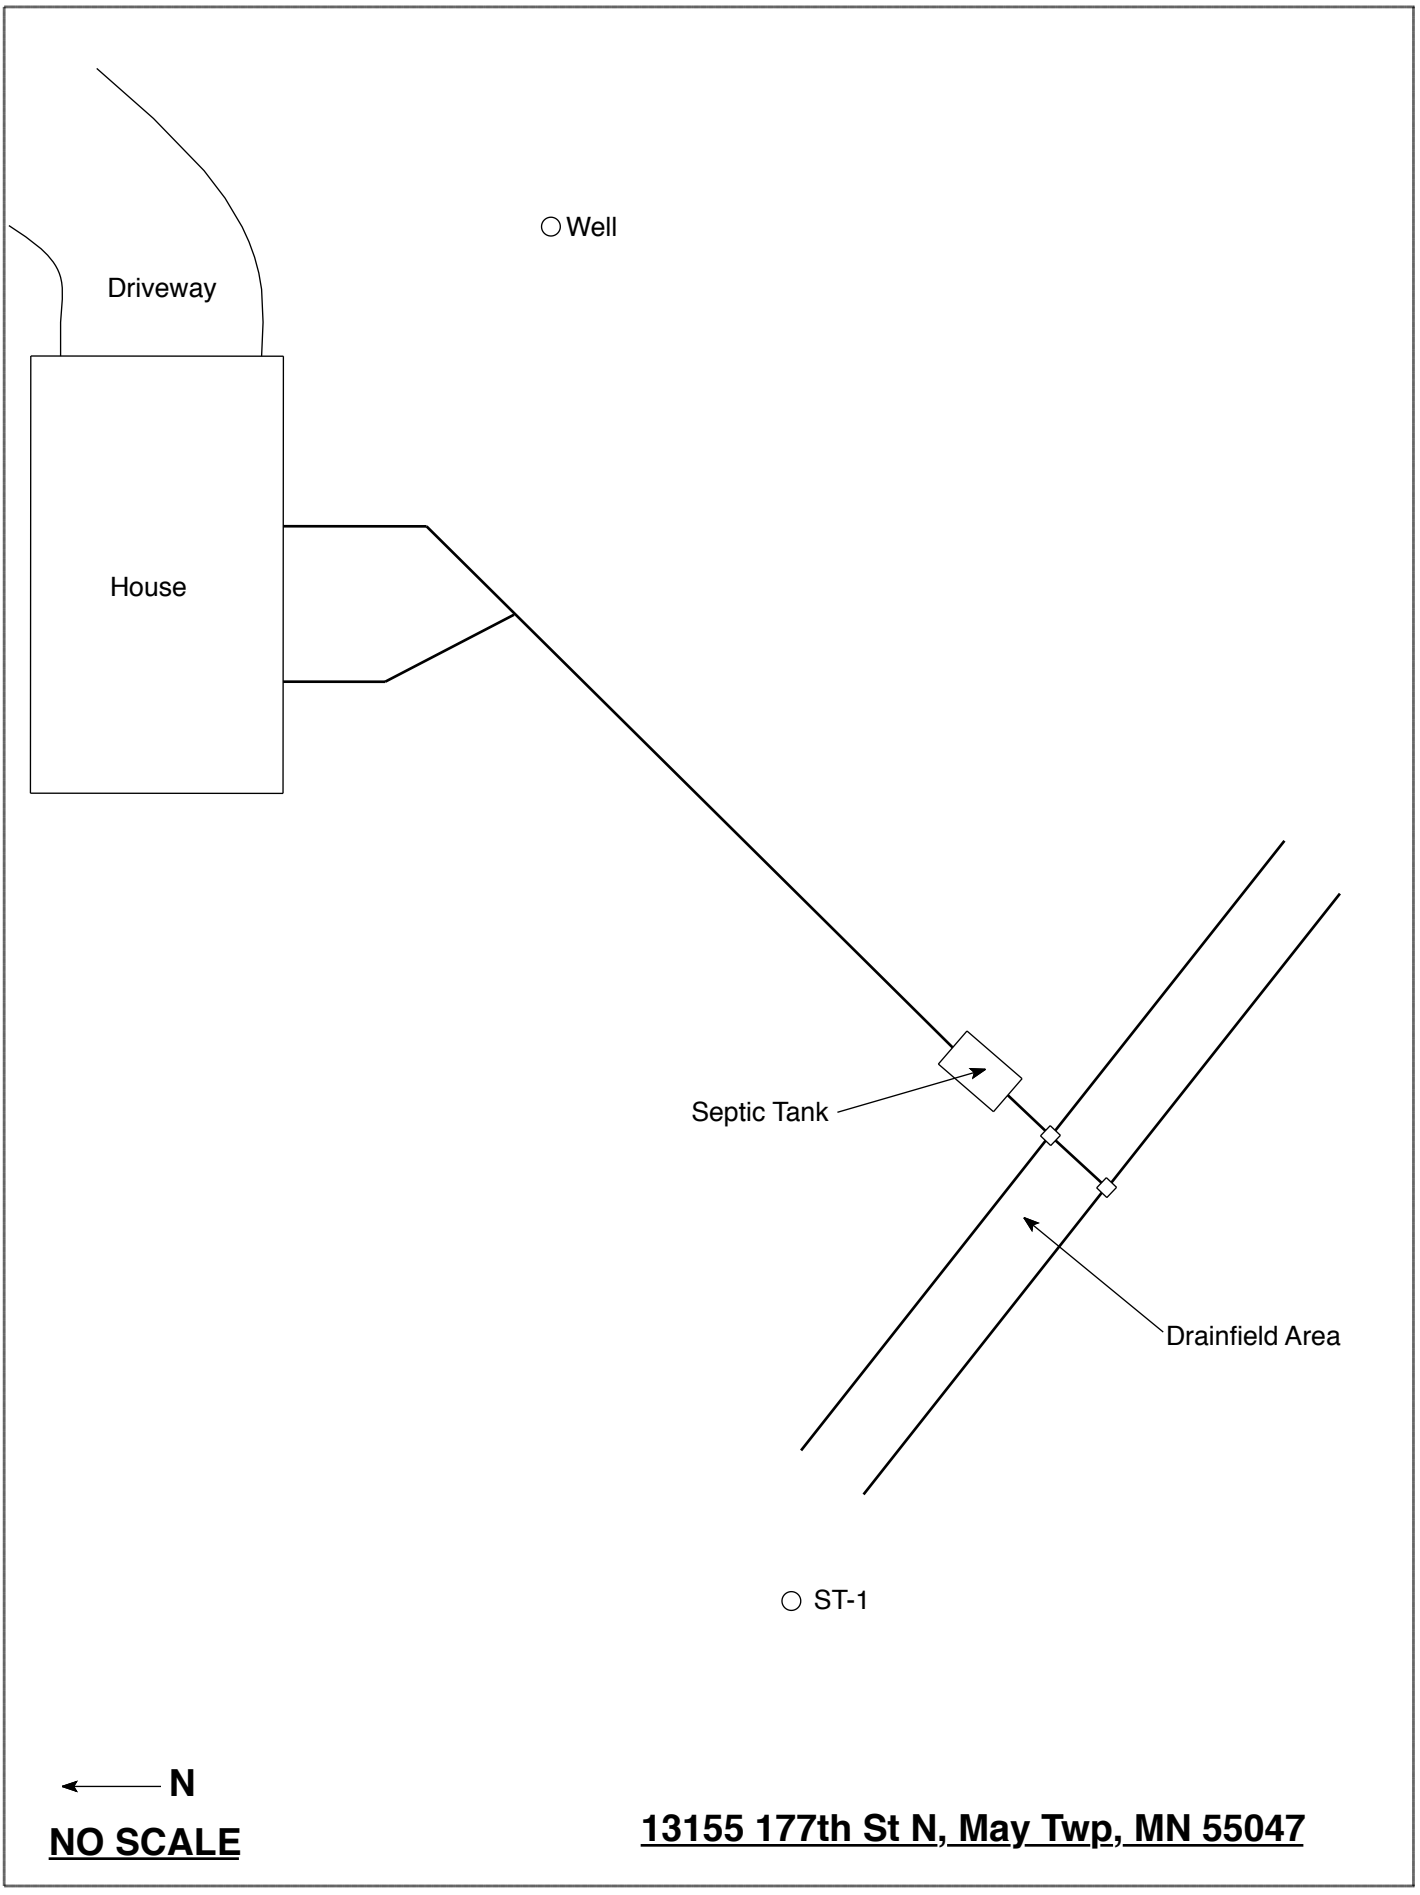
Well
Driveway
House
Septic Tank
Drainfield Area
ST-1
N
NO SCALE
13155 177th St N, May Twp, MN 55047
