Midwest Sewer Services

SUBSURFACE SEWAGE TREATMENT SYSTEM (SSTS) COMPLIANCE REPORT

Date: September 30, 2020 **Time:** 3:00 PM **Owner:** Dustin Grzesik
Inspection Address: 7780 66th St N, Pine Springs, MN 55115

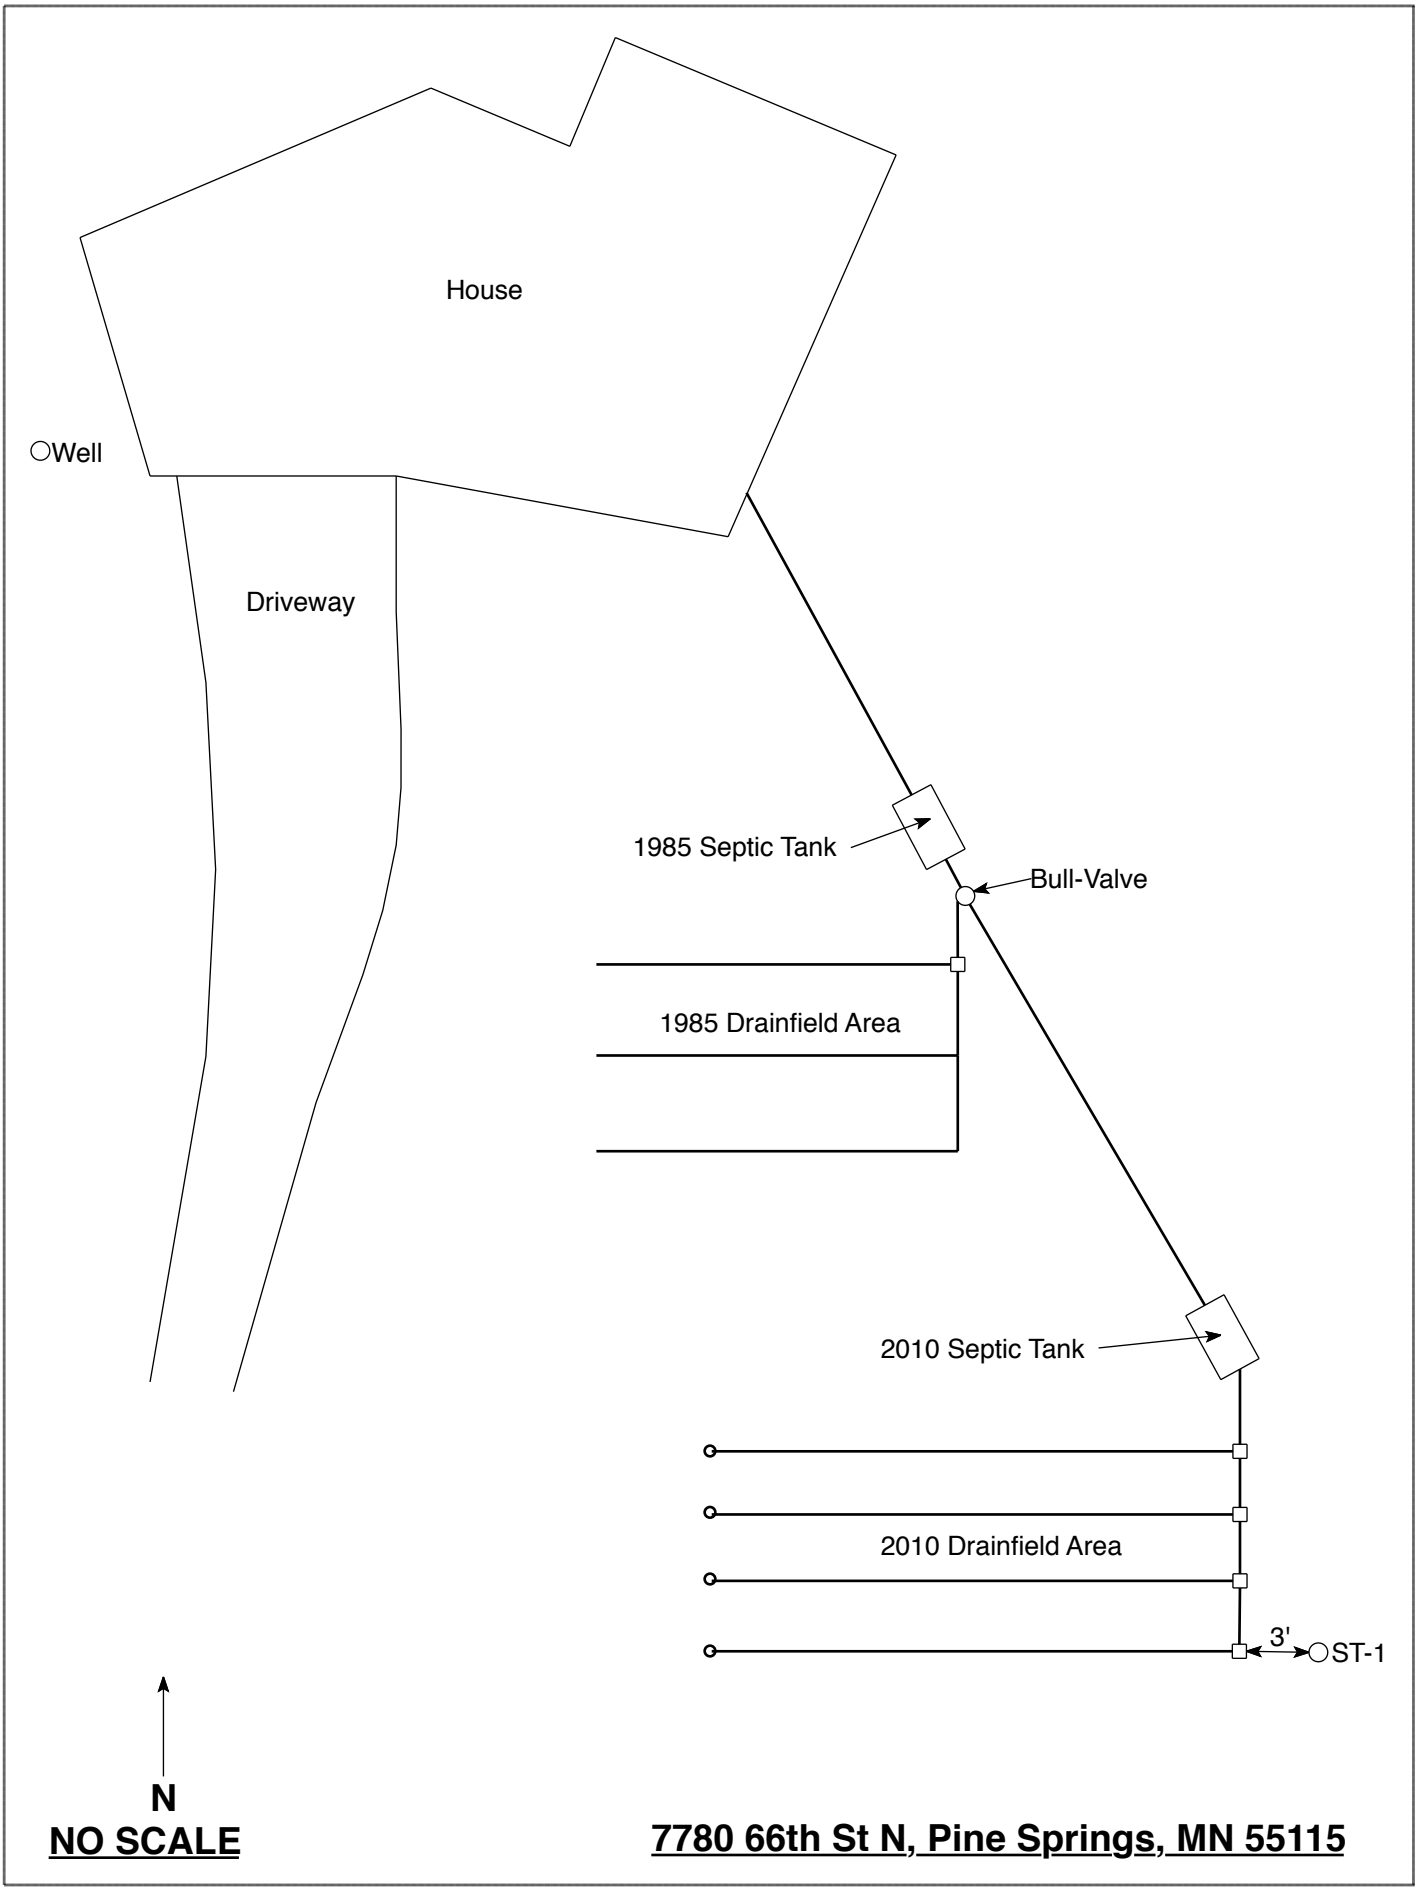
7780 66th St N, Pine Springs, MN 55115

This system consists of two pre-cast septic tanks, a "bull valve", and two separate rock trench drainfields (one drainfield was installed in 1985 and the other was installed in 2010). The "bull valve" allows the flow to be directed to one or both of the drainfields. The valve is currently set to allow flow to the 2010 drainfield. The 1985 system should be permanently disconnected.
