Midwest Sewer Services

SUBSURFACE SEWAGE TREATMENT SYSTEM (SSTS) COMPLIANCE REPORT

Inspection Address: 1411 Racine Ave S, Lake St Croix Beach, MN 55043

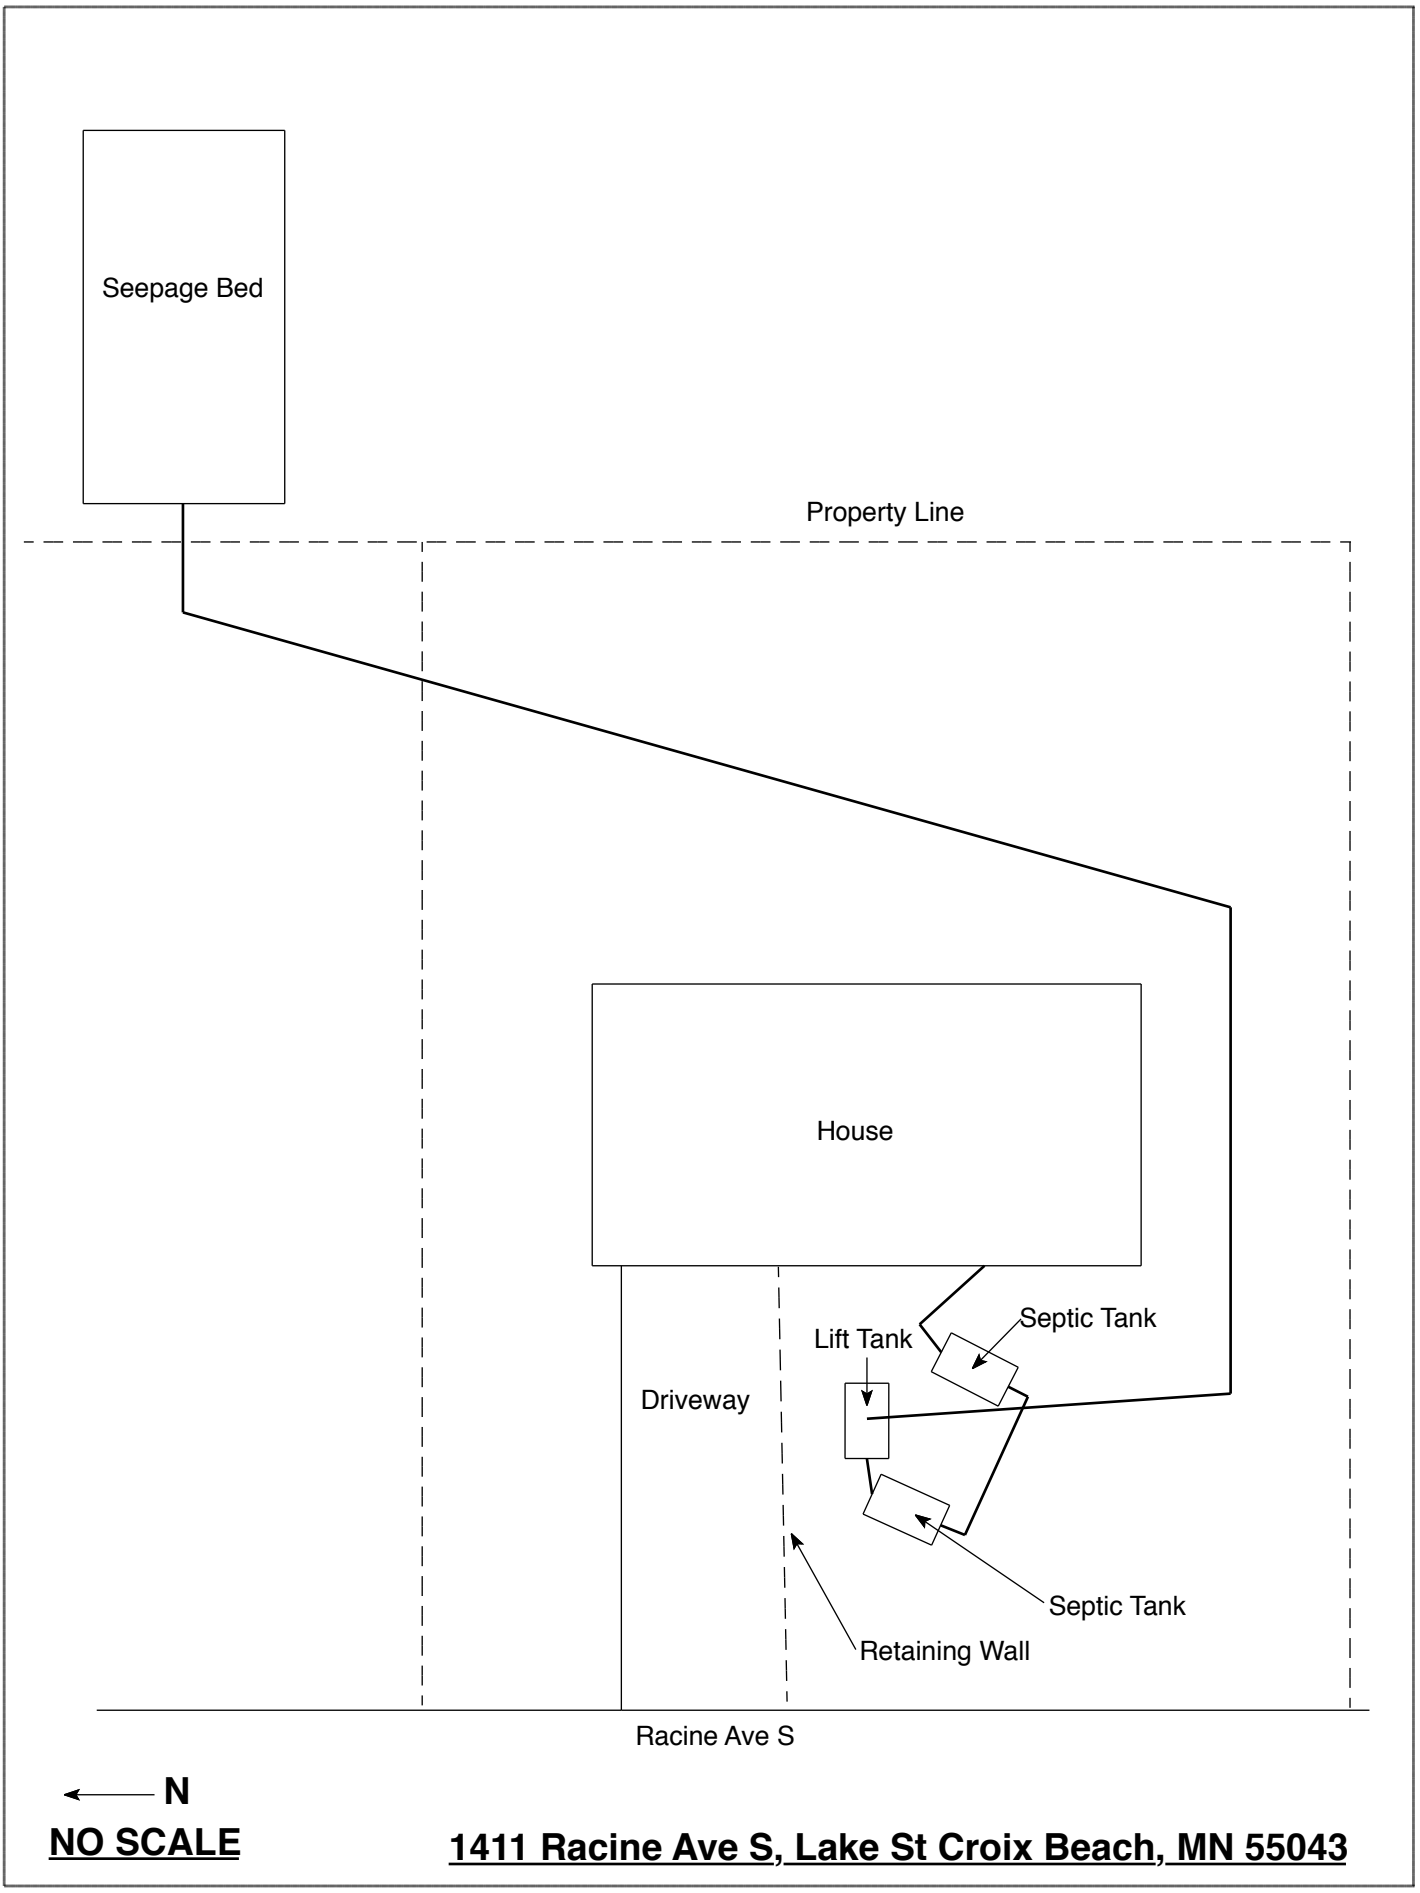
Although not compliance criteria, it should be noted that the seepage bed is located in an easement on the neighboring property. In addition, the septic tanks and lift tank are currently due for maintenance pumping and should be pumped when possible.

Seepage Bed
Property Line
House
Lift Tank
Septic Tank
Driveway
Septic Tank
Retaining Wall
Racine Ave S
N
NO SCALE
1411 Racine Ave S, Lake St Croix Beach, MN 55043

The septic tanks and lift tank are currently due for maintenance pumping and should be pumped when possible.
